PRELIMINARY INTERPRETIVE REPORT 2012-2

**ACTIVE AND POTENTIALLY ACTIVE FAULTS ALONG
THE ALASKA HIGHWAY CORRIDOR, TETLIN JUNCTION
TO THE CANADA BORDER**

Rich D. Koehler and Gary A. Carver

May 2012

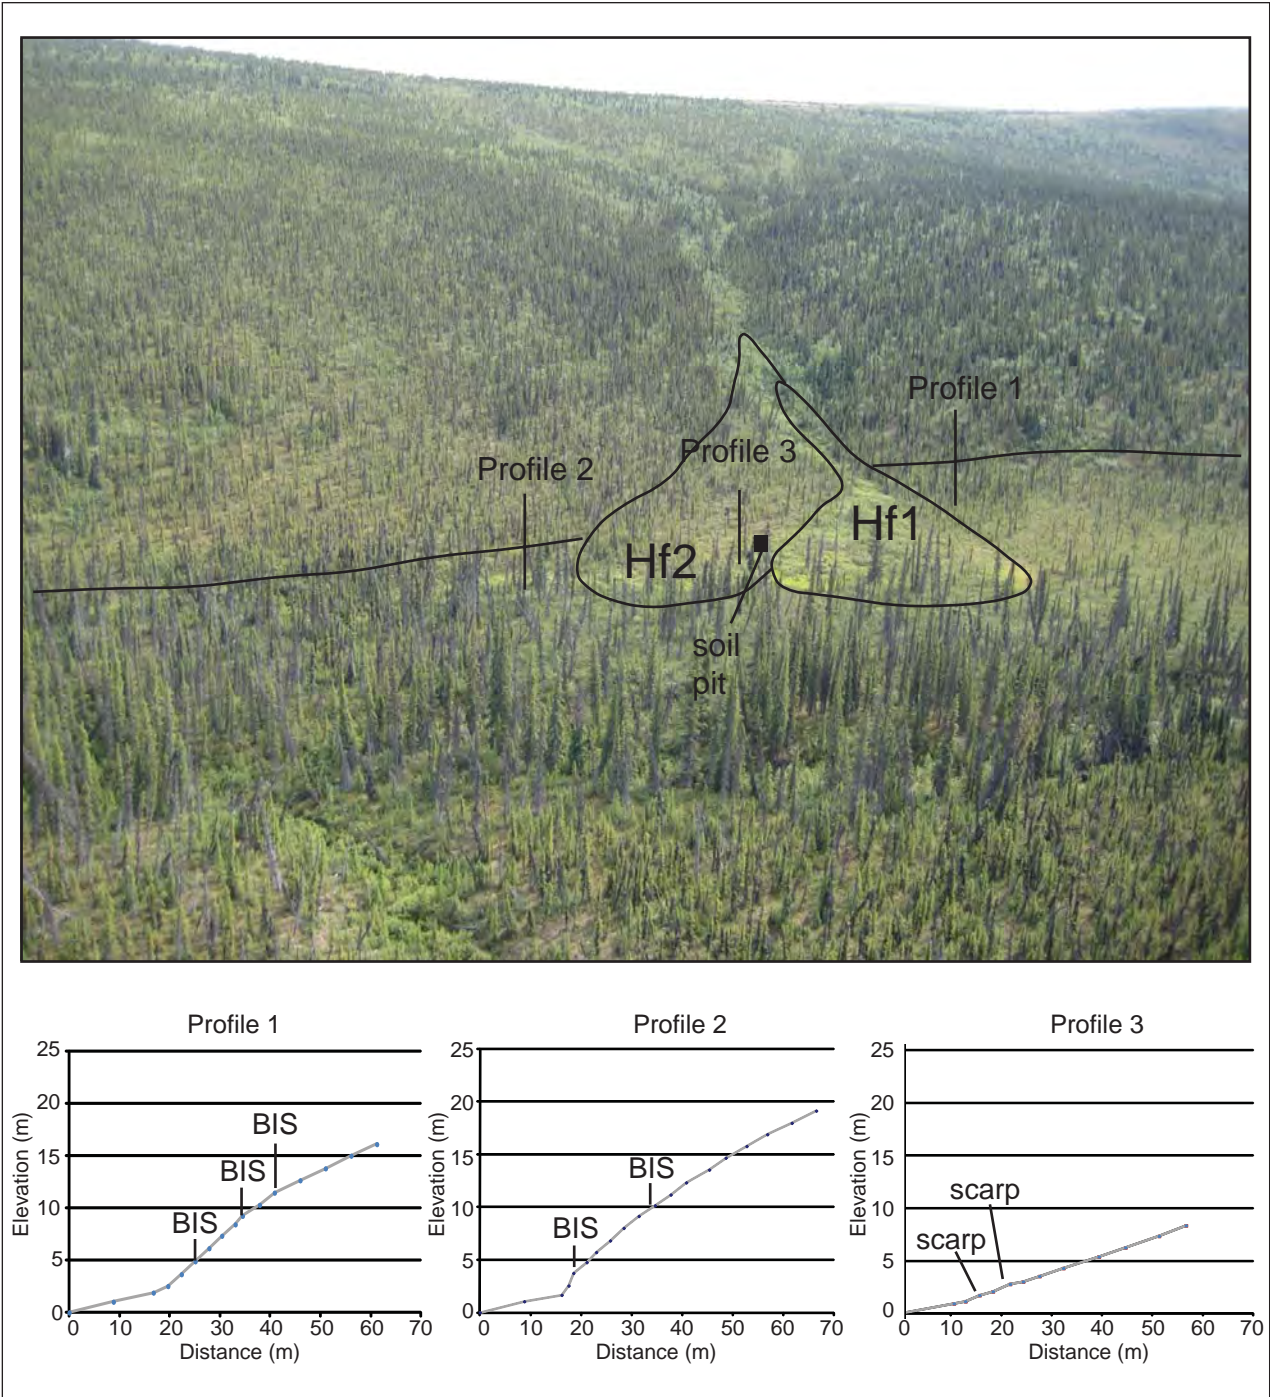
At OBS 3, a north-facing alluvial fan emanates from a broad colluvial hollow that occurs along the alignment of scarps (figs. 5 and 6). From the air, we noted the possibility of the fault extending part way across the eastern side of the fan. Subsequently, we conducted ground traverses along the fault and surveyed several topographic profiles to evaluate the recency of faulting in more detail. A semi-continuous bedrock scarp ranging from 2 to 10 m high extends along the base of the slope on either side of the fan (figs. 6 and 7). Scattered tabular boulders averaging 1–2 m in diameter are present at the base of the scarp. Profiles 1 and 2 were surveyed across the scarp west and east of the fan, respectively. These profiles show the scarp is gently sloping, but contains several subtle breaks in slope (bevels?). Profile 2 has an oversteepened base; however this feature is localized. Profile 3 was surveyed across the projection of the scarp in the older part of the alluvial fan (surface Hf2, fig. 6), where we observed two

Figure 6. Photograph of alluvial fan crossing the upland segment of the Caribou Creek fault, showing locations of profiles 1, 2, and 3 and soil pit on Hf2 surface. Location of alluvial fan shown in figure 5 as OBS3. BIS; break in slope. Coordinates for endpoints of profiles are: Profile 1, 63.4226, -142.1488 and 63.4231, -142.1490; Profile 2, 63.4247, -142.1439 and 63.4241, -142.1435; and Profile 3, 63.4240, -142.1459 and 63.4236, -142.1456.

semi-parallel breaks in slope. The profile indicates that the breaks in slope occur across two <1-m-high scarps. The scarps do not continue across the inset fan surface (surface Hf1). A soil pit excavated into the Hf2 surface adjacent to profile 3 indicates that the surface is likely Holocene in age (fig. 8). Although we cannot preclude that the scarps are tectonic in origin without subsurface observations, the lack of similar scarps along the length of the fault indicates that an alternative mechanism is responsible for their formation. Possible mechanisms include erosion by floodwaters emanating from the mouth of the canyon, fan deposition associated with draping over a preexisting bedrock scarp, or game trails, or both.

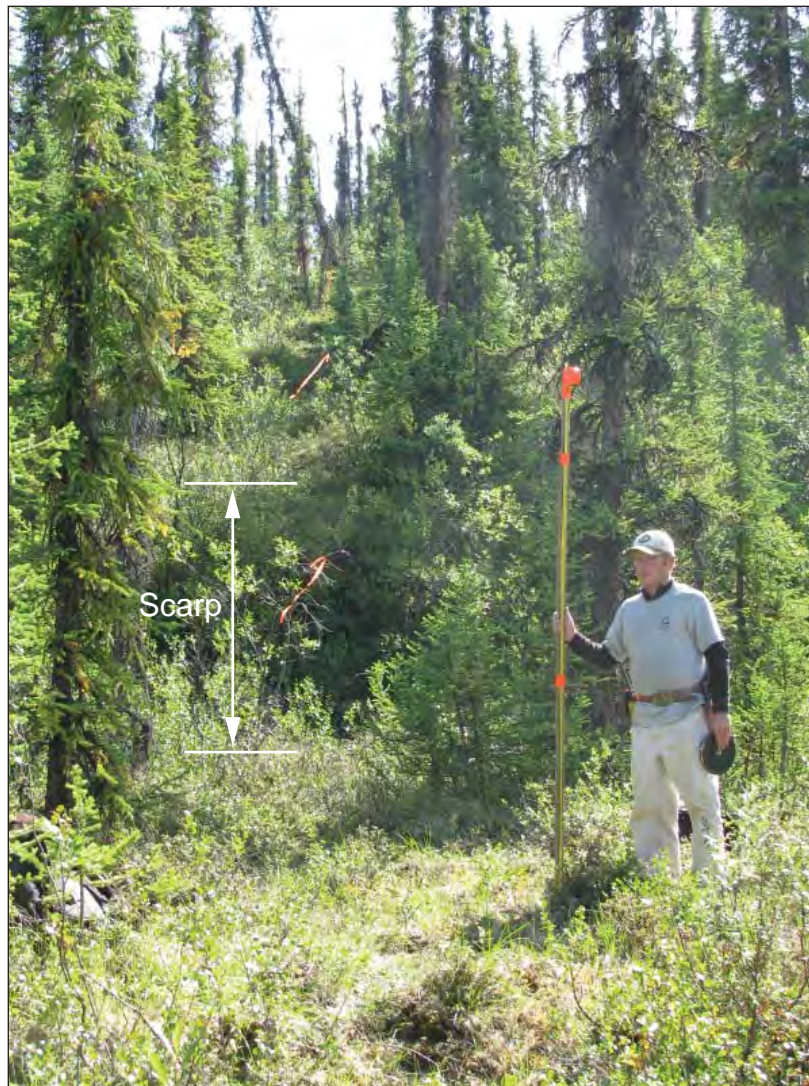
Figure 7. Photograph of scarp at Profile 2, showing oversteepened base. Geologist and 2.25 m survey rod for scale. Location of Profile 2 shown in figure 6.

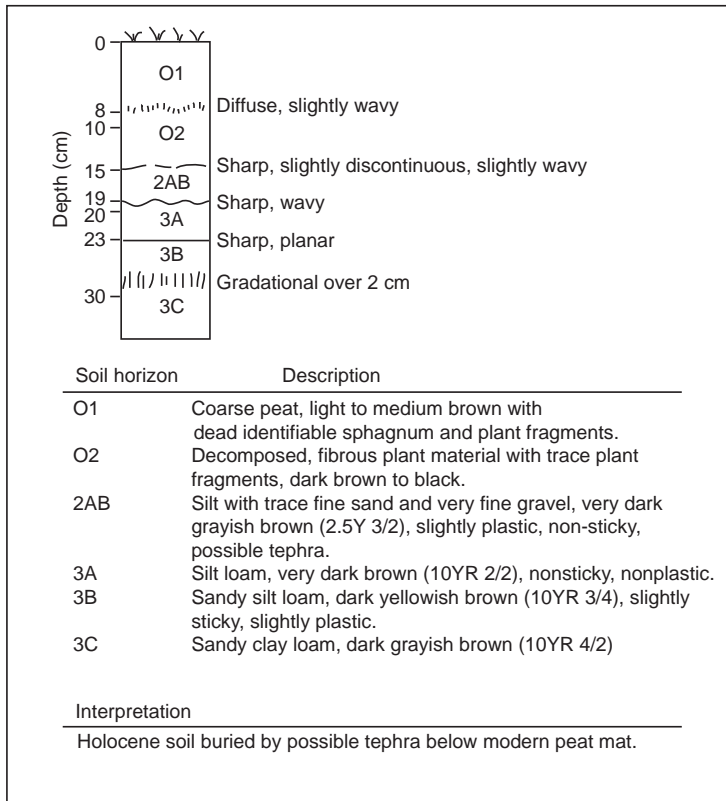
Figure 8. Soil profile and description of soil pit excavated adjacent to profile 3 on the Hf2 alluvial fan surface along the Caribou Creek fault zone. Soil pit coordinates: 63.4238, -142.1457; location shown in figure 6.

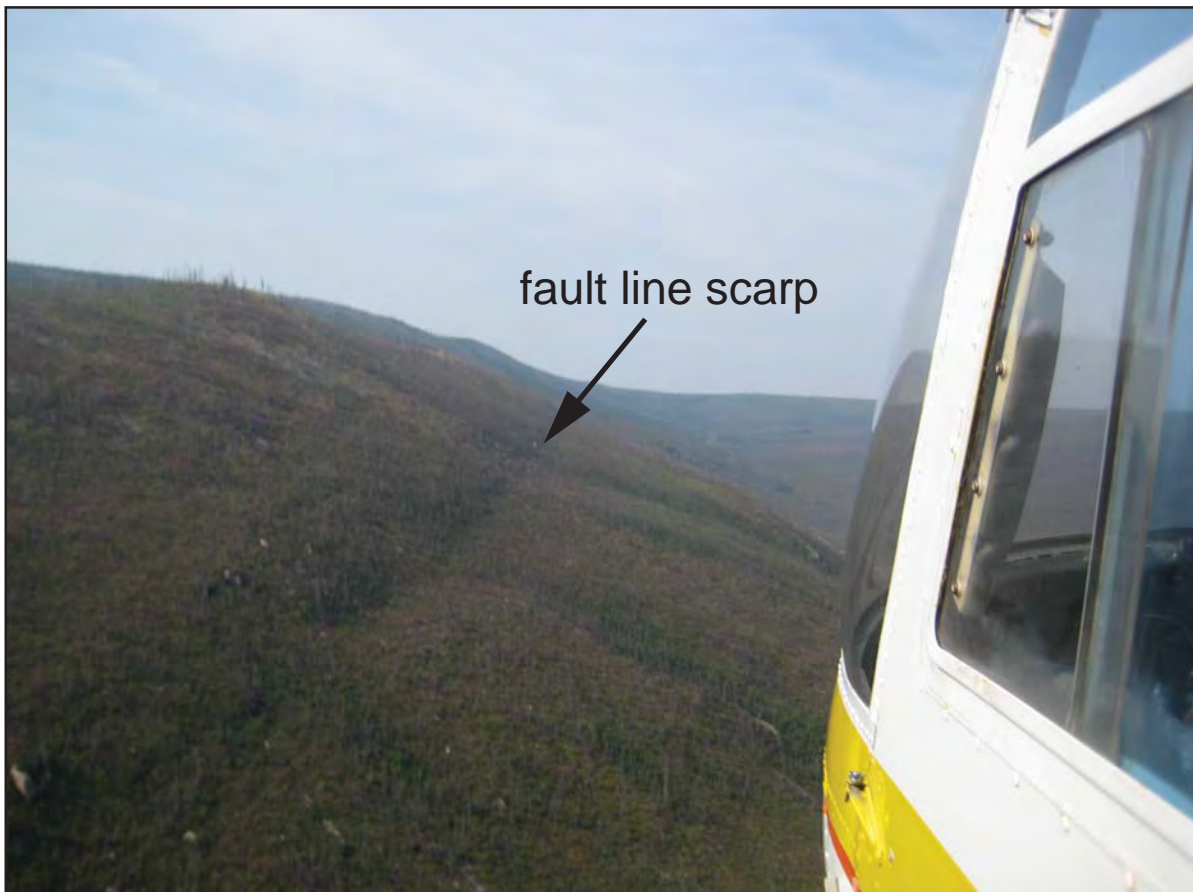
Figure 9. View westward along the upland segment of the Caribou Creek fault, showing fault-line scarp traversing gently north-facing slope. Location of scarp is shown in figure 5 (OBS4). Photo taken from the air near coordinates 63.3967, -142.2726.

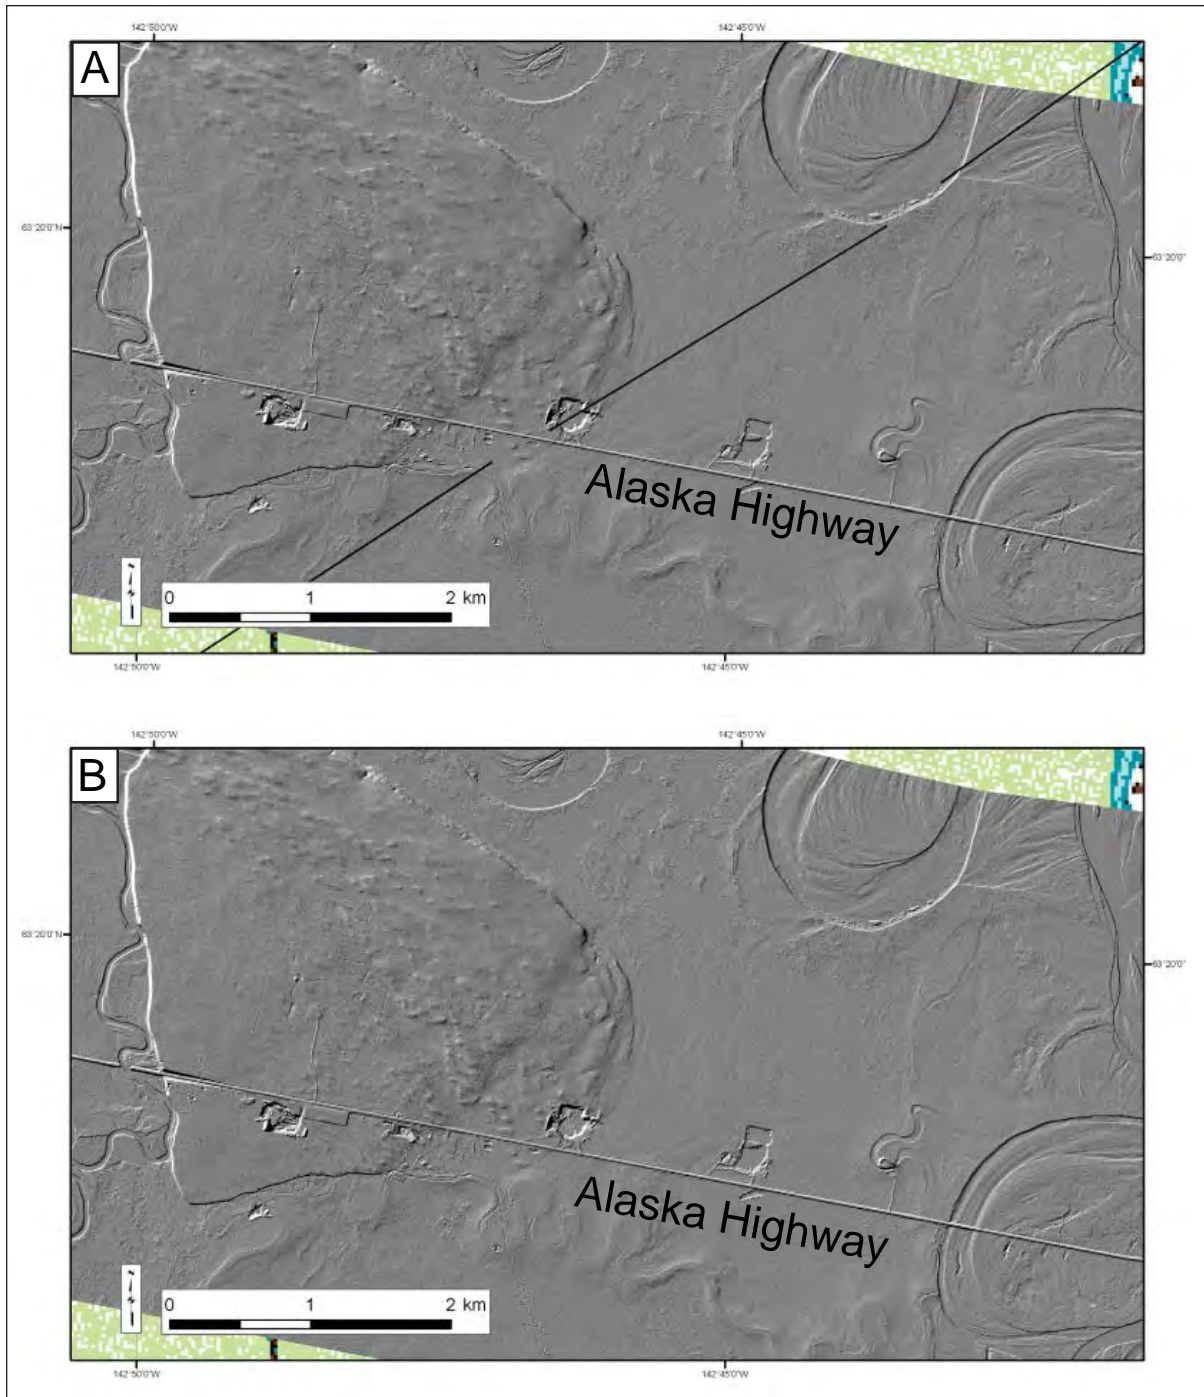
We inspected the lidar data visually on-screen at a scale of 1:6,000 to determine the presence or absence of scarps, offset deposits, deflected streams, and other tectonically related features. Previously mapped potential faults observed in the field during this investigation and covered by the lidar data include the Dennison Fork fault, Caribou fault, and the Midway Lakes faults. Hillshade images of the mapped traces of these faults are shown on figures 12–14. These figures also show identical images with the faults removed. The Dennison Fork fault extends across several floodplain deposits of different age associated with the Tanana River and is not expressed in the hillshade image (fig. 12). The Caribou fault also extends across Tanana River floodplain deposits as well as terraces on the north bank of the river, and sand dunes deposited on the south-facing slope of the uplands, none of which show any evidence of displacement (fig. 13). Similarly, the Midway Lakes faults are not expressed across bedrock hills, colluvial sideslopes, and floodplain deposits along their mapped traces (fig. 14). Observations derived from inspection of the lidar images, including the lack of displacement of youthful sediments and negligible topographic expression, further substantiate our field observations and demonstrate that the Dennison Fork fault, Caribou fault, and Midway Lakes faults have not been active in Holocene and likely Quaternary time.

Figure 12. (A) Lidar hillshade images showing the mapped trace of the Dennison Fork fault (Woodward–Clyde Consultants, 1981). (B) Same image as A without the mapped trace, showing the lack of tectonic features in the landscape.

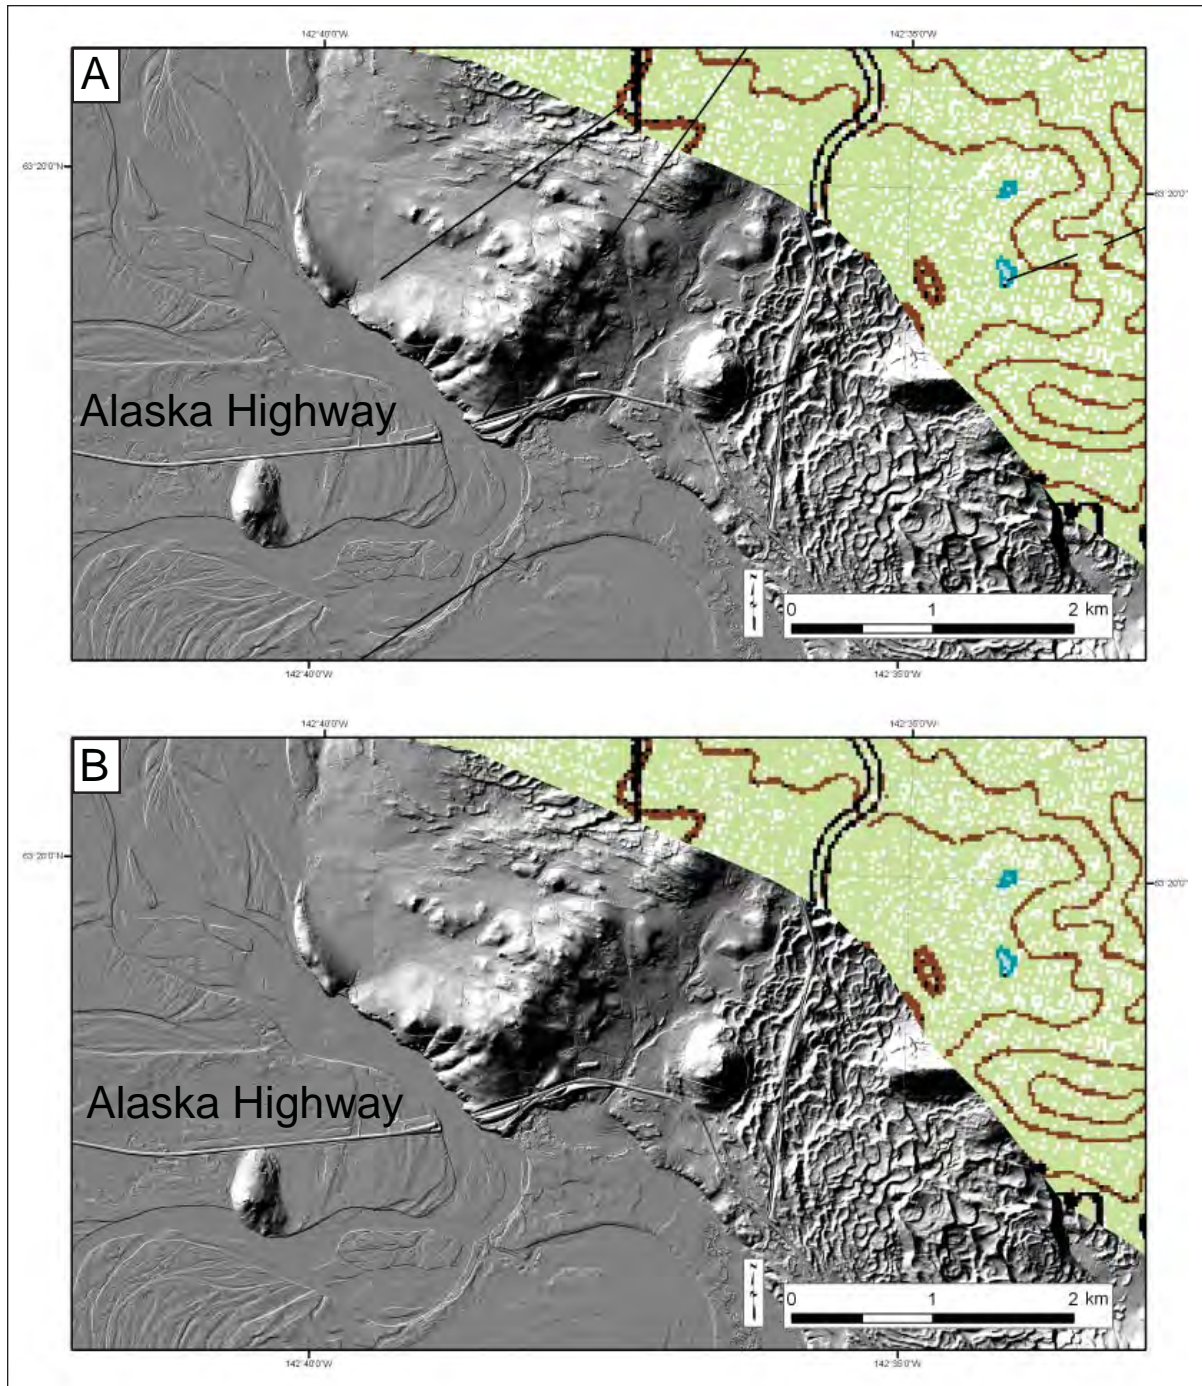
Figure 13. (A) Lidar hillshade images showing the mapped trace of the Caribou Creek fault (Woodward–Clyde Consultants, 1981). (B) Same image as A without the mapped trace, showing the lack of tectonic features in the landscape.

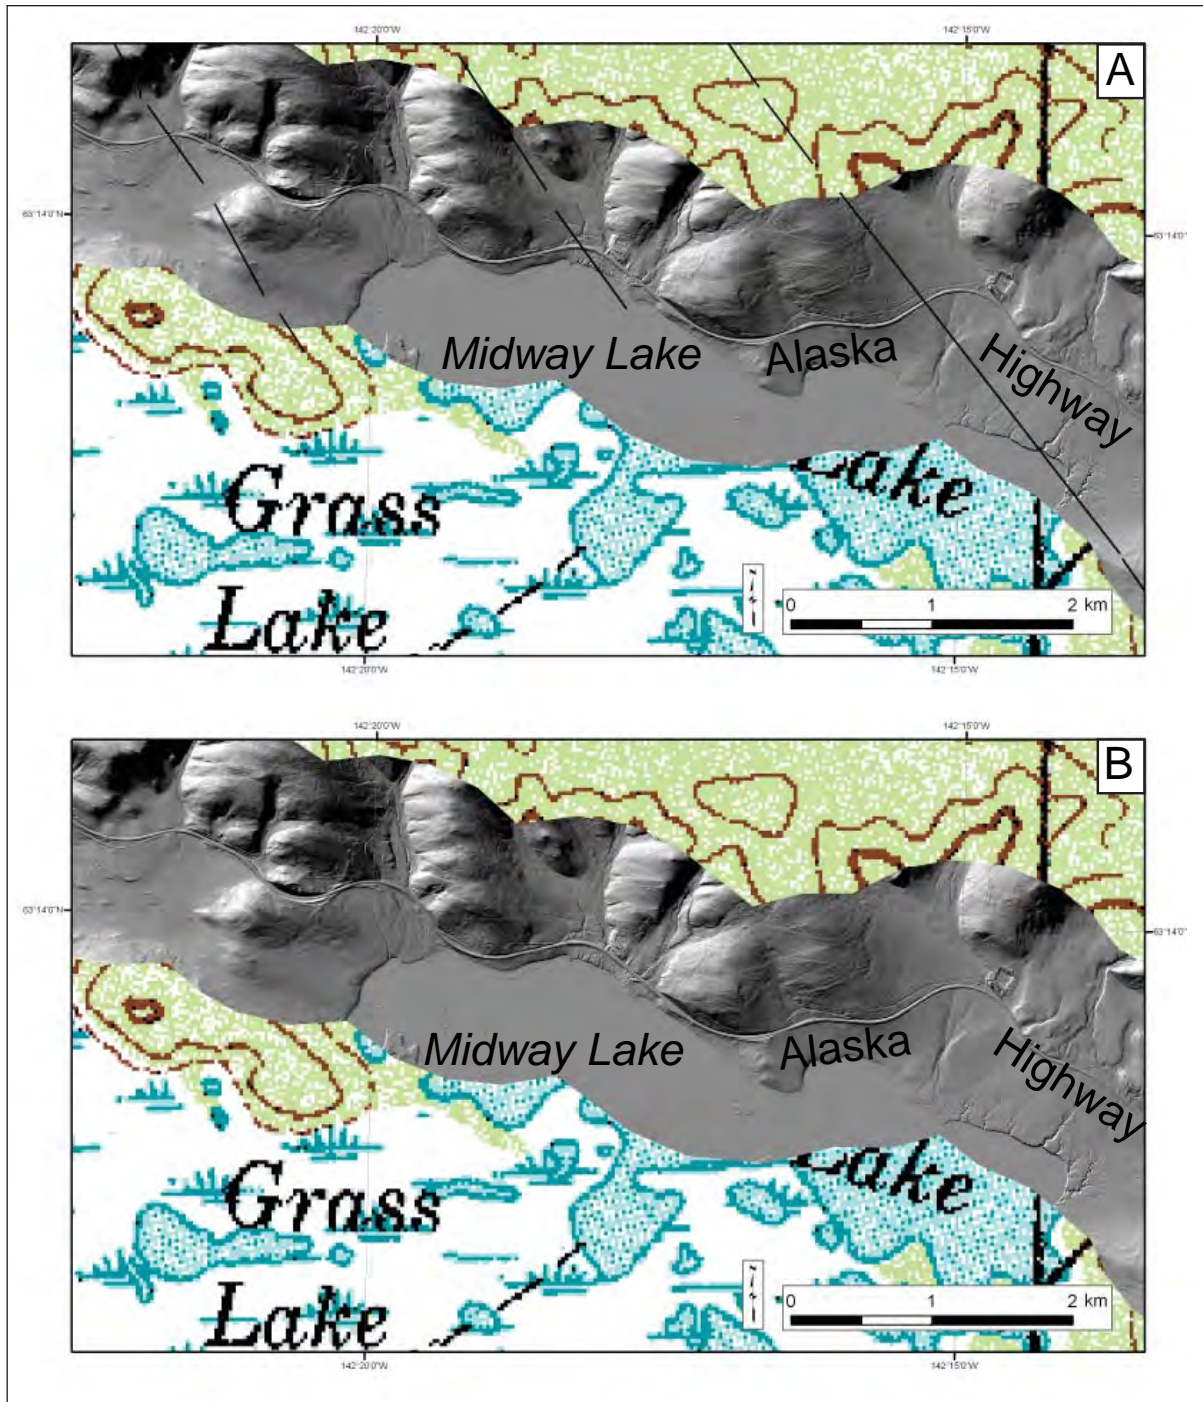
Figure 14. (A) Lidar hillshade images showing the mapped trace of the Midway Lake faults (Woodward–Clyde Consultants, 1981). (B) Same image as A without the mapped trace, showing the lack of tectonic features in the landscape.

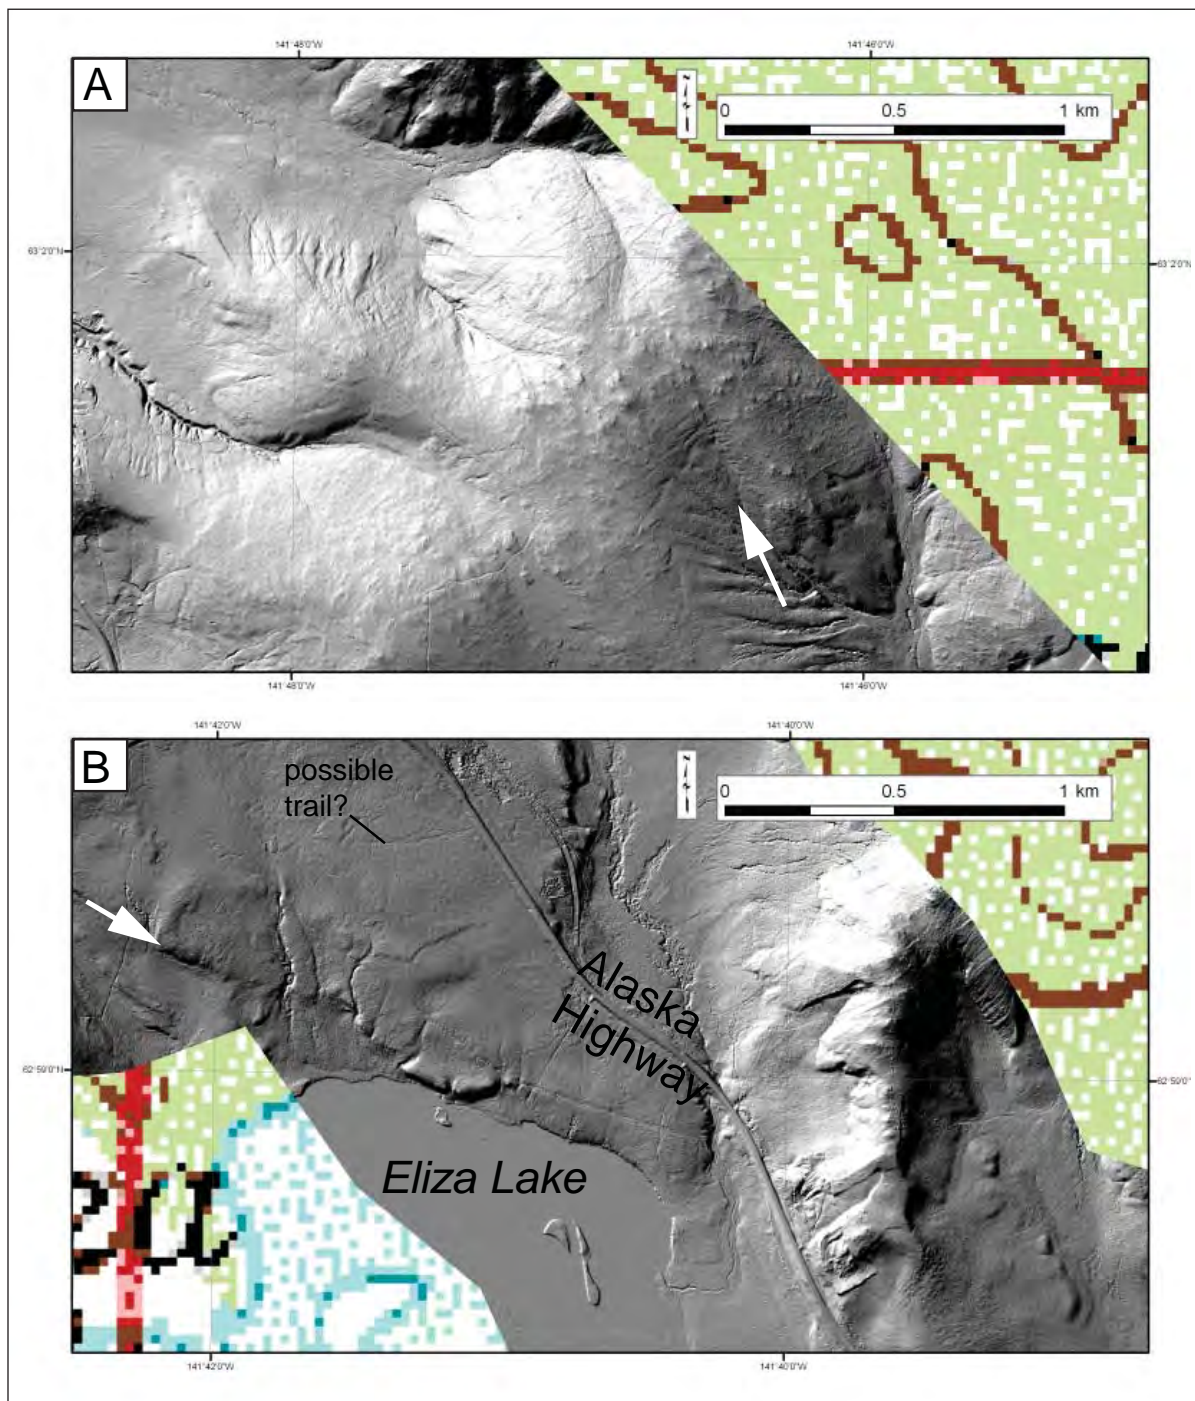
Several lineaments observed on the lidar hillshade images are of suspicious origin. A north–northwest-trending lineament was observed extending across the bedrock hills 2.2 km north of Northway Junction southeast of the Northway Junction faults (fig. 15A). This feature is approximately 1 km long and is characterized by a linear valley extending across the crest of a broad bedrock hill, and a subtle linear drainage. The feature is not expressed along the lower colluvial slopes of the hill to the southeast and does not extend across the Tanana River floodplain deposits. Several linear features extend orthogonal to the feature on the crest of the hill. Based on its short length and lack of expression in Quaternary sediments, we suspect that this feature is an inactive bedrock fault and that the orthogonal features may be joints.

Another suspicious lineament was observed approximately 5 km southeast of Northway Junction. This lineament is about 2 km long and extends northwest from the northern side of Eliza Lake (fig. 15B). The lineament is characterized by several south–southwest-facing escarpments in bedrock with a mantle of eolian deposits. The scarp appears to continue to the northwest for a short distance but is diminished in size. A small scarp that may extend across Quaternary deposits is present along the base of the bedrock escarpment near the center of the lineament. Based on the lack of continuity of this small scarp and the length of the bedrock escarpment, as well as the lack of escarpments in the Tanana River floodplain sediments southeast of Eliza Lake, we suspect that the lineament is not a youthful fault. The escarpment may be a relict bedrock escarpment that has been buried by eolian deposition. However, because the lineament was not inspected in the field we cannot preclude it is a tectonic fault. North of this escarpment, a subtle sinuous lineament was observed (fig. 15B); this feature is also discontinuous and may be a game trail or drainage channel.

Figure 15. Suspicious features identified during inspection of lidar hillshade images (not field checked). Features indicated by white arrows. (A) Lineament extending across the crest of a rounded bedrock hill 2.2 km north of Northway Junction. (B) Lineament extending parallel to the base of the hills along the northern margin of the lowlands near Eliza Lake about 5 km southeast of Northway Junction.
