**PRELIMINARY INTERPRETIVE REPORT 2010-1**

**ACTIVE AND POTENTIALLY ACTIVE FAULTS IN OR  
NEAR THE ALASKA HIGHWAY CORRIDOR, DOT LAKE  
TO TETLIN JUNCTION, ALASKA**

September 2010

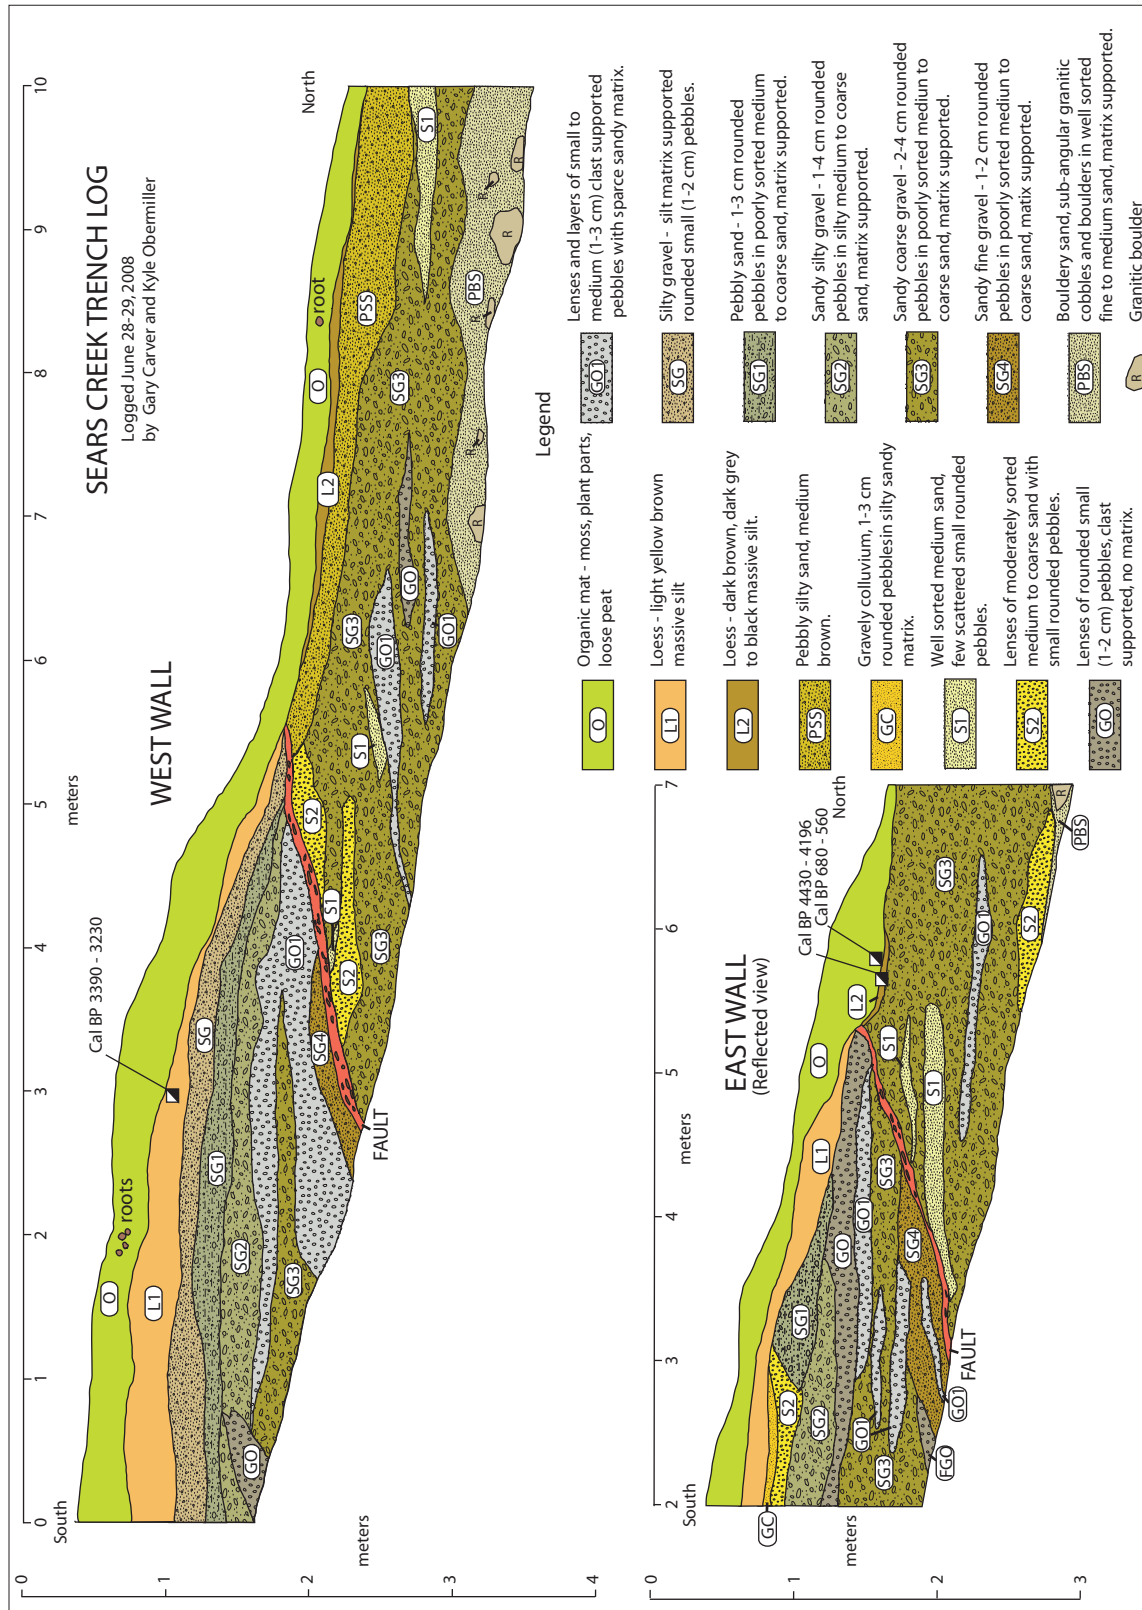
Figure 4. Log of the Sears Creek trench across the Dot "T" Johnson fault adjacent to the Alaska Highway near Sears Creek. The locations and 2-sigma calibrated ages of radiocarbon samples that limit the timing of faulting are shown on the log.

Two additional trenches were dug with a large track-mounted excavator across the Dot “T” Johnson fault during the 2008 field season, the Sears Creek and D“T”J III trenches (fig. 3). The Sears Creek trench was located across a 2-m-high north-facing scarp about 20 m north of the Alaska Highway and 100 m west of Sears Creek. The trench exposed a south-dipping low-angle thrust fault that offsets interbeds and lenses of fluvial sand, gravel, and overlying silt and loess (fig. 4).

The fault truncates beds and lenses in both the hanging wall and footwall and is marked in the trench by a single 2–4-cm-wide planar zone of mixed silt and sandy silt containing tabular pebbles and cobbles aligned along the fault (fig. 4). The fault dips  $12^\circ$  to  $14^\circ$  to the south and daylights at the base of the scarp. No secondary or branch faults were observed in the trench. Beds could not be matched across the fault in the 1.5-m-high trench wall exposures, and no evidence of multiple slip episodes were found in the trench, suggesting the dip-slip displacement on the most recent event was at least 3 m and resulted from a single earthquake. No organic material was found in the fluvial gravels, but detrital charcoal recovered from the base of the overlying silt and loess yielded  $^{14}\text{C}$  ages that limit the fault displacement to more recent than 4,430–3,230 cal BP. The base of an unfaulted organic mat capping the silt and loess dated to 650–560 cal BP.

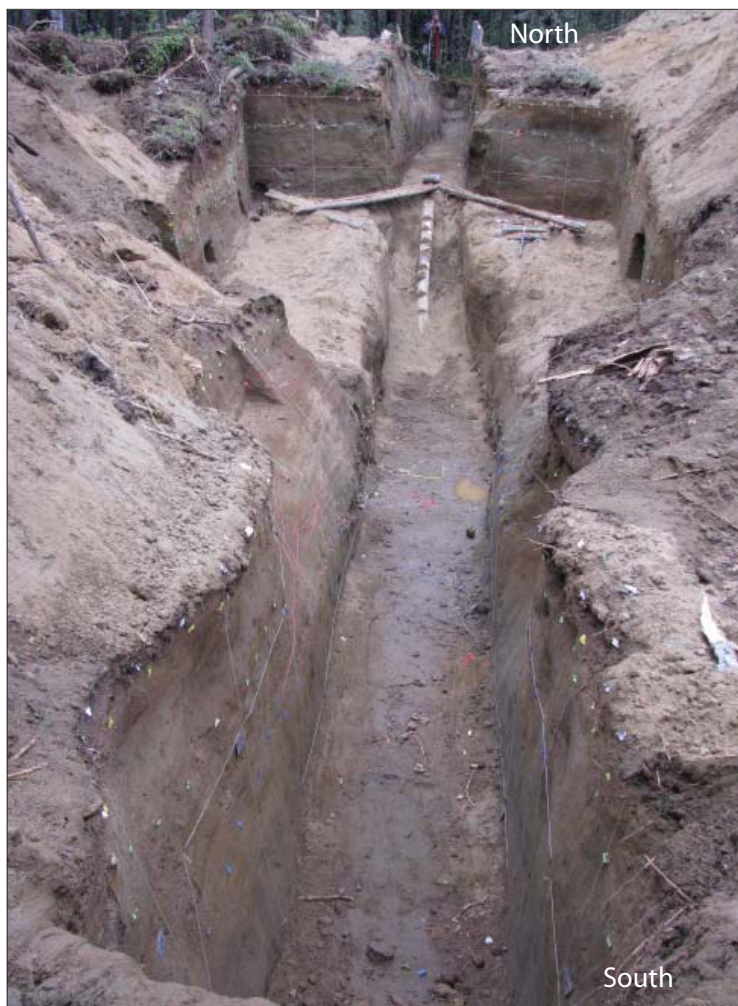
Figure 5. Dot “T” Johnson trench D“T”J III viewed from the south. The trench consisted of a benched central part with shallower unbenched north and south sections. Two people are standing at the north end of the trench for scale.

The second trench excavated across the Dot “T” Johnson fault (trench D“T”J III) during the 2008 field season was about 300 m west of trench D“T”J I, where the moletrack scarp transitions into a 4-m-high, south-facing planar scarp. The trench was excavated in three sections, a 10-m-long, 2-m-deep north section in the hanging wall above the crest of the scarp, a 9-m-long, 3.5-m-deep benched middle section across the scarp, and an 8-m-long, 2-m-deep south section in the footwall (figs. 5–8).

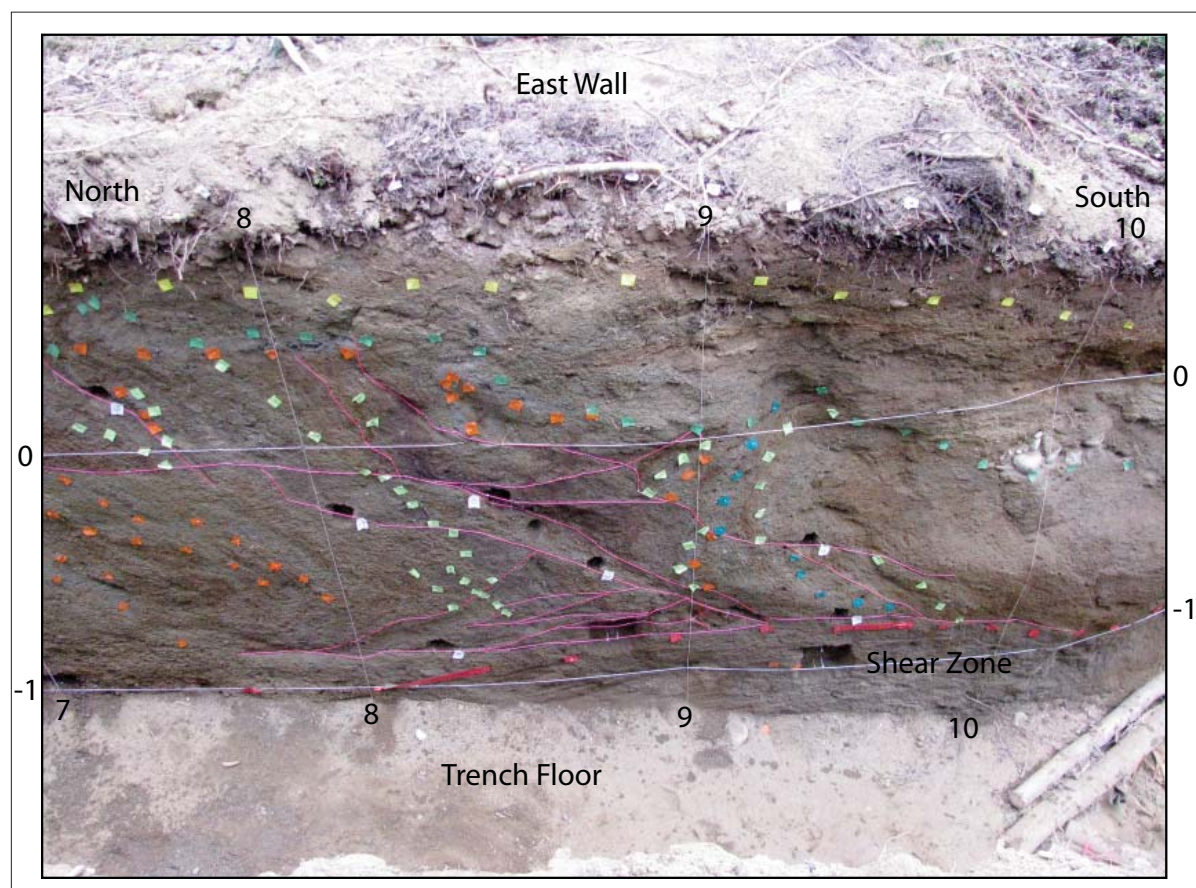
Figure 6. Close-up view of a section of the east wall of trench D“T”J III. The red lines mark small conjugate thrust faults in the hanging wall near the top of the scarp. The steeply dipping beds marked by the light green, blue, and orange flagging are in the detached noses of overturned fault propagation folds. At the base of the trench, the red-flagged contact marks the top of a shear zone that constitutes the principal thrust fault.

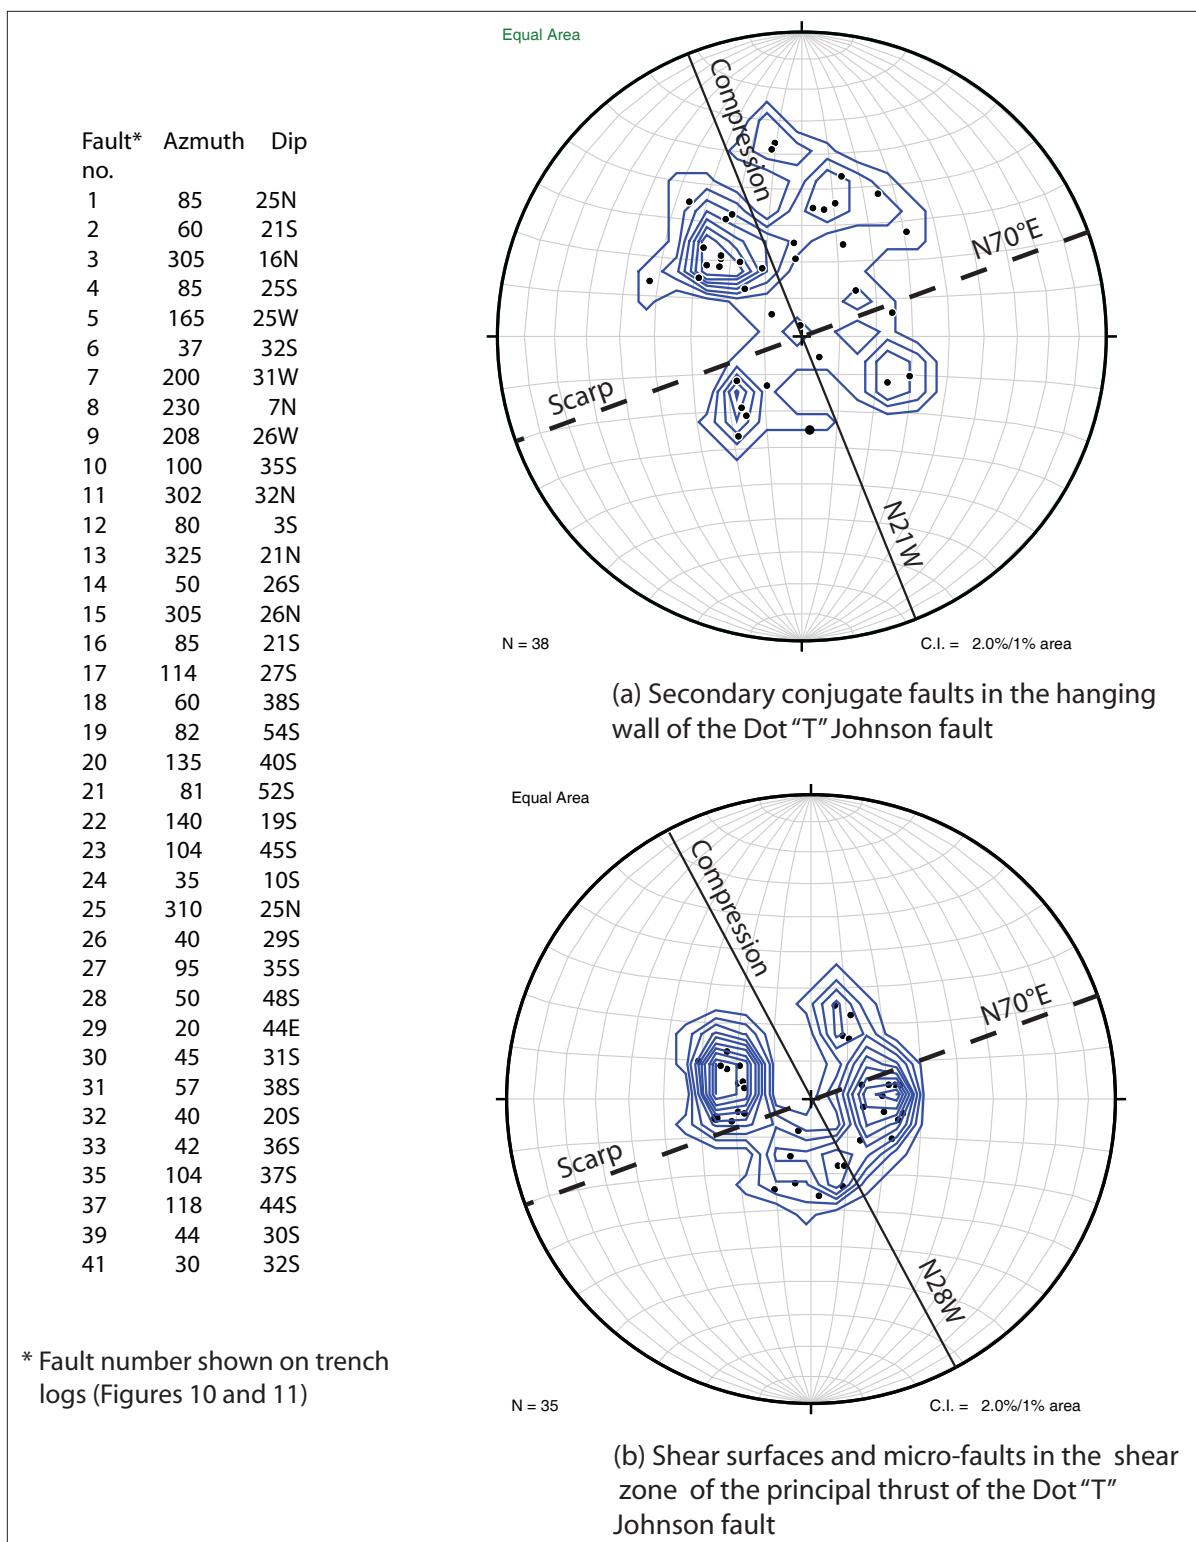
Figure 11. Stereogram plots of poles to planes of secondary conjugate faults in the hanging wall (a) and shears and micro-faults in the principal thrust (b) of the Dot "T" Johnson fault measured in trench D "T" J III. The stereograms also show the trend of the scarp at the trench site and best fit orientation of the axis of principal compression ( $\sigma_1$ ) from the secondary conjugate faults in the hanging wall and the micro-faults and shears in the principal thrust fault shear zone.

the scarp. The shear zone is more than a meter thick in the north part of the trench and thins beneath the scarp to a tapered fault tip beneath the toe of the scarp. The fault does not daylight, but ends at the fault tip in the top of the flood deposits about a meter beneath the ground surface. Overlying fluvial and colluvial sediments and soil are warped up over the tapered shear zone and fault tip. The geometry of the shear zone indicates much of the growth of the scarp has resulted from internal thickening of the shear zone by nearly horizontal thrust displacement on the closely spaced micro-faults and inter-granular shears in the coarse flood sands. The dip of micro-faults and shears in the primary thrust zone were between about  $10^\circ$  and  $25^\circ$  and their average strike about  $N28^\circ W$ , nearly perpendicular to the  $N70^\circ E$  trend of the scarp (fig. 11).

Structural analysis of the complex faulting pattern in the hanging wall of the fault exposed in D“T”J III trench shows the displacement on the thrust is nearly pure dip-slip and the orientation of the principal compression axis

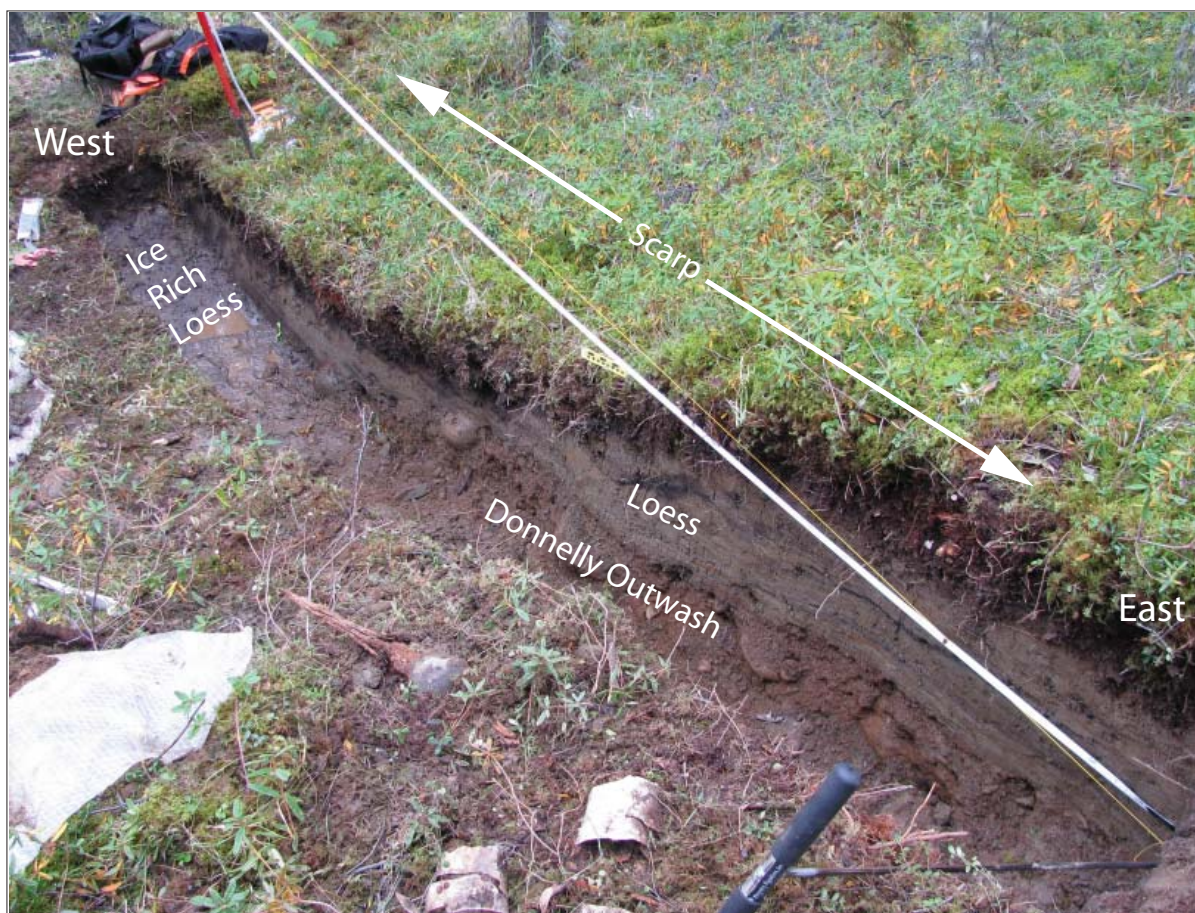
Figure 13. Oblique photo of the Bear Creek trench. No evidence of faulting was observed in the trench, and the contact between the Donnelly outwash and loess was not offset in the upper part of the trench. However, the ice-rich frozen loess prevented excavation of the outwash-loess contact in the lower part of the trench at the base of the scarp where a fault would be expected to daylight. Thus we consider the trench to be inconclusive in demonstrating a lack of faulting.

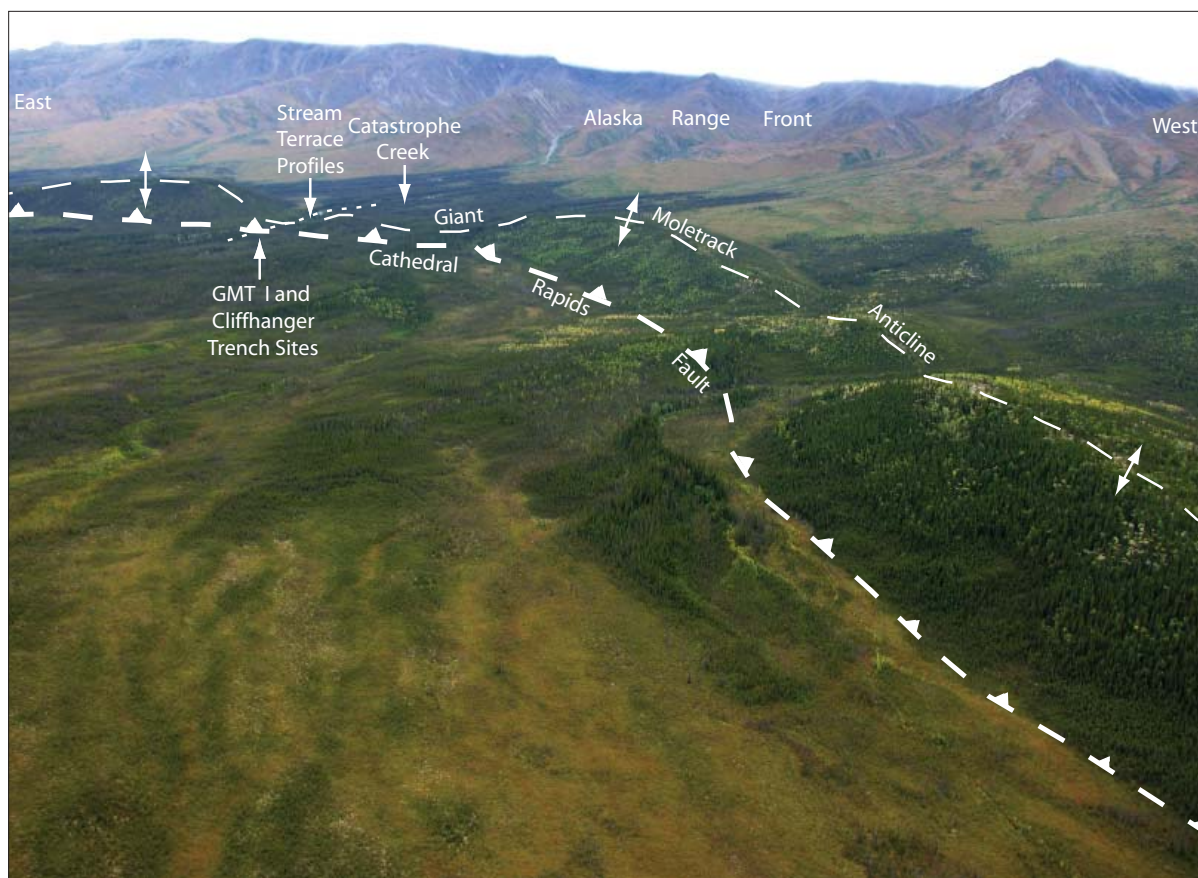
Figure 15. Oblique aerial view looking to the southeast along the central section of the Cathedral Rapids fault and western segment of the Giant Moletrack anticline ridge. The location of the measured stream terrace profiles along Catastrophe Creek and sites of the Cliffhanger and GMT I trenches are shown in the upper left part of the photo.

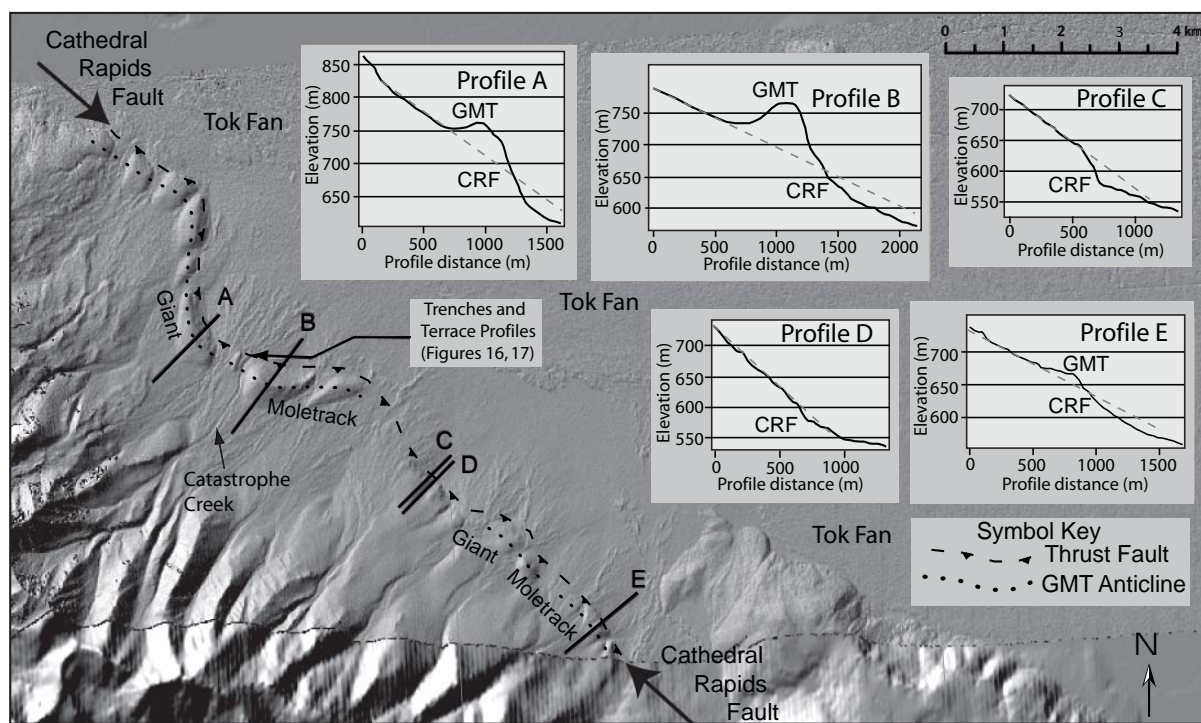
Figure 16. Shaded-relief digital elevation model (DEM) view of the Giant Moletrack and adjacent Cathedral Rapids fault scarp. A 5-m-resolution AirSAR DEM covers the area of the Giant Moletrack anticline and adjacent Cathedral Rapids fault scarp. This DEM is superimposed on the USGS National Elevation Dataset DEM with 30-m resolution to show the relief of the adjacent areas south of the coverage of the AirSAR. The sinuous Cathedral Rapids fault scarp (dashed thrust fault symbol) and Giant Moletrack anticline axis (dotted line) occur outboard of the range front on a wide piedmont apron of coalescing alluvial fans where small streams emanating from the mountains cross the piedmont apron. Profiles A–E (labeled solid lines on the image and solid lines on the inset profile diagrams) were measured using the AirSAR digital data across the anticline and fault scarp. The anticline ridge is labeled GMT and the Cathedral Rapids fault is labeled CRF on the profiles. The gray dashed lines on the profile diagrams illustrate the minimum vertical offset of Quaternary alluvial deposits across the fault. The ages of the alluvial surfaces that these profiles transect are unknown, but the surfaces downhill (on the footwall) of the scarp are younger due to alluvial deposits from drainages that have incised through the scarp. Note the anticline does not appear on profiles C and D.

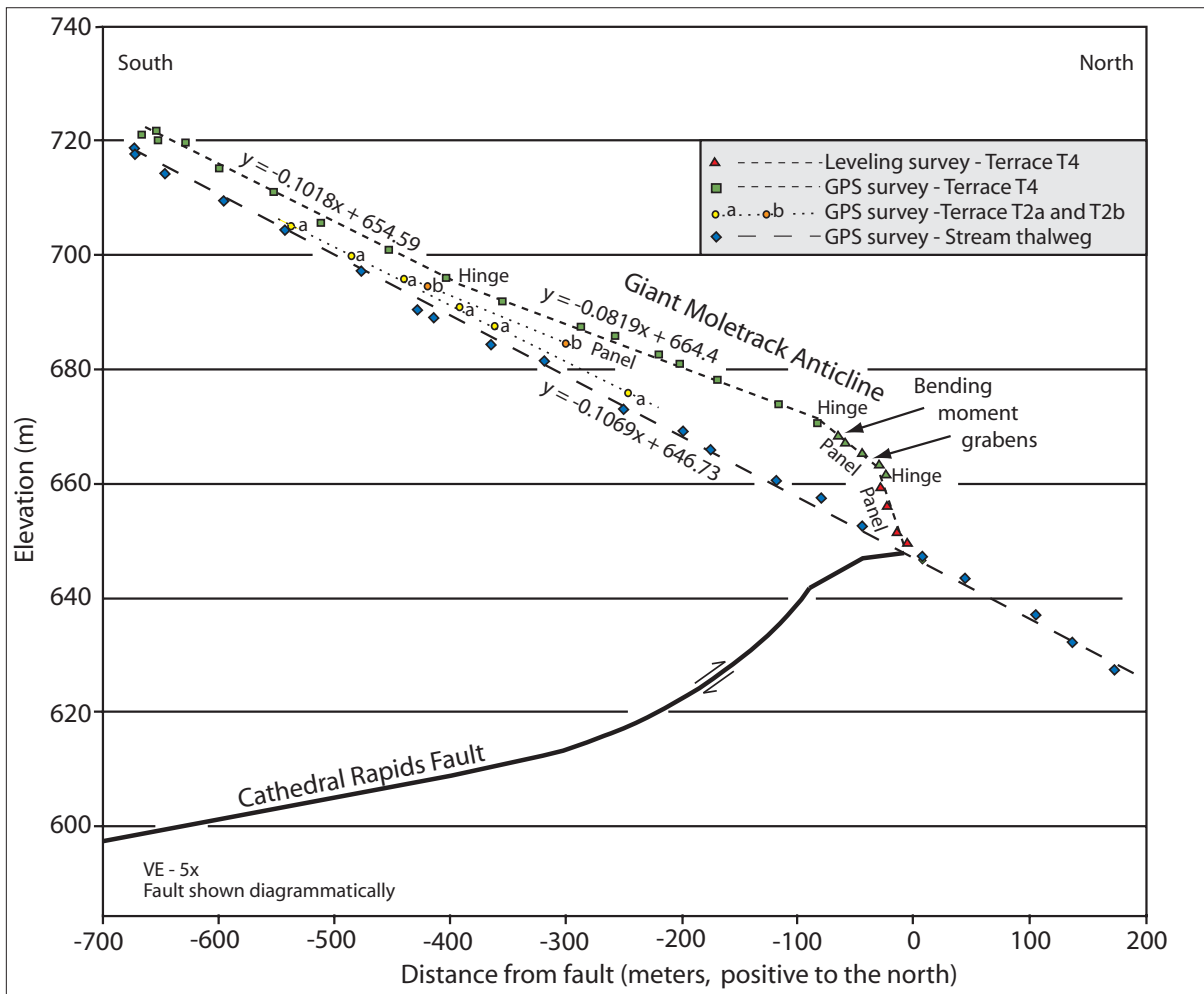
Figure 17. Differential GPS topographic profiles of stream terraces across the Giant Moletrack anticline and Cathedral Rapids fault scarp. Stream survey points (green diamonds) were collected along the thalweg of the streambed of the ephemeral, informally named Catastrophe Creek. The stream thalweg profile is shown with the long-dashed line. Terraces T2a and T2b are discontinuous, low terraces with <2 m elevation differences (yellow circles and dotted lines). Terrace T4 (green squares and short-dashed line) is a distinct, continuous terrace that is easily followed for its entire length. Equations are linear regressions for the two long, near-planar segments of T4 and the thalweg profile of Catastrophe Creek. The red triangles were obtained from a leveling survey across the forelimb panels of folded Terrace T4. The back tilting of the central panel of Terrace T4 relative to the stream profile likely results from a listric fault in the near surface (Amos and others, 2007). Location and dip of the fault in the subsurface is shown diagrammatically.

Two segments of T4, one upslope of the anticline and the other across the anticline, were fit by linear regressions to distinguish planar panels that are separated by narrow hinges (fig. 17). The upstream segment of T4 is nearly parallel to Catastrophe Creek and thus has likely uplifted monotonically over a planar thrust fault segment

at depth. The downstream segment of T4 is distinctly back-tilted relative to the stream gradient, indicating a change in fault geometry (a listric ramp) as the fault plane approaches the surface. Amos and others (2007) observed similar terrace geometry on active thrust faults in New Zealand, and demonstrated that the back tilting of terraces could most easily be explained by a listric fault in the subsurface. To the north, beyond the back-tilted segment of T4, the terrace surface gradually steepens to where it abruptly drops off at the north-facing forelimb and scarp (fig. 17). This terrace does not appear at the surface downslope of the fault scarp due to presence of younger alluvial fan deposits covering the footwall. Slope processes and lateral incision during alluvial fan formation has locally modified the steep face of the anticline forelimb and fault scarp, but it is clear that the T4 terrace surface is dramatically folded to form this scarp face.

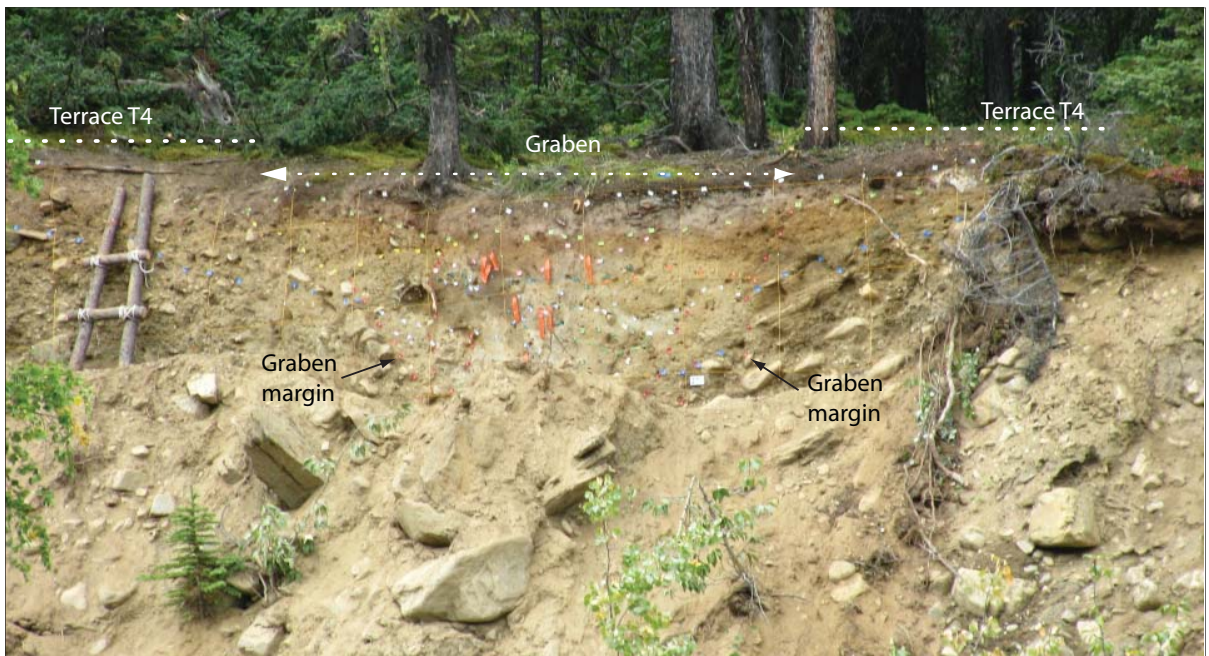
Figure 20. Photo of the Cliffhanger trench exposure. The trench exposure provides a cross section through one of two grabens on bending moment faults in the crest of the Giant Moletrack anticline.

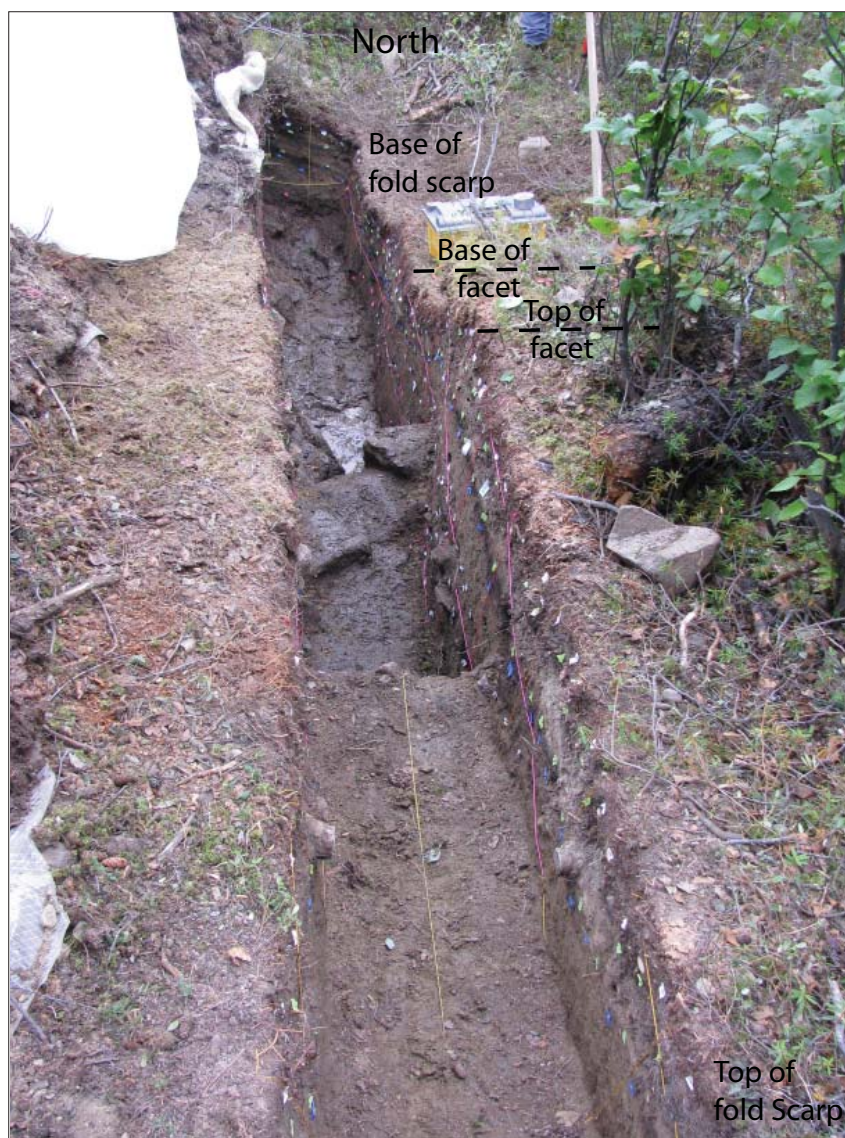
Figure 23. Photo of trench GMT I viewed to the north from the top of the scarp on terrace T2b.

On the east side of Catastrophe Creek, opposite the Cliffhanger trench, we identified an ~2-m-high gently sloping scarp offsetting a young terrace, possibly correlative with terrace T2b. This scarp aligns with an abrupt slope break immediately to the east that we interpret as the fold scarp of the Cathedral Rapids fault (fig. 19). A steeper, ~1-m-high facet is present along sections of the fold scarp including the section where it offsets the Catastrophe Creek terrace. The steeper facet is not present on the west side terrace. We excavated a 7-m-long and approximately 1-m-deep trench (trench GMT I) across the scarp where the steeper facet ends (figs. 23 and 24).

In general, the stratigraphy exposed in the trench is characterized, from top to bottom, by: (1) a 20–30 cm section of interbedded organic mats and well sorted fluvial sands (units O, S1, O1, S2, and O2); (2) 40–70-cm-thick stratified colluvial deposits, with local fluvial sand horizons (units C1, C1a, and C1b) containing discontinuous thin streaks of very-fine-grained black organics and charcoal (white flagging and white dashed lines on the trench wall photo shown in fig. 25 and black dashed lines on the trench log shown in fig. 26); and (3) frozen, boulder-rich colluvial units at the bottom of the trench (units C2 and C3). These frozen sediments were the lower limit of our excavation. This stratigraphy is for the most part parallel bedded and gently inclined beneath the fold scarp at the same angle as the ground surface. A small pit excavated into the undeformed terrace surface above the scarp encountered the same stratigraphy as in the trench. Bedding in the pit is horizontal (fig. 26). We interpret the gently sloping scarp to be a fold scarp at the tip of the Cathedral Rapids fault.

There are distinct differences in the scarp morphology between the two trench walls,

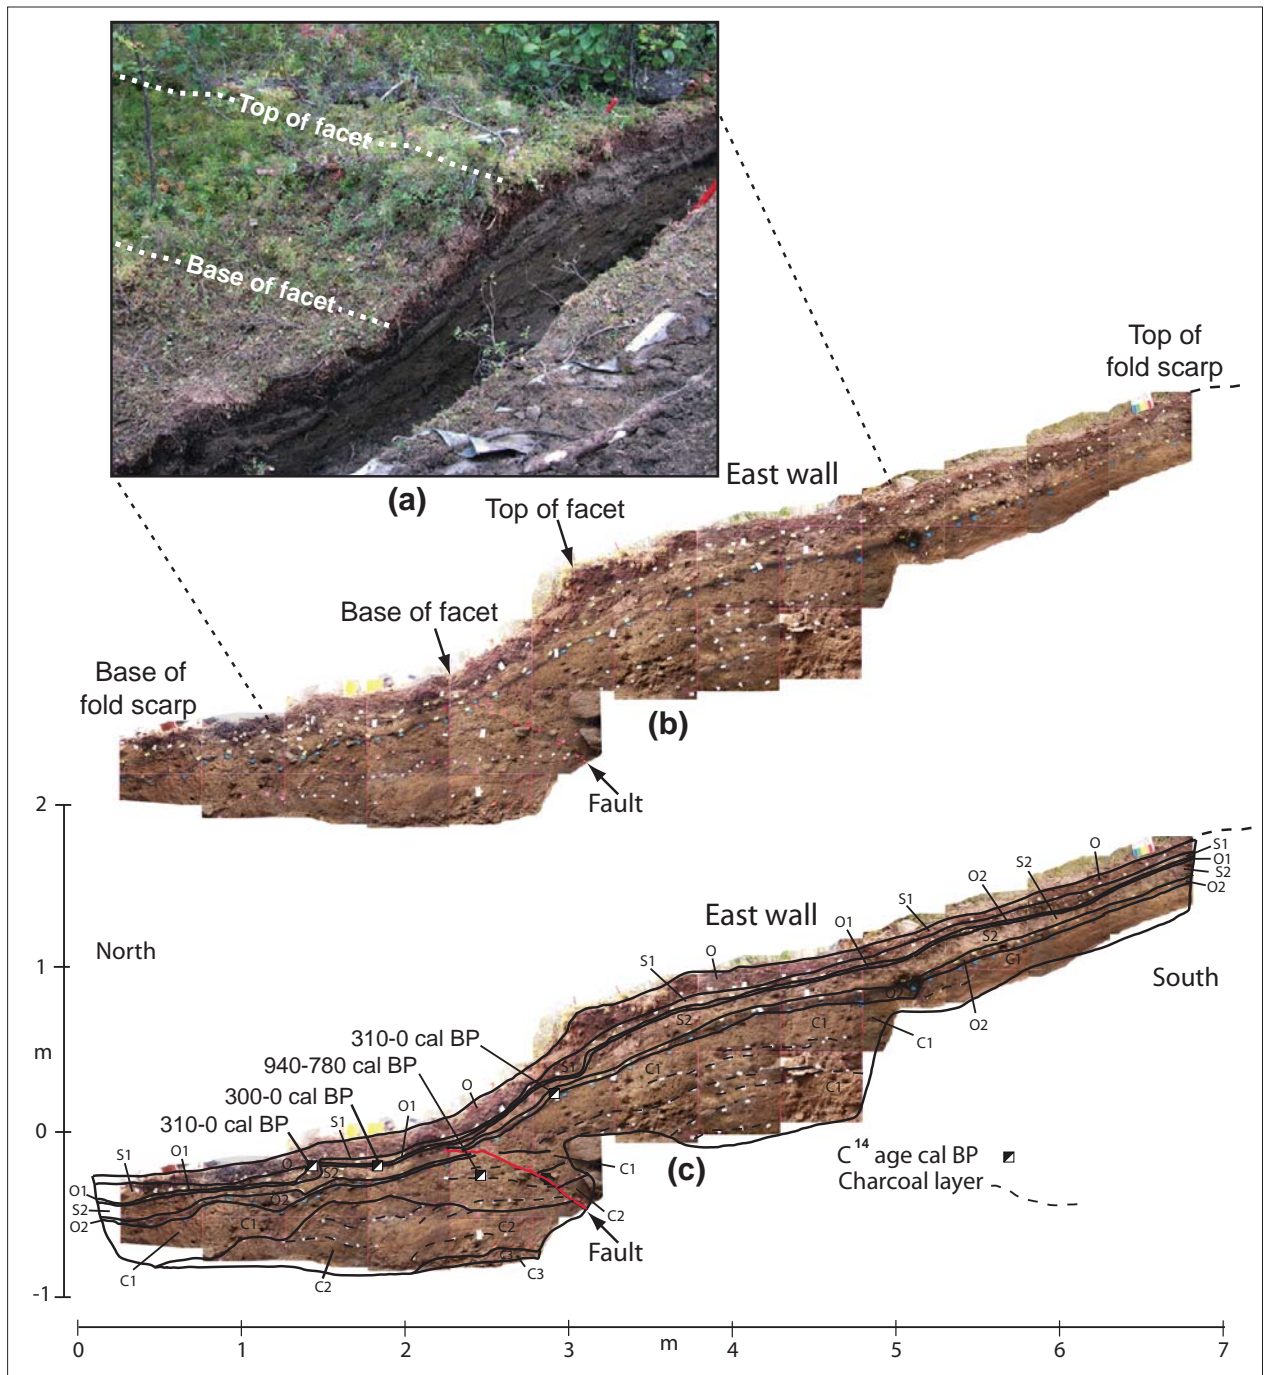
Figure 24. (a) Oblique view of the east wall of trench GMT I showing the steep facet on the fold scarp. (b) Photo mosaic of the east wall of trench GMT I. (c) Interpreted photo mosaic of the east wall of trench GMT I. Unit designations from the trench log (fig. 26).

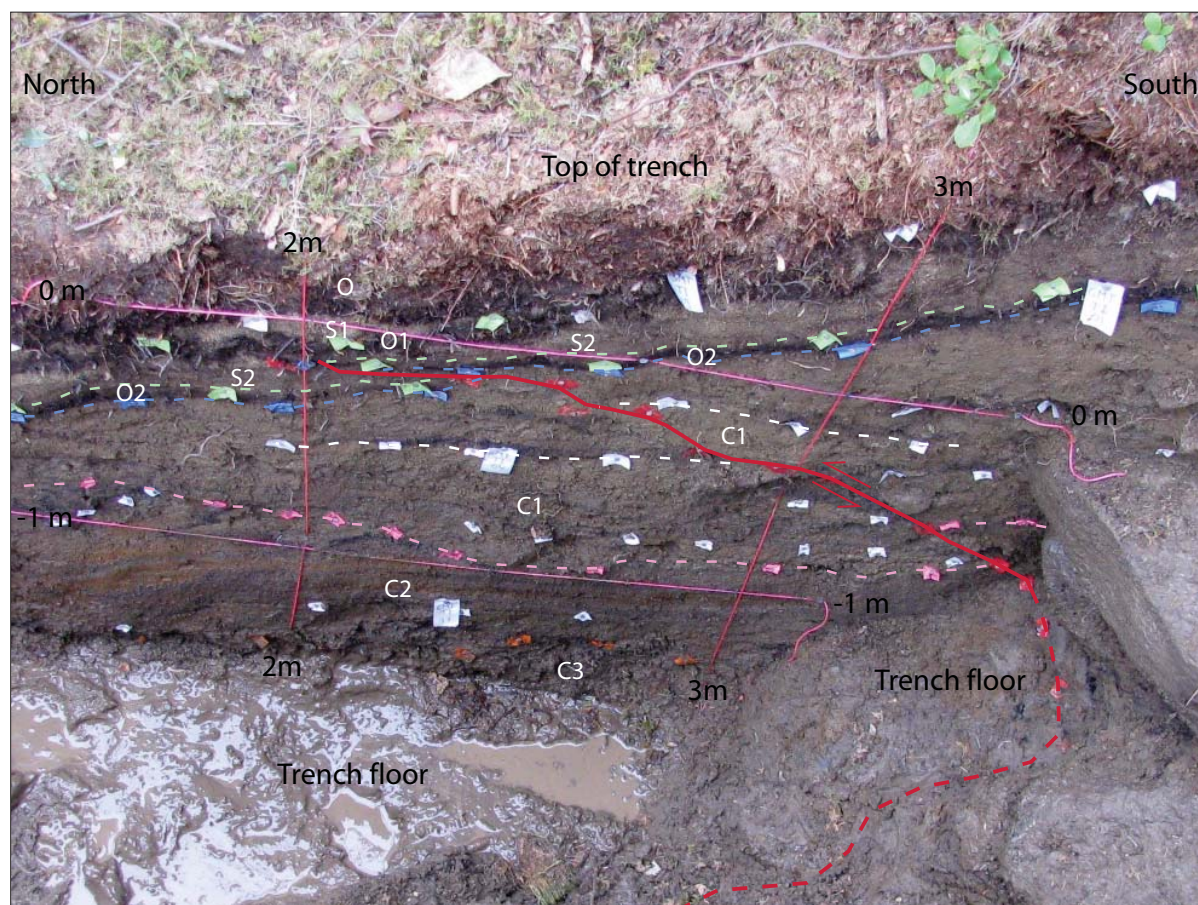
Figure 25. Close-up view of the fault in the east wall of GMT I trench. The light green dashed line marks the base of the lower layer of a well sorted fluvial sand (unit S2). The blue dashed line is the base of a charcoal-rich organic silt (unit O2). The white dashed lines mark thin streaks of fine-grained charcoal and organic material in the colluvium (unit C1). The pink dashed line shows the base of this colluvium. The fault (red line) offsets the charcoal streaks and contacts between the colluviums C2 and C1 and the overlying organic layer O2 and base of the fluvial sand S2. Where the fault crosses the trench floor it is deflected around large boulders on the west side of the trench and is oblique to the orientation of the trench. Unit designations are from the trench log (fig. 26).

Our favored interpretation is that the sands were deposited during overbank floods of the creek and covered with an organic mat before the terrace was deformed. The 2-m-high gentle scarp represents a fold scarp generated by a single episode of recent displacement on a largely blind south-dipping thrust with most of the displacement accommodated by folding at the surface. Based on the 2-m-high fold scarp and an assumed dip of 30° for the fault at depth (the dip of the small fault exposed in the trench), geometric relations suggest about 4 m of dip-slip displacement on the fault at depth. As the fault approached the surface, slip on the fault decreased and warping of the sediments increased, producing the fold scarp. With the small (10–15 cm) displacement of the fault at the surface, and a strong mechanical contrast between the essentially cohesionless fluvial sand unit S2 and the fibrous, densely rooted overlying organic mats (O and O1), we speculate that the surface trace of the fault-exploited unit S2 is a

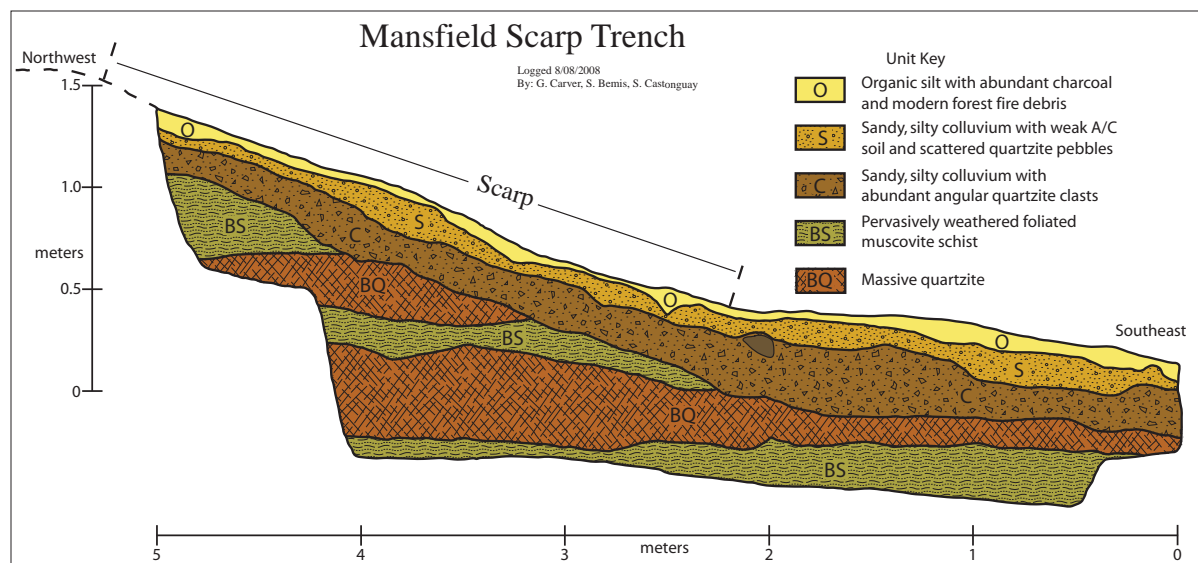
Figure 29. Mansfield scarp trench log. Contacts between the schist (BS) and quartzite layers (BQ) in the bedrock and the overlying colluvial (C), loess (O), and soil (S) units are not offset where they cross the base of the scarp that defines the Mansfield lineament at this location, showing the scarp is not the result of faulting.

The trench was sited across a well-defined 1.5-m-high southeast-facing scarp on the most continuous and prominent lineament about 4.8 km north-northeast of Mansfield Lake (figs. 3 and 28). The trench exposed pervasively weathered and intact horizontally interlayered muscovite schist and quartzite (fig. 29). A mantle of thin layers of colluviums, a weak A–C soil horizon, and organic silt (loess) unconformably overlies the bedrock. The interlayered bedrock crosses the scarp with no evidence of faulting, and the unconformable contact between the bedrock and overlying colluviums was not offset. No evidence of a fault was found in the trench. We interpret the scarp at the trench site to be the result of differential erosion of the resistant layers of quartz and soft-weathered schist. We conclude the Mansfield Creek lineaments reflect differential erosion of the bedrock underlying the slopes in the Mansfield Creek drainage. While some of the lineaments may be the surface expression of bedrock faults, they are not expressed in the valley fill alluvium where they trend across drainages containing young alluvial sediments. We do not believe these lineaments are active faults.
