PRELIMINARY INTERPRETIVE REPORT 2009-6a

**SURFICIAL GEOLOGY OF ALASKA HIGHWAY CORRIDOR,
ROBERTSON RIVER TO TETLIN JUNCTION, ALASKA**

Richard D. Reger, Trent D. Hubbard, and Gary A. Carver

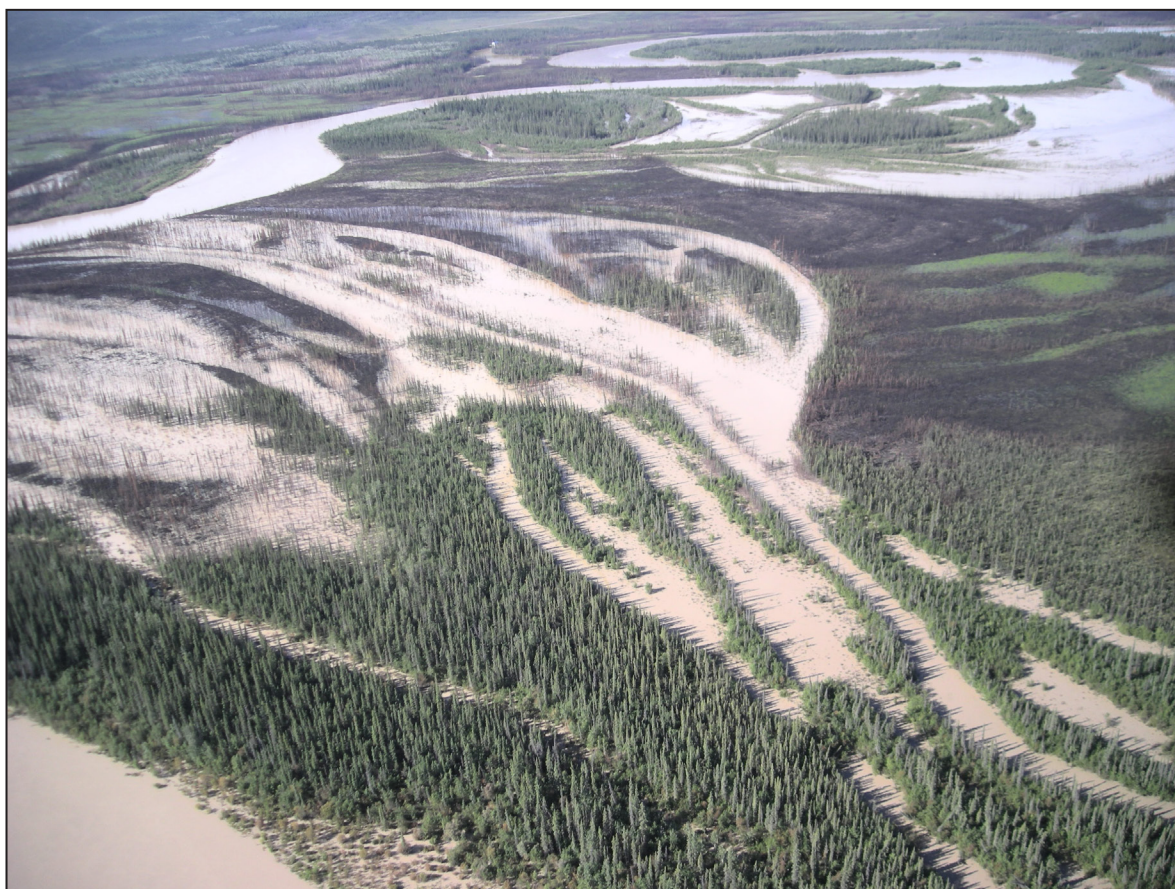
Oblique view of flooding along the Tanana River northeast of Tanacross. Note meander scrolls clearly visible in the flooded area. Photograph taken 07/26/2010 by T. D. Hubbard.

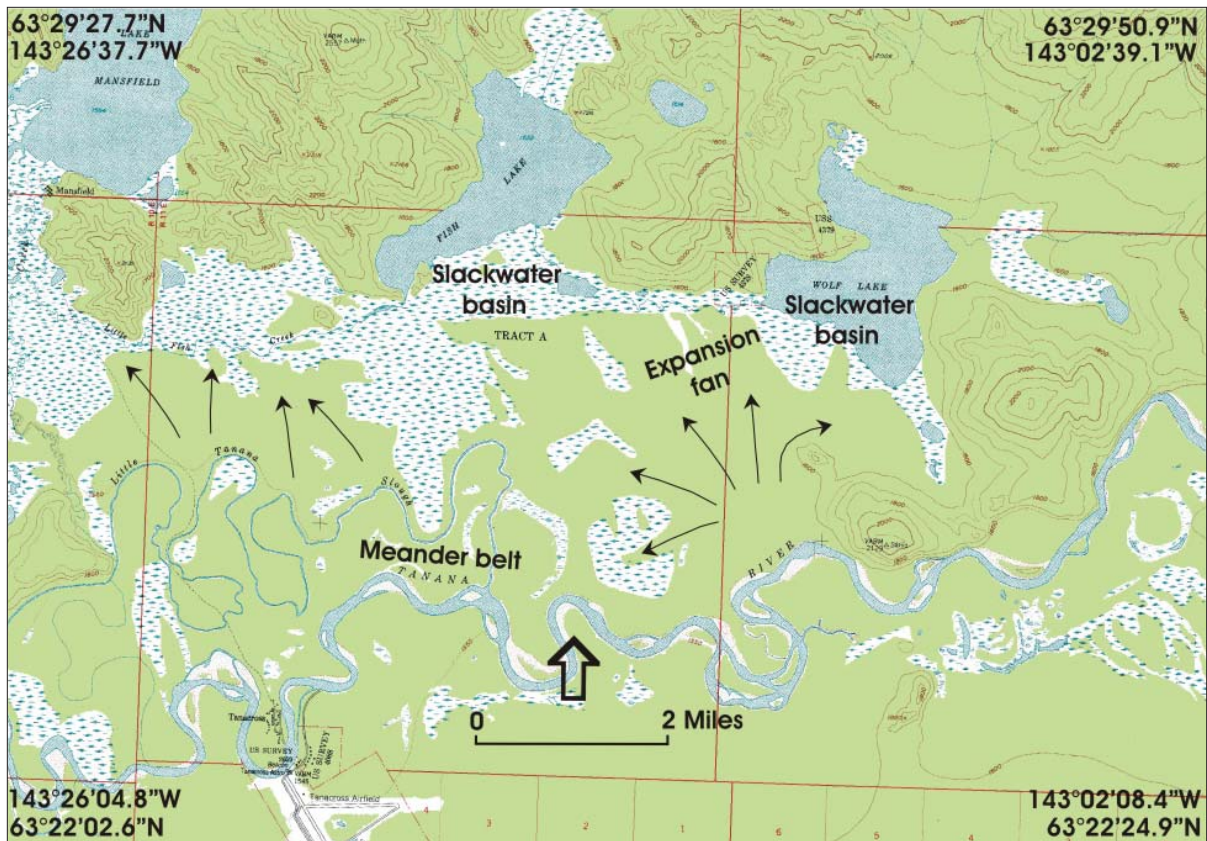
Figure 2. Map showing expansion-fan and slackwater-basin complex in Fish Lake–Wolf Lake area, north central Tanacross B-5 Quadrangle. Arrows indicate general directions of overbank flows.

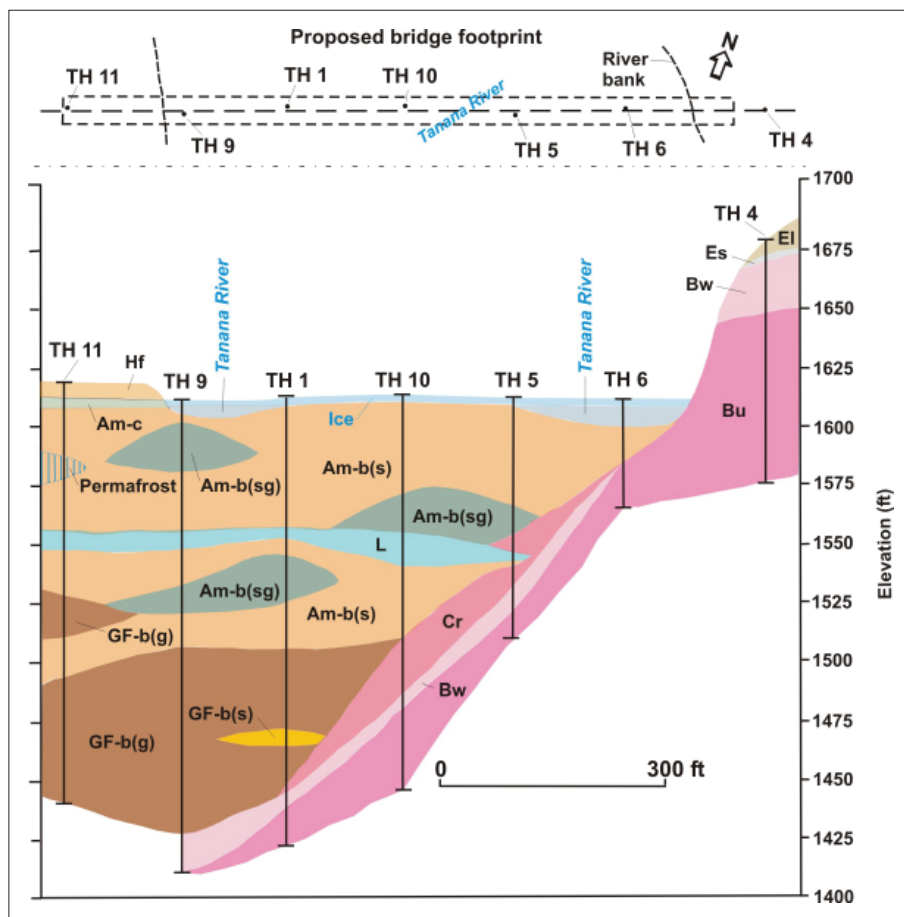
Figure 3. Interpretation diagram of borings drilled in and near the footprint of proposed bridge #505 over the Tanana River at milepost 1303.3 Alaska Highway in the southeastern Tanacross B-4 Quadrangle (Fitch, 2008). Symbols: Am-c = fine-grained cover sediments in inactive floodplain of meandering Tanana River; Am-b(s) = bedload sands deposited by meandering Tanana River; Am-b(sg) = bedload sands with minor pebble gravel deposited by meandering Tanana River; Bu = unweathered to slightly weathered granitic bedrock; Bw = weathered granitic bedrock; Cr = granitic colluvium (gravels mixed with grus and fragments of weathered granite); El = loess; Es = eolian sand; GF-b(g) = bedload gravels of outwash alluvium; GF b(s) = bedload sands of outwash alluvium; Hf = highway fill; L = lacustrine clays, silty clays, and clayey silts. Vertical exaggeration = 3.2.

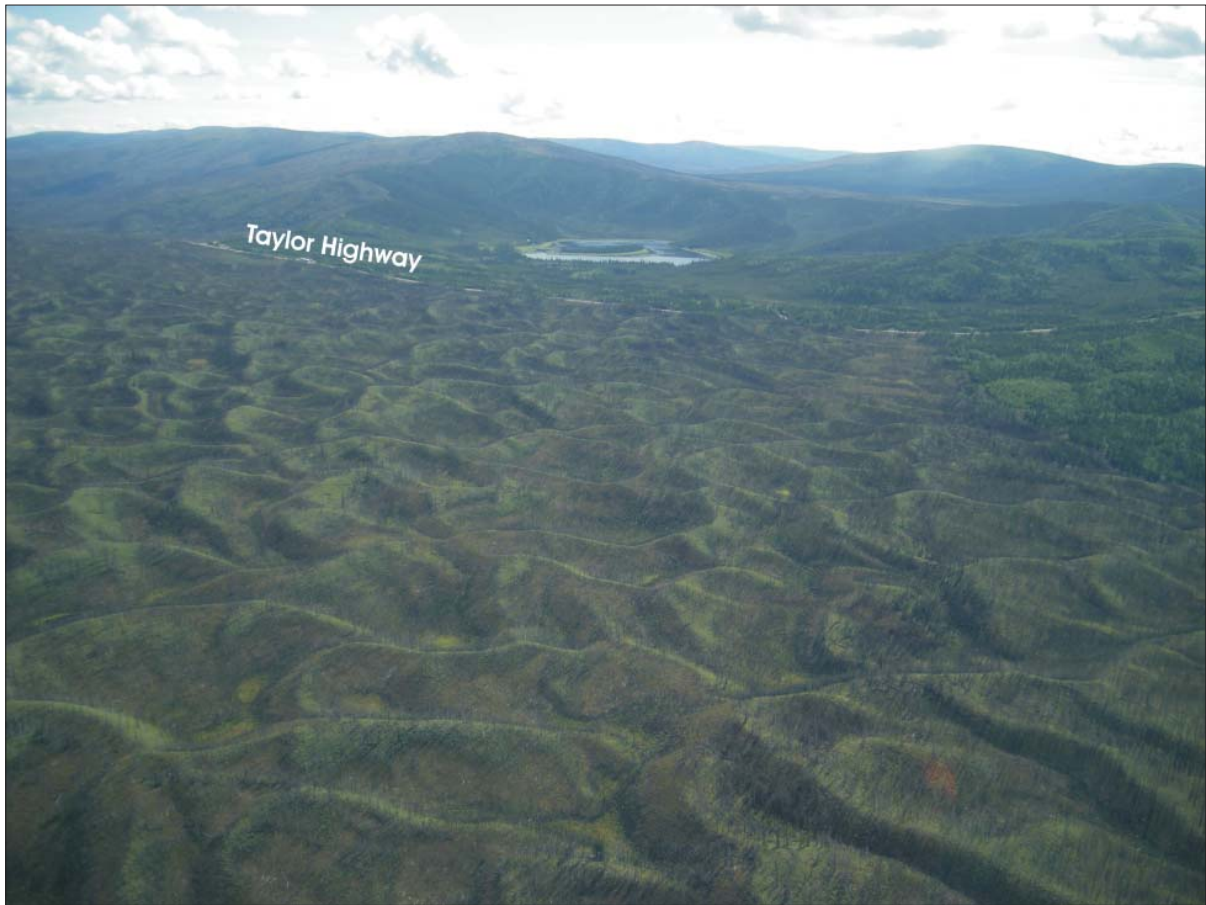
Figure 4. Photo showing aerial view northeast of the clearwater lake impounded behind parabolic sand dunes in a recent burn near the Taylor Highway north of Tetlin Junction in the east-central Tanacross B 4 Quadrangle. Photograph taken 06/12/2007 by R.D. Reger.

Across the Tanana River northeast of the Tok fan is the Tetlin Junction dune field (sheet 4). The position of this dune field relative to the Tok fan indicates that the eolian sands there were deposited by strong katabatic winds sweeping northeastward out of the Tok River valley across the Tok fan. The orientations of parabolic sand dunes west of the Taylor Highway (fig. 4) indicate that winds have most recently blown across the dune field from the Tok fan toward the northeast, although dune orientations east of the Taylor Highway record winds blowing from the south and southeast there (Carrara, 2006). The 60-m-deep canyon of middle Porcupine Creek demonstrates that the dune field in the Tetlin Junction–Porcupine Creek area is very thick. Numerous rills with convex cross profiles in the eolian-sand blanket west of lower Porcupine Creek indicate that the sand is thick there also.

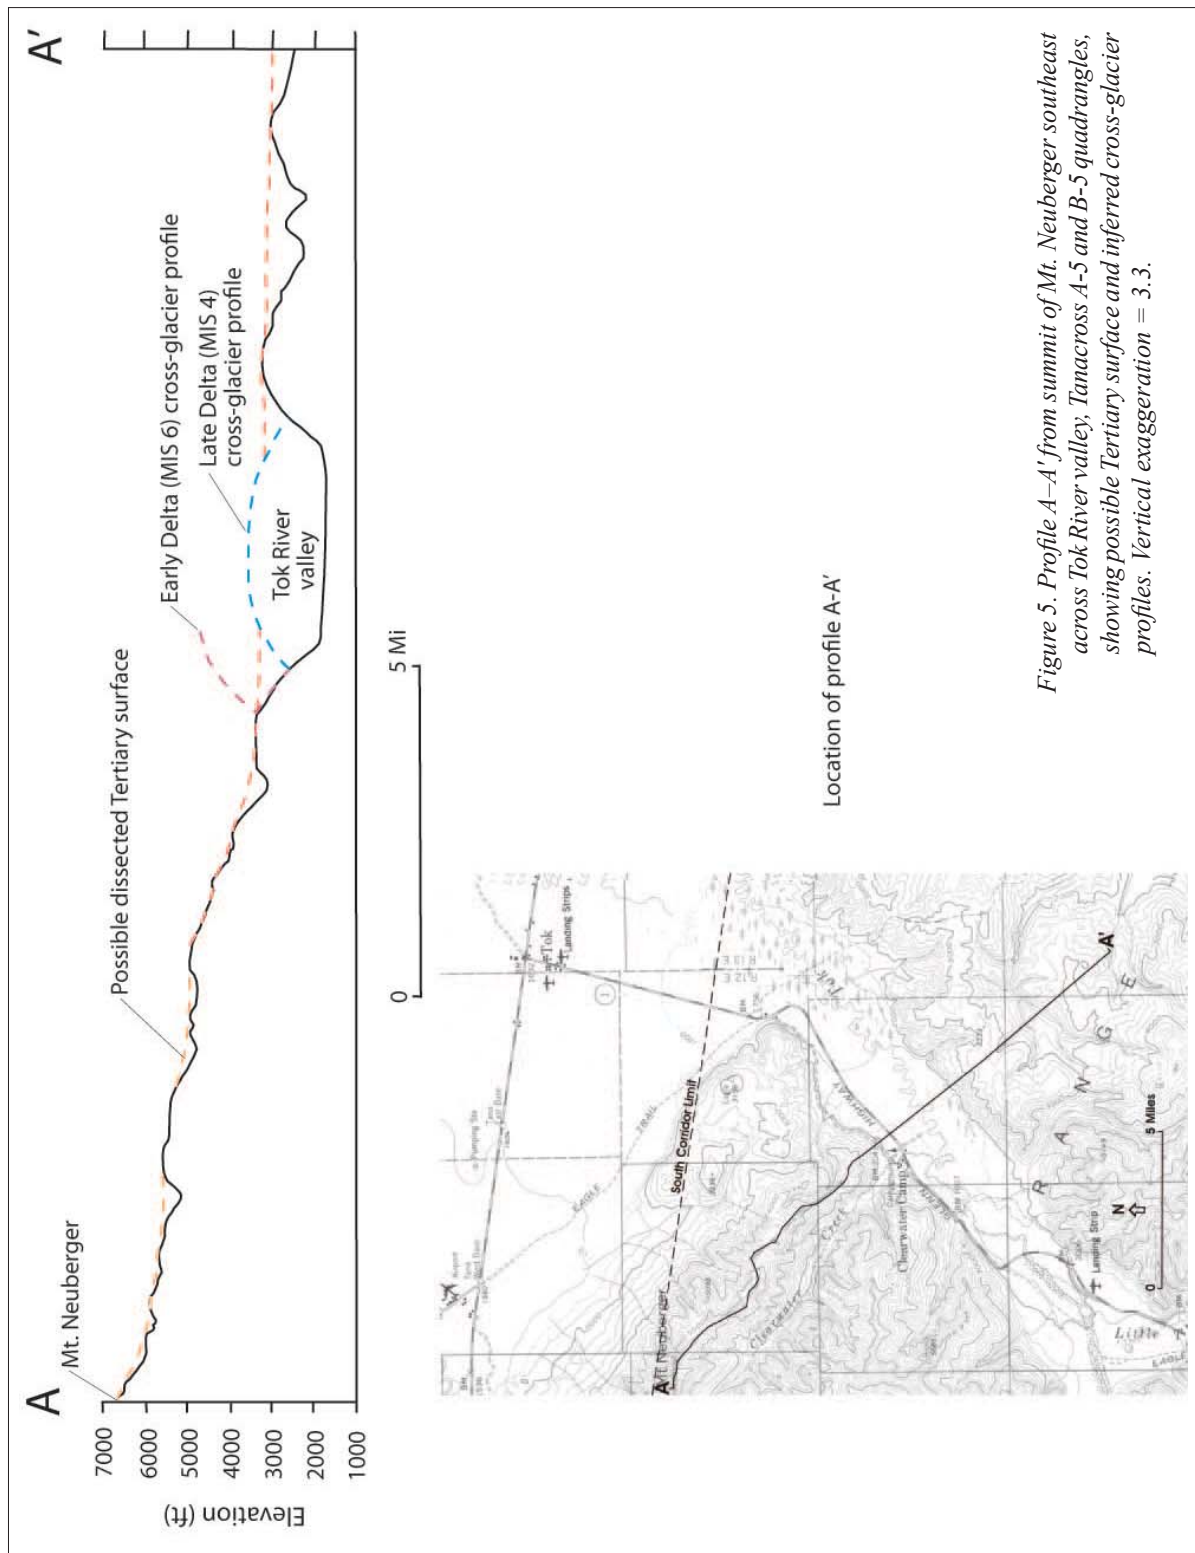
Figure 5. Profile A-A' from summit of Mt. Neuberger southeast across Tok River valley. Tanacross A-5 and B-5 quadrangles, showing possible Tertiary surface and inferred cross-glacier profiles. Vertical exaggeration = 3.3.

by Carrara (2004a), indicating that the landform is littered with residual coarse, angular products of frost-rived bedrock. However, except on the uppermost slopes of Mt. Neuberger, dry exposures on ridges and slopes are vegetated with discontinuous *Dryas* mats; moist slopes are well vegetated by a variety of moisture-tolerant alpine plants and exhibit landforms produced by gelifluction. Bedrock tors along ridge crests and on upper side slopes demonstrate that differential stripping by periglacial slope processes has removed at least 5 m of the metamorphic bedrock. The steeper, western portion of this surface could reflect ~152 m of original relief on the former surface, or could result from faster uplift of the Alaska Range to the west. Toward the southeast, the slope of this surface is fairly uniform down to ~3,500 ft (~1,065 m) elevation, which could be the highest level reached by glaciation in the Tok River valley (fig. 5).

Below an elevation of ~3,500 ft (~1067 m), the valley of the Tok River is clearly inset into the dissected upland surface to the northwest and southeast (fig. 5). Changes in the slopes of the walls of the Tok River valley at ~3,500 ft (~1067 m) and ~2,500 ft (~762 m) elevation along the profile could mark the upper limits of early and late phases of the Delta glaciation. Foster (1970) mapped discontinuous lateral moraines to which she assigned a pre-Delta age along both sides of the Tok River valley almost to the range front. Based on the presence of a brunisol of variable thickness on these features and numerous well preserved erratics with significant weathering rinds, Duk-Rodkin and others (2004) correlated that brunisol with the Diversion Creek soil, which postdates the Reid glaciation in the Yukon Territory, and correlated the Tok River valley moraines with the Delta glaciation to the west and the Black Hills glaciation (Fernald, 1965b) to the east. We mapped a lateral moraine with Delta affinities to within 5 km of the southern boundary of the map area along the lower northwest wall of the lower Tok River valley.

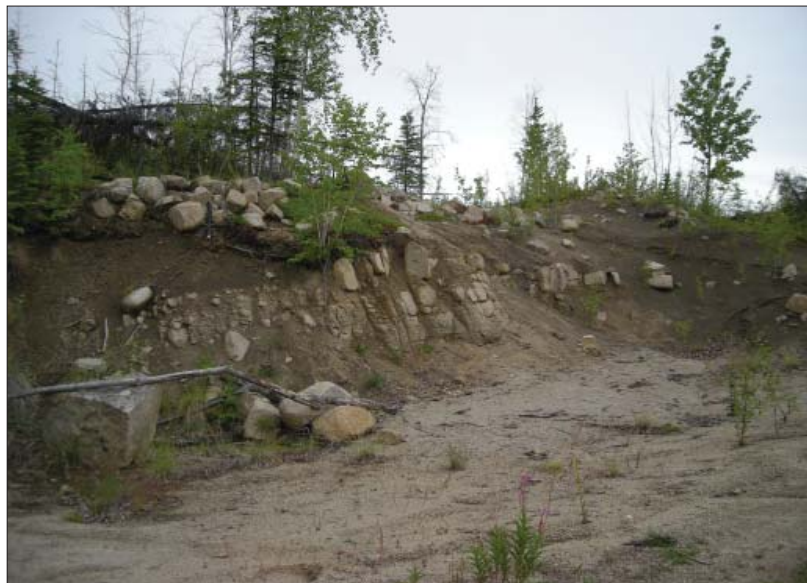
Figure 6. Photo showing view northeast of subrounded to rounded granitic corestones and weathered granitic bedrock in a quarry near the mouth of Porcupine Creek, east-central Tanacross B-4 Quadrangle. Photograph taken 07/23/2008 by R.D. Reger.

Duk-Rodkin and others (2002, 2004) described fairly well preserved granitic, volcanic, and chert clasts that they identified as erratics at the mouth of Porcupine Creek at ~2,210 ft (~670 m) elevation northeast of Tok at the margin of the southern Yukon–Tanana Upland (sheet 2). They attributed these clasts to a pre–middle Pleistocene glaciation from the eastern Alaska Range that advanced down the Tok River valley and filled the Tok–Tanacross basin to at least ~2,210 ft (~670 m) elevation. This occurrence is very unusual for the Tanana River valley, where several workers have searched in vain for evidence of glaciation north of the Tanana River. Carrara (06/04/2008, written commun.) visited two sites identified by Florence Weber, one of the coauthors of the 2004 Duk-Rodkin and others paper, as sites visited by their field party. There, he found only spheroidally weathered boulders derived from the local granitic bedrock. We visited the sites identified by Carrara and support his interpretation that the round, granitic boulders are corestones produced by weathering of the granitic bedrock (fig. 6).

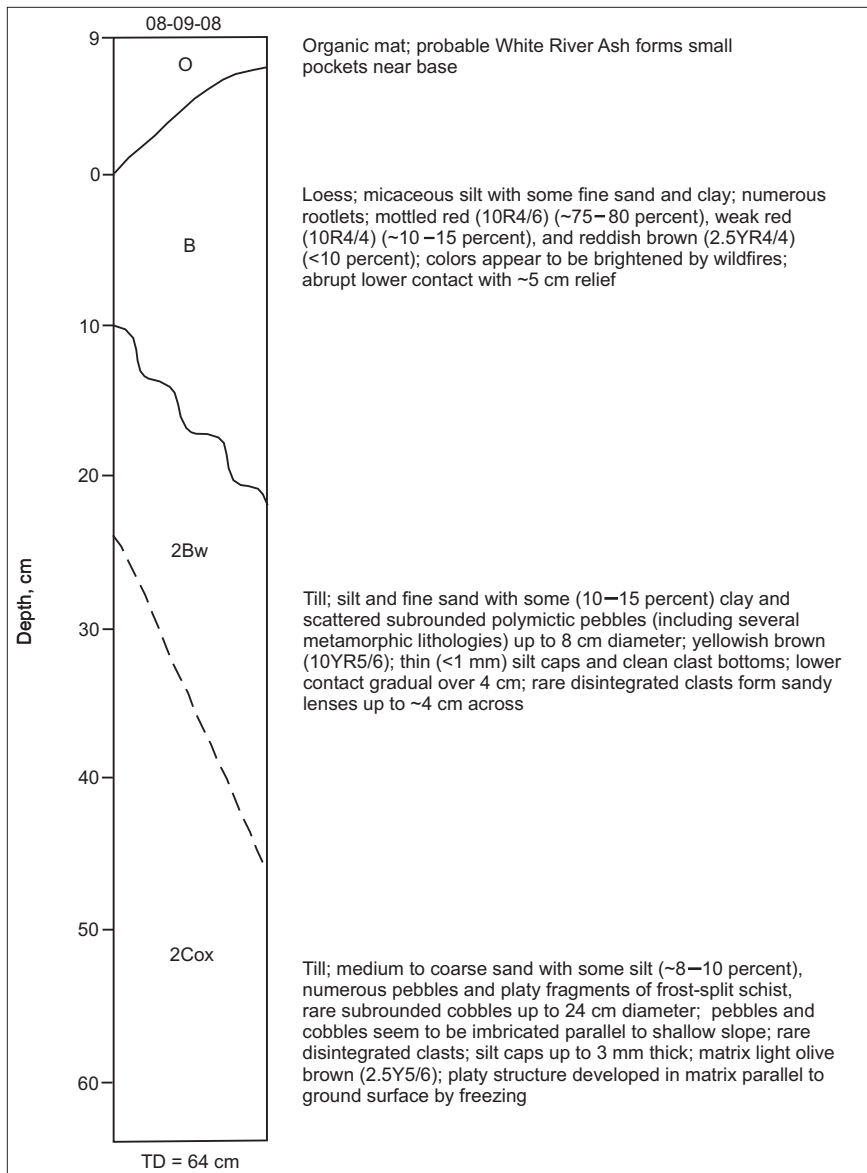
Figure 7. Soil profile (SP-6) in Robertson River terminal moraine of Delta glaciation, southwestern Tanacross B-6 Quadrangle. Elevation 1,700 ft (518 m).

A remnant of the terminal moraine of the Robertson River glacial advance of Delta age is preserved between the massive terminal moraine of Donnelly age and the bedrock hill surrounding Jan Lake to the north (sheet 1). A soil test pit (SP-6) dug into this feature exposed 10 to 22 cm of micaceous silty loess overlying till (silt and fine to coarse sand with some clay and scattered numerous subrounded, polymictic pebbles and cobbles up to 24 cm in diameter) (fig. 7). The loess contains a B horizon, which is mottled by frost action to red (10R4/6) (estimated 75–80 percent), weak red (10YR4/4) (estimated 10–15 percent), and reddish brown (2.5YR4/4) (estimated <10 percent). The red colors are thought to result from oxidation during repeated wildfires, and probably do not reflect the antiquity of the soil profile. The underlying 2Bw zone, which is yellowish brown (10YR5/6) and 14 to 24 cm thick, is developed in till. Silt caps on clasts in this horizon are thin (<1 mm) and bottom surfaces are clean. In the 2Cox horizon, a platy structure that developed parallel to the ground surface may be the result of freezing and thawing of the ground or may be evidence of downslope displacement of the near-surface till. Matrix color in this horizon is light olive brown (2.5Y5/6), and silt caps are up to 3 mm thick.

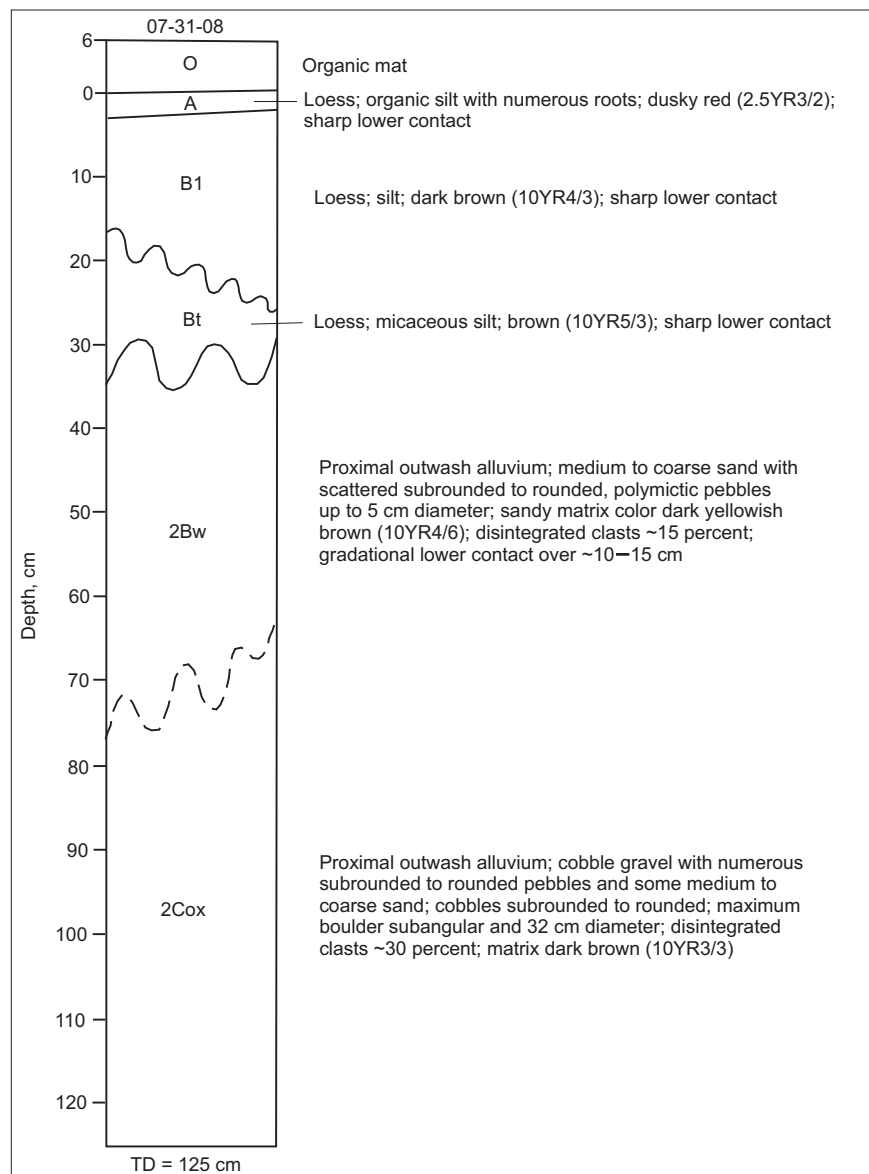
Figure 8. Soil profile (SP-7) in proximal outwash of Delta age in east-central Tanacross B-6 Quadrangle. Elevation 1,600 ft (488 m).

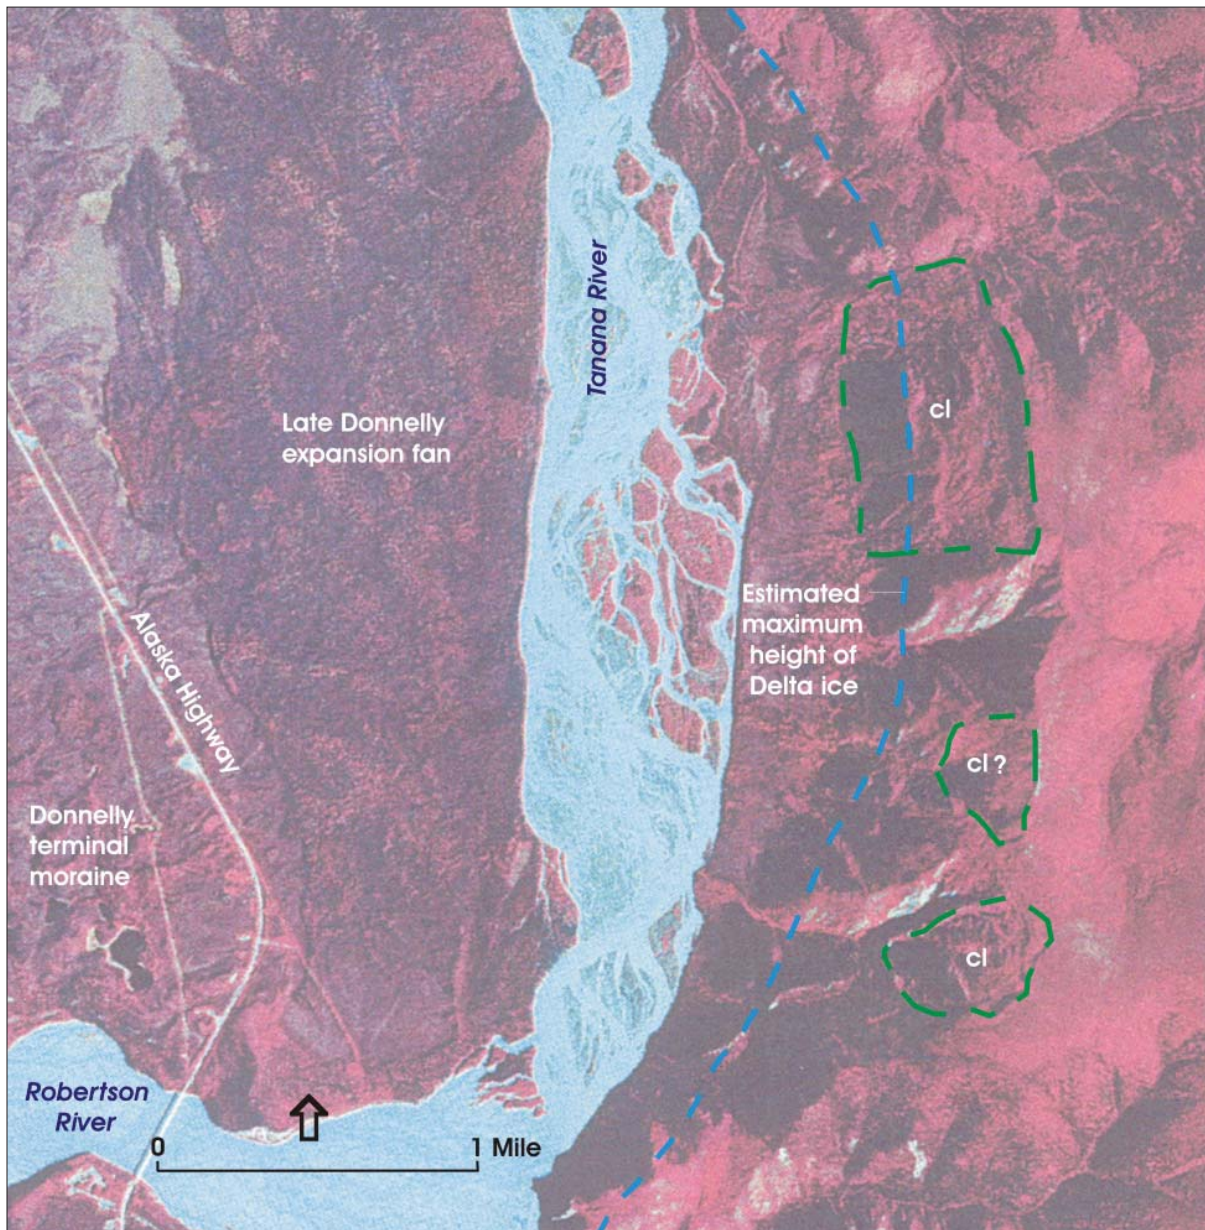
Figure 9. Airphoto showing estimated maximum height of glacial ice during Delta glaciation and failures (cl) in granitic bedrock, Tower Bluffs, Tanacross B-6 and C-6 quadrangles (Alaska High Altitude Photograph ALK 60 CIR 8485 taken August 1980).

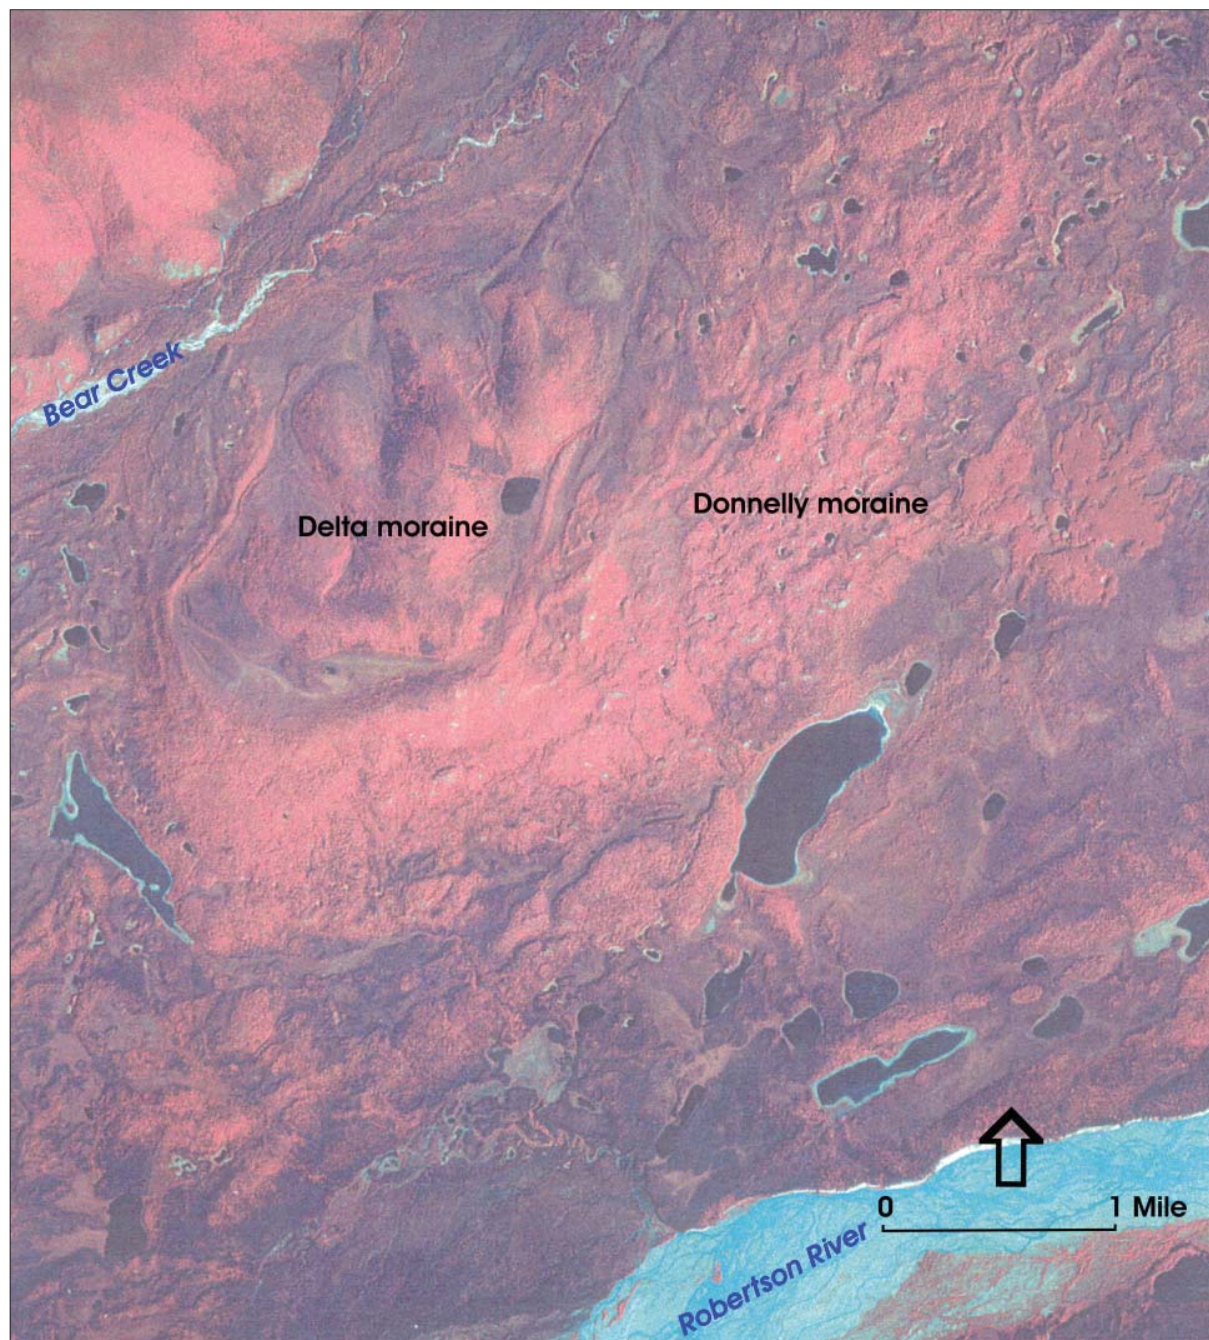
Figure 10. Airphoto comparing surface forms of Robertson River moraines of Delta and Donnelly ages in Mt. Hayes C-1 Quadrangle (Alaska High Altitude Photograph ALK 60 CIR 8487 taken August 1980).

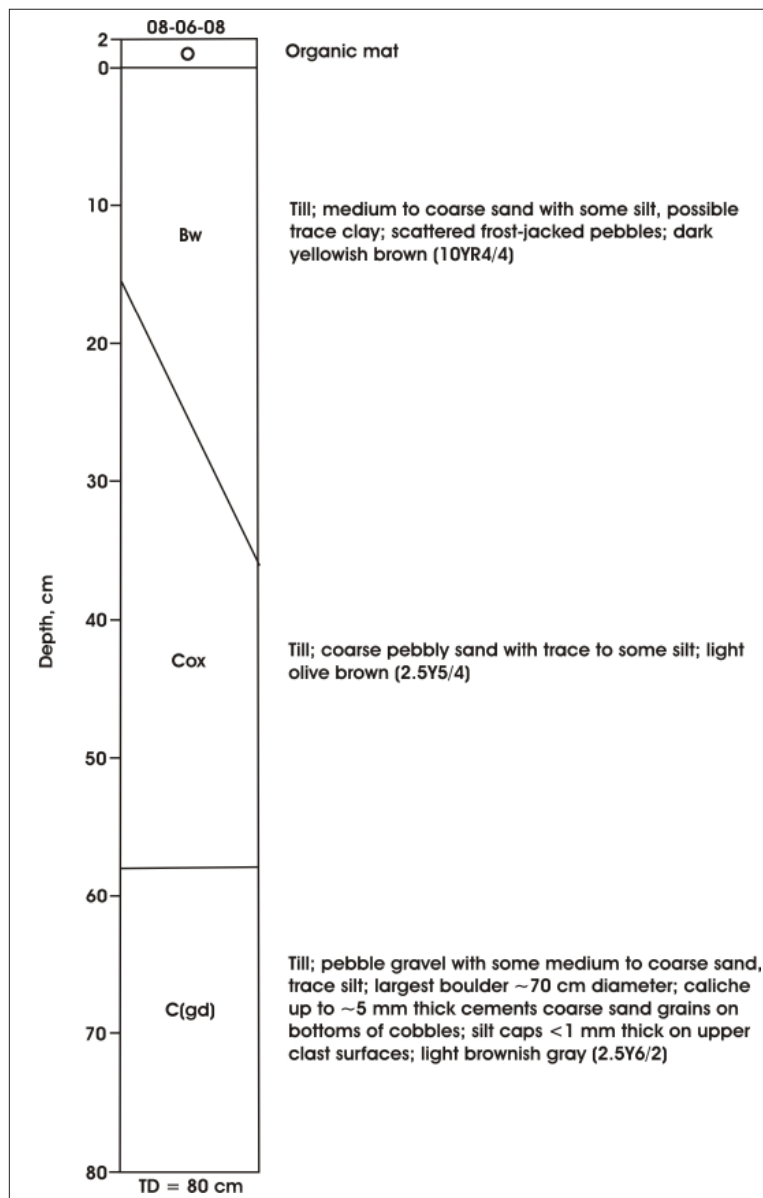
Figure 11. Diagram showing section of soil profile (SP-8) exposed in crest of highway cut through Donnelly terminal moraine of Robertson River glacier in northwestern Tanacross B-6 Quadrangle. Elevation 1,660 ft (506 m).

A post-Donnelly soil profile (SP-8) is exposed at the top of the highway cut through the prominent Donnelly terminal moraine of the Robertson River glacier (sheet 2). This profile features a weakly developed, 15- to 36-cm-thick, dark yellowish brown (10YR4/4) Bw horizon developed in the near-surface till (fig. 11). The underlying Cox horizon is light olive brown (2.5Y5/4) in color, and the base of the weathered zone is ~58 cm deep. An interesting

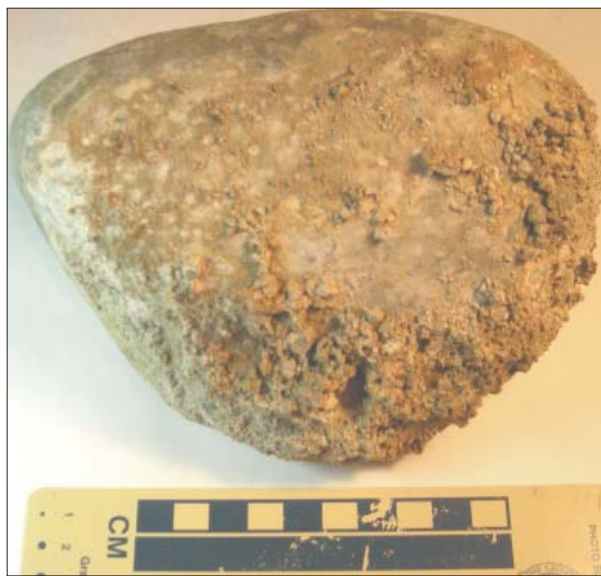
Figure 12. Photo showing 5-mm-thick layer of caliche-cemented coarse sand that coats lower surfaces of this noncalcareous metamorphic cobble from ablation till in Donnelly moraine exposed in highway cut in northwestern Tanacross B-6 Quadrangle. Scale in cm.

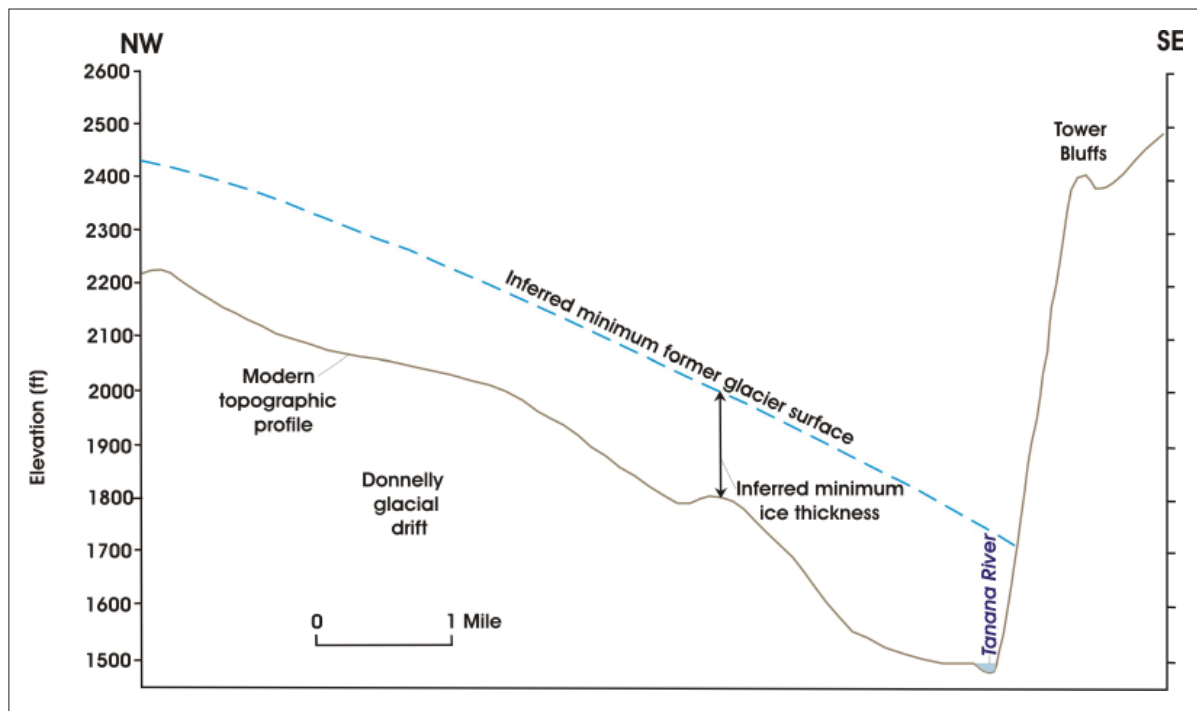
Figure 13. Model for blockage of Tanana River at Tower Bluffs by Robertson River glacier during Donnelly glaciation.

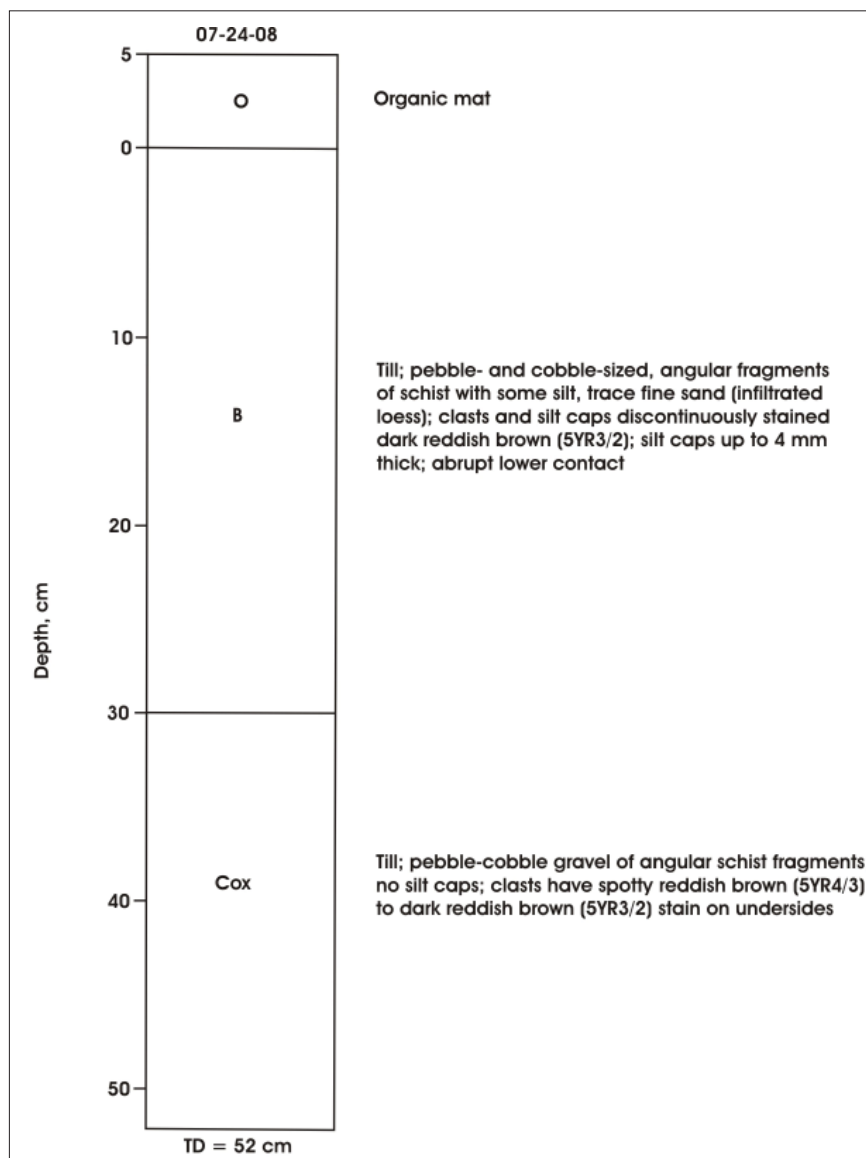
Figure 14. Section exposed in test pit (SP-9) in rounded crest of Holocene end moraine at head of west fork of Sheep Creek in northwestern Tanacross B-6 Quadrangle. Elevation ~5,190 ft (~1,582 m).

A small Holocene moraine, previously interpreted to be a rock glacier by Carrara (2004a), impounds a shallow tarn at the head of the west fork of Sheep Creek (sheet 1). A shallow test pit (SP-9) dug into this moraine exposed an inceptisol developed in coarse till of angular schist pebbles and cobbles (fig. 14). Loess (silt with trace fine sand) has infiltrated the open-work gravel to a depth of ~30 cm, and staining of till stones and their 3-mm-thick silt caps in the B horizon is dark reddish brown (5YR3/2). In the Cox horizon, silt caps are lacking, and spotty staining is reddish brown (5YR4/3) to dark reddish brown (5YR3/2).

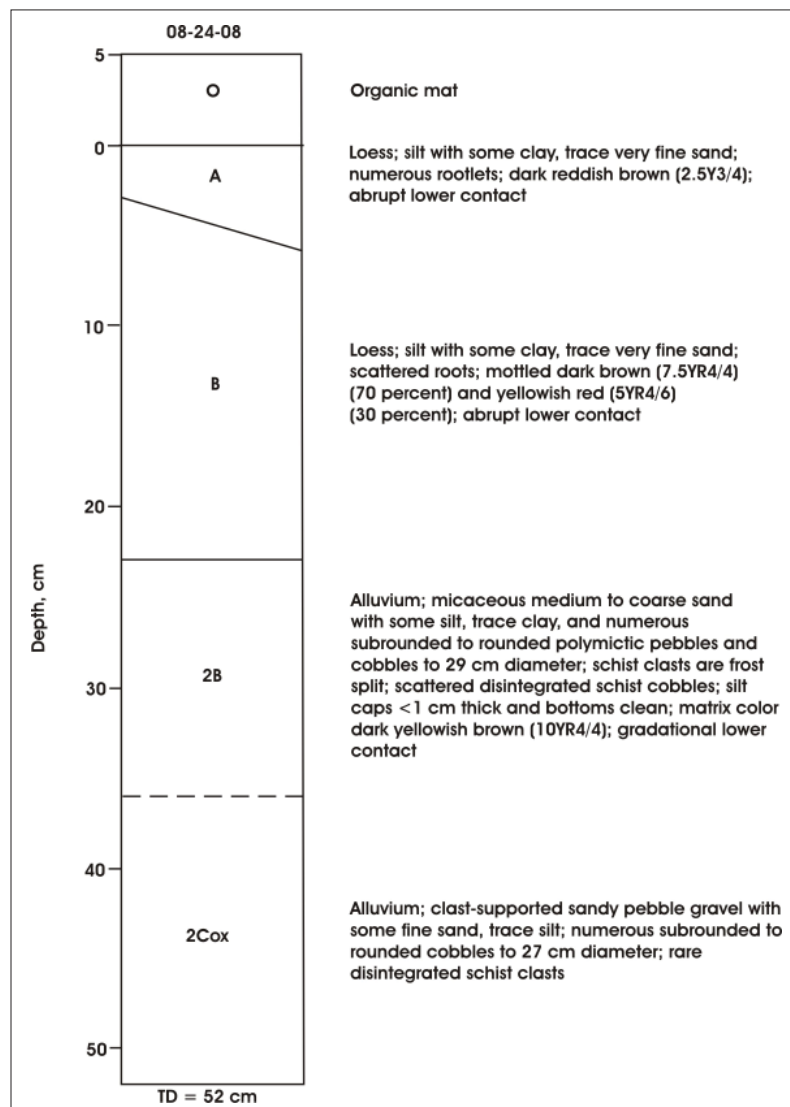
Figure 15. Section exposed in test pit (SP-10) in expansion fan of Donnelly age in northwestern Tanacross B-6 Quadrangle. Elevation ~1,560 ft (~475 m).

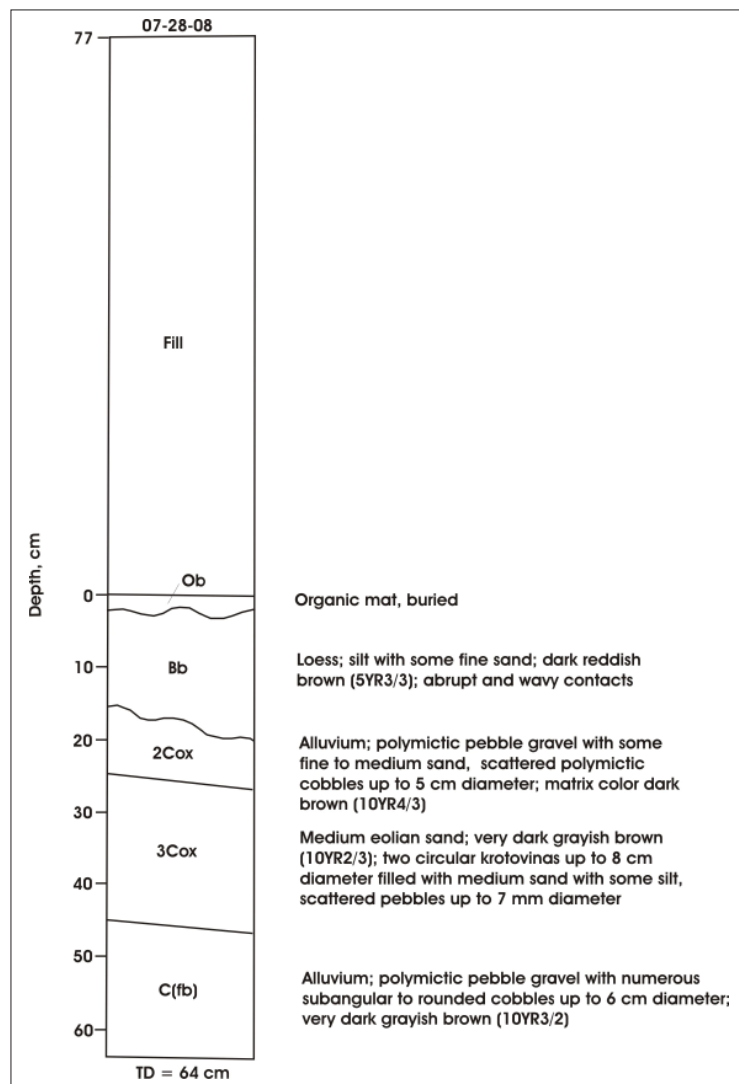
Figure 16. Soil profile (SP-11) exposed in west wall of M.S. 62-2-009-5 in western Tok fan in west-central Tanacross B-5 Quadrangle. Elevation 1,554 ft (474 m).

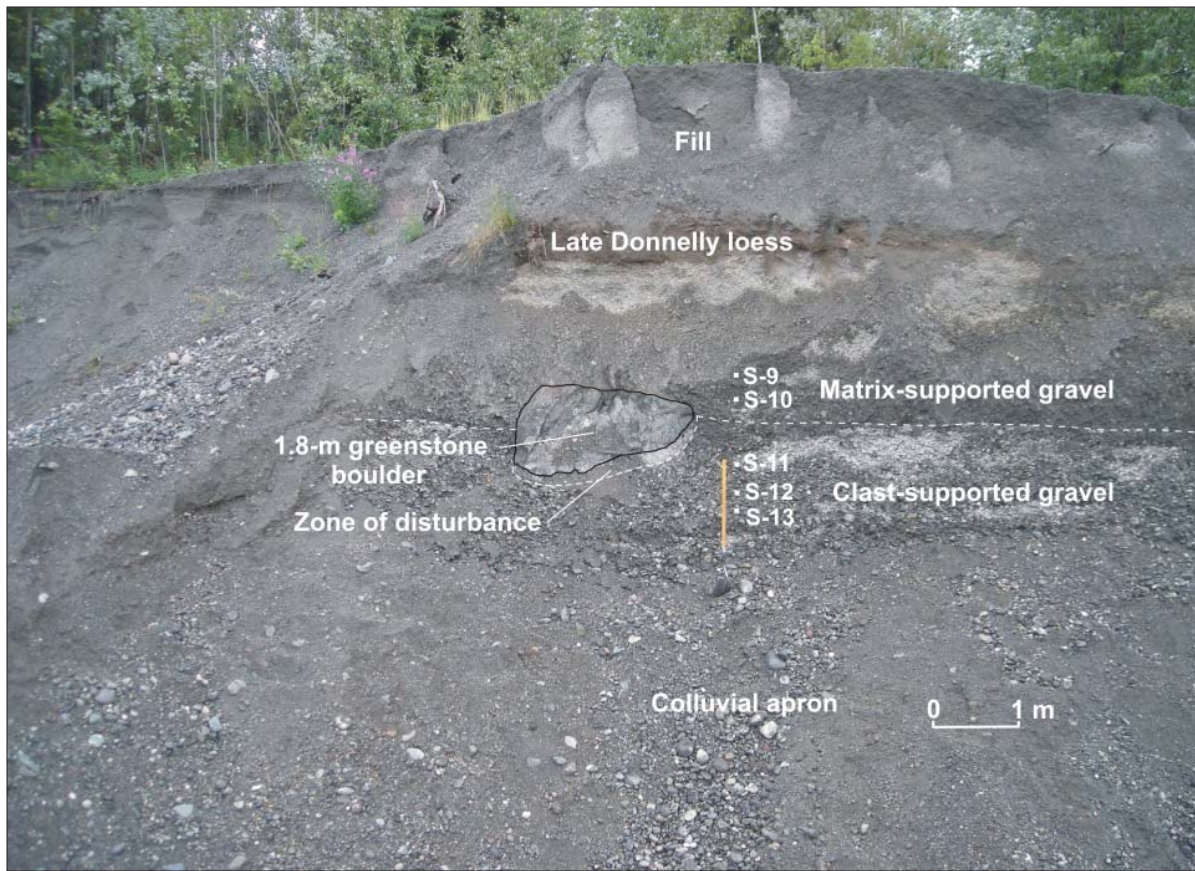
Figure 18. Photo showing extraordinarily large in-situ greenstone boulder (outlined for clarity) in clast- and matrix-supported gravels and sample locations in south wall of M.S. 62 2 005-2, northeastern Tok fan, Tanacross B-4 Quadrangle (sheet 4, locality A). Photograph taken 07/29/2008 by R.D. Reger.

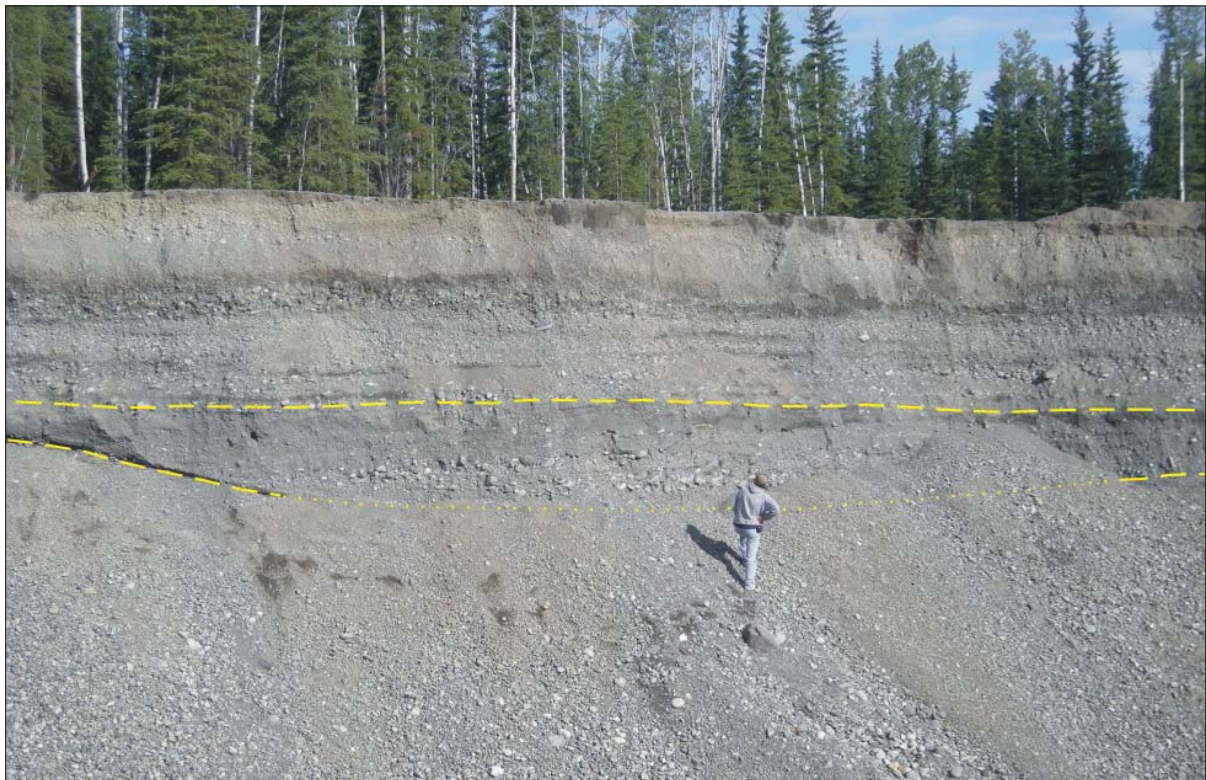
Figure 19. Photo showing cross section through large channel filling in west wall of M.S. 62 2 005-2, northeastern Tok fan, Tanacross B-4 Quadrangle (sheet 4, locality A). Contact dotted where inferred beneath colluvial apron. Person provides scale. Photograph taken 08/01/2008 by R.D. Reger.

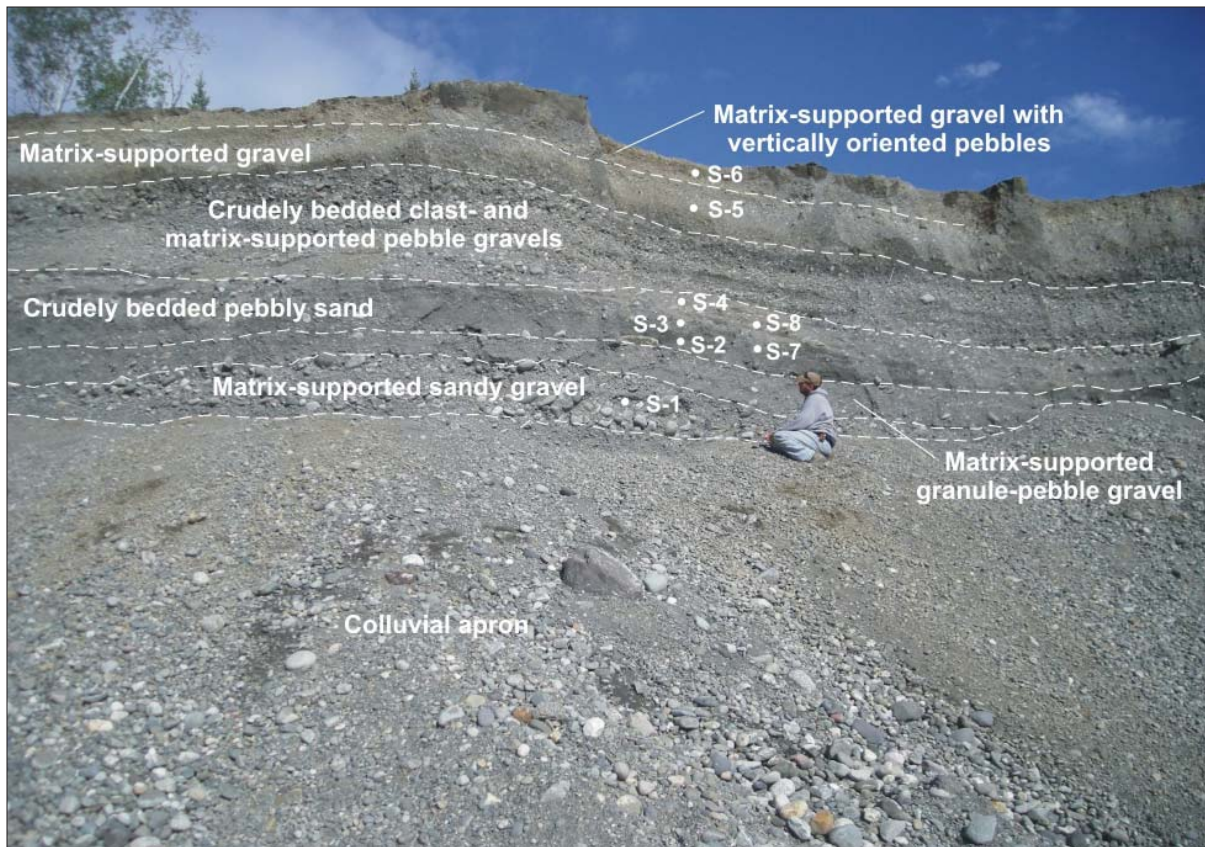
Figure 20. Photo showing locations of samples in exposed gravels and sands in west wall of M.S. 62-2-005-2, northeastern Tok fan, Tanacross B-4 Quadrangle (sheet 4, locality A). Photograph taken 08/01/2008 by R.D. Reger.

Inspection of the nearby pit walls indicated that the interbedded gravel and pebbly sand beds were generally massive, less than 1 m thick, tabular, had abrupt lower and upper contacts, and paralleled the fan surface. Cross bedding was not generally present. However, expansion of M.S. 62-2-005-2 during the 2010 construction season exposed a 1-m-thick pebble gravel bed with oblique tangential cross bedding dipping north-northeast in the southern pit wall. Two channel fills were identified, including a 50-cm-thick lens-shaped filling of massive sand in the south wall and a ~1-m-thick channel fill of massive sand overlying clast-supported gravel in the west wall of the pit (fig. 19)⁸. Eight samples of clast- and matrix-supported gravels and pebbly sand (S-1 through S-8) were collected from the west wall of M.S. 62-2-005-2 and analyzed for grain-size distribution (fig. 20). Sieve analyses

Particularly noteworthy, although not investigated in detail, is the ubiquitous presence of vertically oriented pebbles in matrix-supported gravel at the top of the section (fig. 20 and table 3, sample S-6). A possible explanation for the vertical pebble fabric is reorientation of pebbles by settling in liquefied gravels during strong earthquakes. We reject reorientation of the pebbles by frost jacking as a mechanism because of the ubiquitous distribution of the fabric.
