PRELIMINARY INTERPRETIVE REPORT 2009-6a

**SURFICIAL GEOLOGY OF ALASKA HIGHWAY CORRIDOR,
ROBERTSON RIVER TO TETLIN JUNCTION, ALASKA**

Richard D. Reger, Trent D. Hubbard, and Gary A. Carver

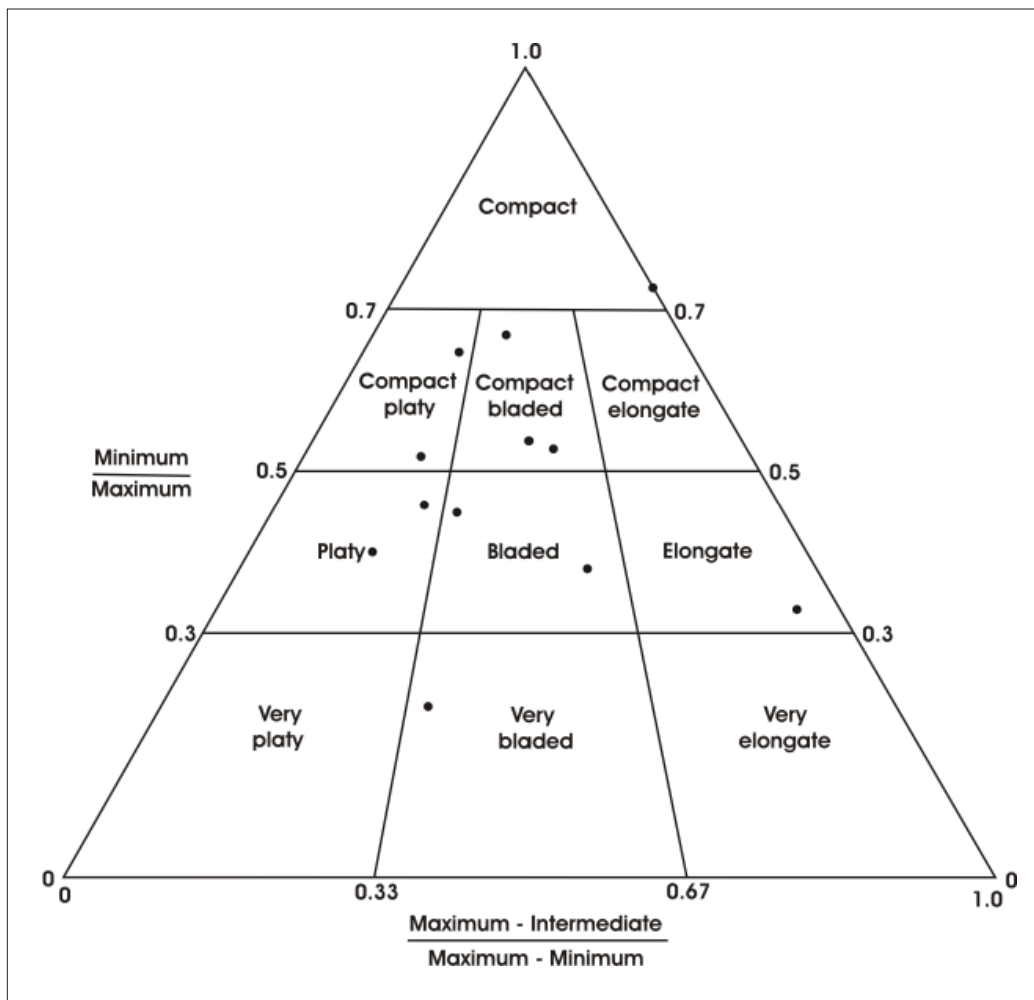
Figure 21. Diagram showing shape classes of extraordinarily large boulders ($n = 12$) in northeastern Tok fan (sheet 4, localities A and B), based on boulder dimensions (table 2) (classification of Sneed and Folk, 1958).

A plot of the shapes of the extraordinarily large boulders at localities **A** and **B** (sheet 4) in the northeastern Tok fan displays a wide variation in form (fig. 21), similar to the triangular plot of granitic flood boulders found farther down the Tanana River drainage in the Mt. Hayes Quadrangle (Reger and others, 2008a, fig. 29). However, large boulders in the Tok fan do not display the rounded corners and edges of well-traveled granitic flood boulders in the Berry–Sears creeks reach of the Tanana River (Reger and others, 2008a and b).

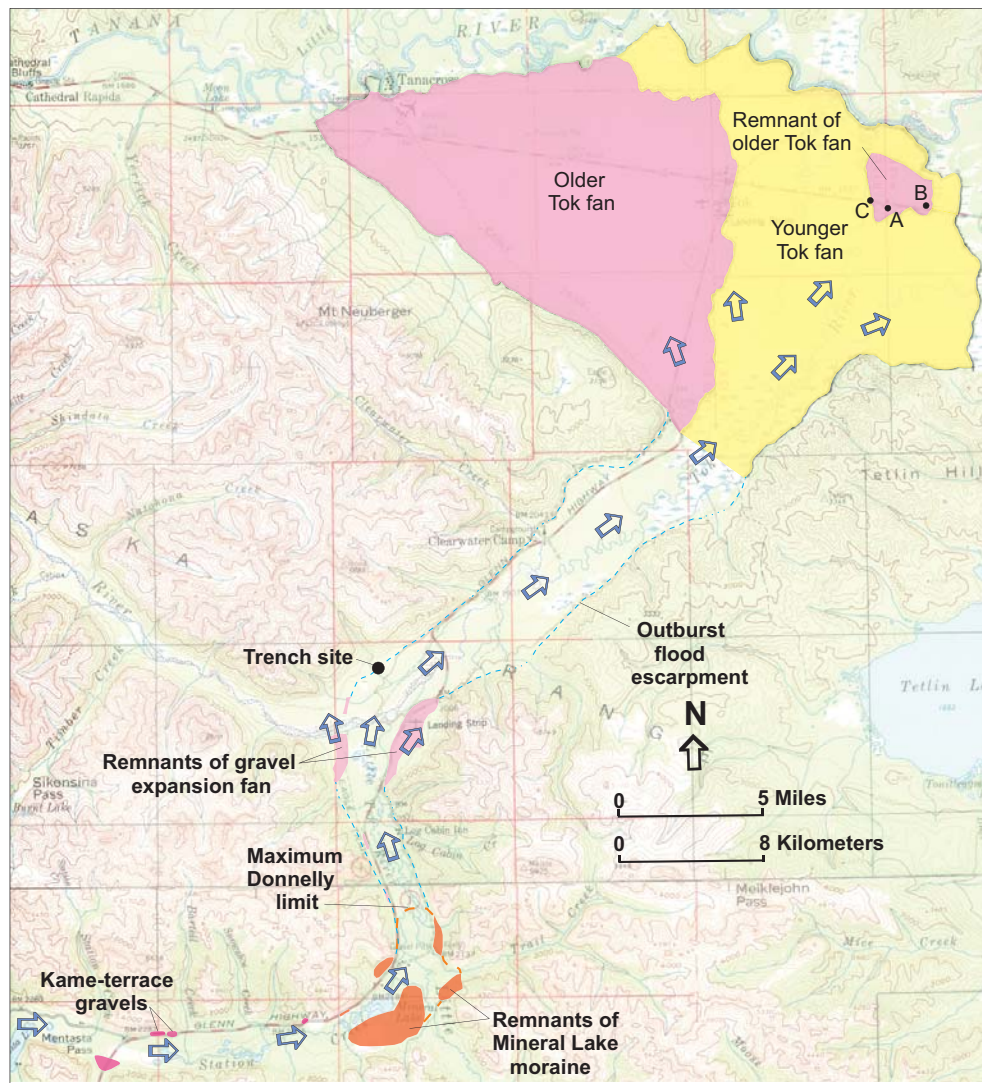
Figure 22. Map showing course of outburst floods (blue arrows) from Mentasta Pass to Tok fan during Donnelly glaciation relative to locations of flood boulders in northeastern Tok fan (sheet 4, localities A–C). Landforms in upper Tok River and Little Tok River valleys interpreted from Foster (1970) and Richter (1976) and verified by field observations. Flood escarpments dashed where discontinuous and dotted where buried and inferred. Asterisk marks site of trenches excavated by Carver and others (2010).

dumped near the sites of their ultimate burial and then may have been rolled across the fan surface a very short distance before being quickly buried by sediments carried in subsequent flood pulses. Large boulders carried or moved by the flood have been found in the Tok fan only in line with the trend of the Tok River valley, indicating that the boulder-bearing outburst floods came from that direction (fig. 22, localities A–C).

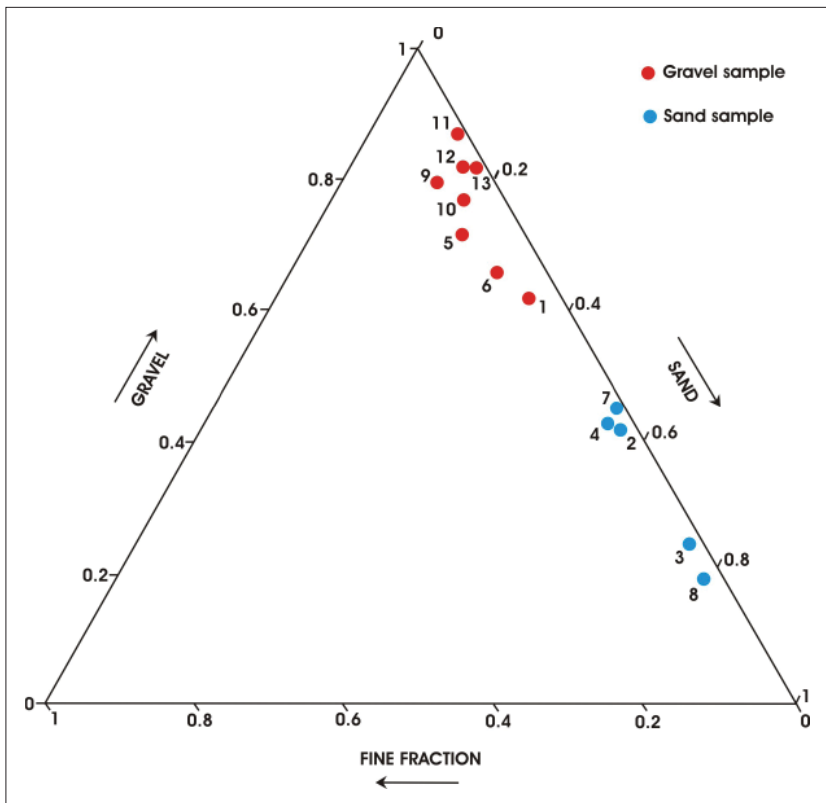
Figure 23. Diagram showing abundances of gravel, sand, and fine-fraction components in samples of gravel and sand beds in south and west walls of M.S. 62-2-005-2 (table 3, appendix), northeastern Tok fan, Tanacross B-4 Quadrangle (sheet 4, locality A).

The interlayered nature of the tabular gravels and sands exposed in the walls of M.S. 62-2-005-2 and the clear difference in their compositions (fig. 23) indicate that the large-magnitude flows pulsed during the outburst flooding, perhaps as a result of two main hydraulic processes. First, temporary blockages of subglacial drainageways through which floodwaters bypassed the glacier dam could have generated flow pulses (Sturm and others, 1987; Sturm and Benson, 1989; Tweed and Russell, 1999). Second, pulsating hydraulic conditions could have resulted from supercritical flood flows released onto the Tok fan at the mouth of the Tok River valley and spreading as upper flow-regime sheet flows across the gently sloping fan surface (Blair and McPherson, 1994). We suggest that gravel-rich beds represent bedload components deposited by water-dominated flood surges and that pebbly sands and matrix-supported gravels preserve components of the suspended load that were deposited by watery hyperconcentrated flows (see sidebar). The lack of waning flood sands on the surface of the Tok fan could have resulted from their reworking into surface dunes or their removal to the southern Yukon–Tanana Upland by strong katabatic winds, similar to the deflation of late Pleistocene sand and loess from the Nenana River valley (Thorson and Bender, 1985). The older part of the broad Tok fan has the morphological characteristics, such as a low gradient, low relief, and a surface network of shallow distributary channels, of a fan dominated by sheetflooding (Blair and McPherson, 1994, fig. 1B).

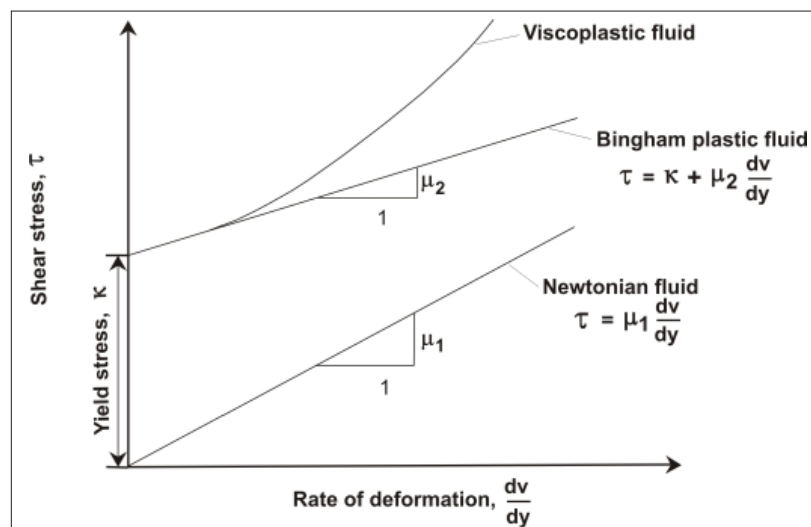
Figure 24. Diagram showing relation of stress to strain in Newtonian and non-Newtonian fluids (after O'Brien and Julien, 1985, fig. 2). Symbols: μ = dynamic viscosity (slope of curve); v = flow velocity; y = flow depth.

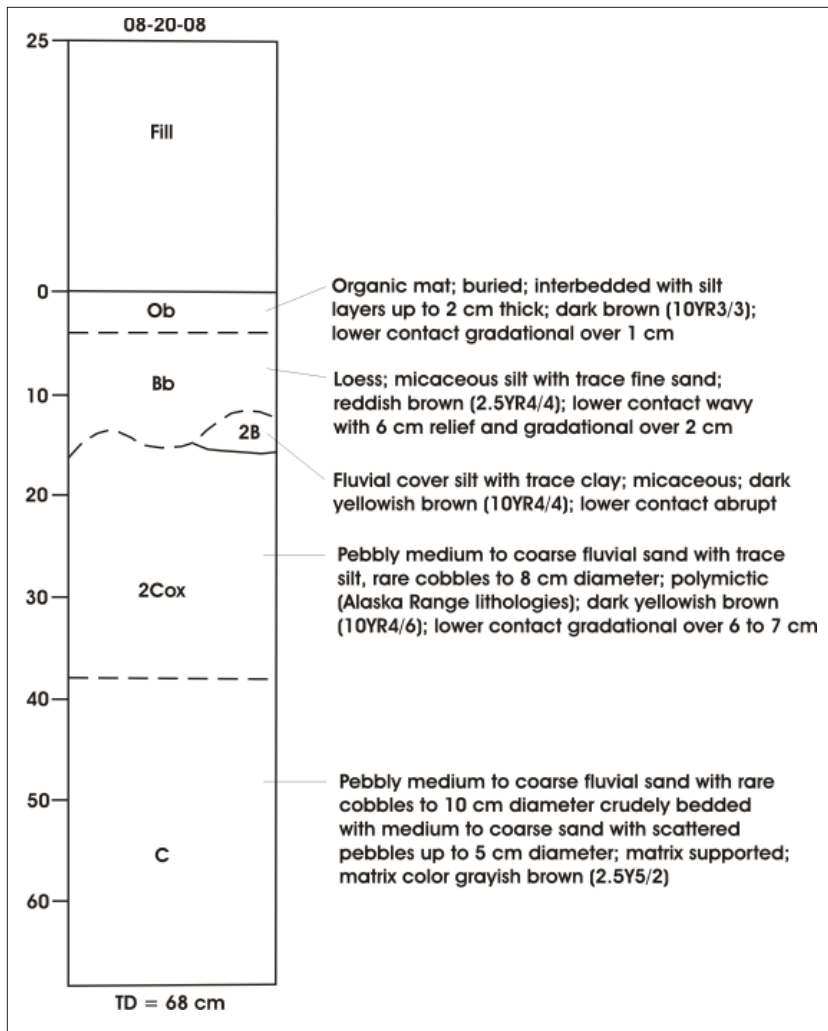
Figure 25. Section (SP-12) exposed in gravel pit in younger part of Tok fan in southwestern Tanacross B-4 Quadrangle. Elevation ~1,660 ft (~506 m).

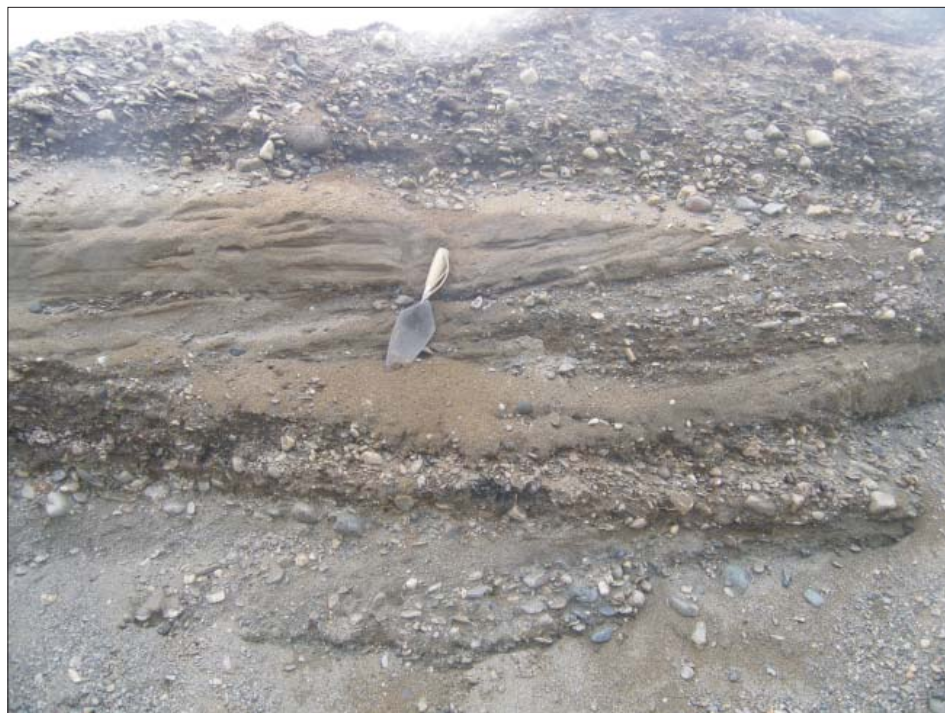
Figure 26. Photo showing cross-bedded sand and sandy pebble–gravel fill in a shallow channel on the younger Tok fan east of the Tok River, central Tanacross B-4 Quadrangle. Massive sandy pebble gravels beneath the channel fill are bedload deposits of the meandering stream that built the fan. Trowel provides scale. Photograph taken 08/19/2008 by T.D. Hubbard.

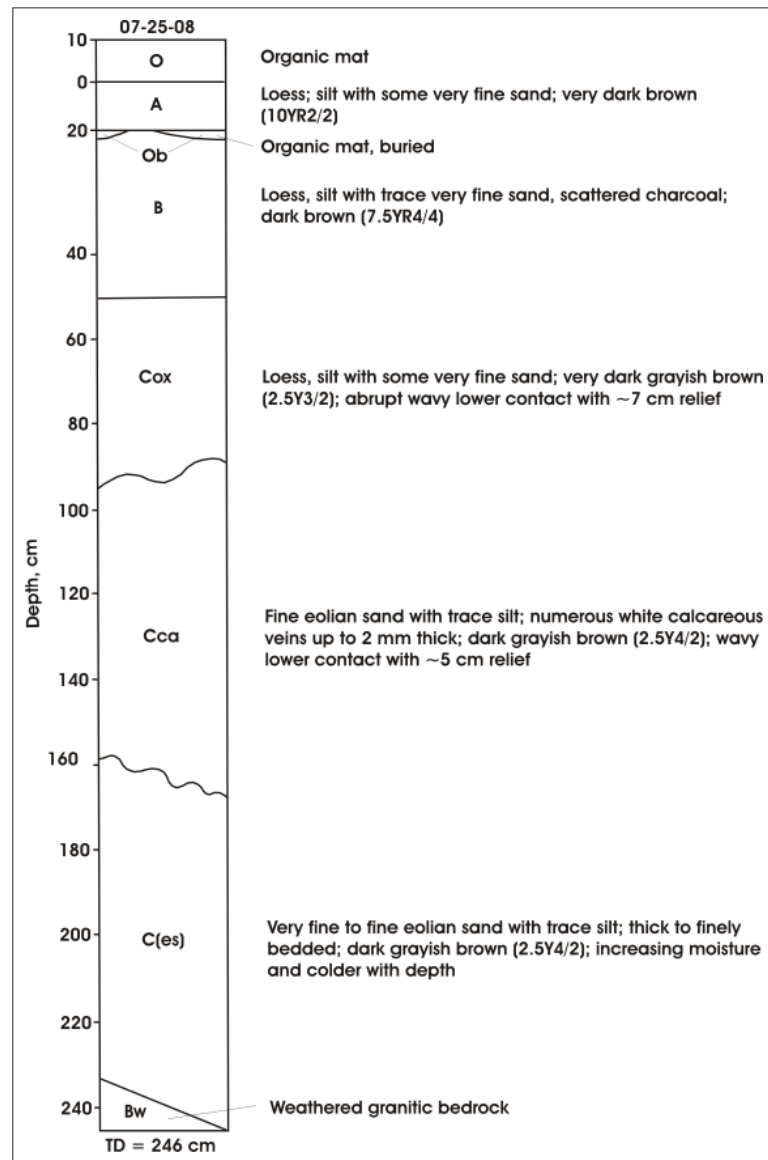
Figure 27. Stratigraphic section (SP-13) in loess and eolian sand blanket over grüßified granitic bedrock on north bank of Tanana River at centerline of proposed new Alaska Highway bridge, southeastern Tanacross B-4 Quadrangle.

We found no flood deposits on the 21-m-high bedrock bluffs north of the Tanana River crossing by the Alaska Highway. A cut along the proposed new route of the Alaska Highway (sheet 4, SP-13) displayed up to 95 cm of

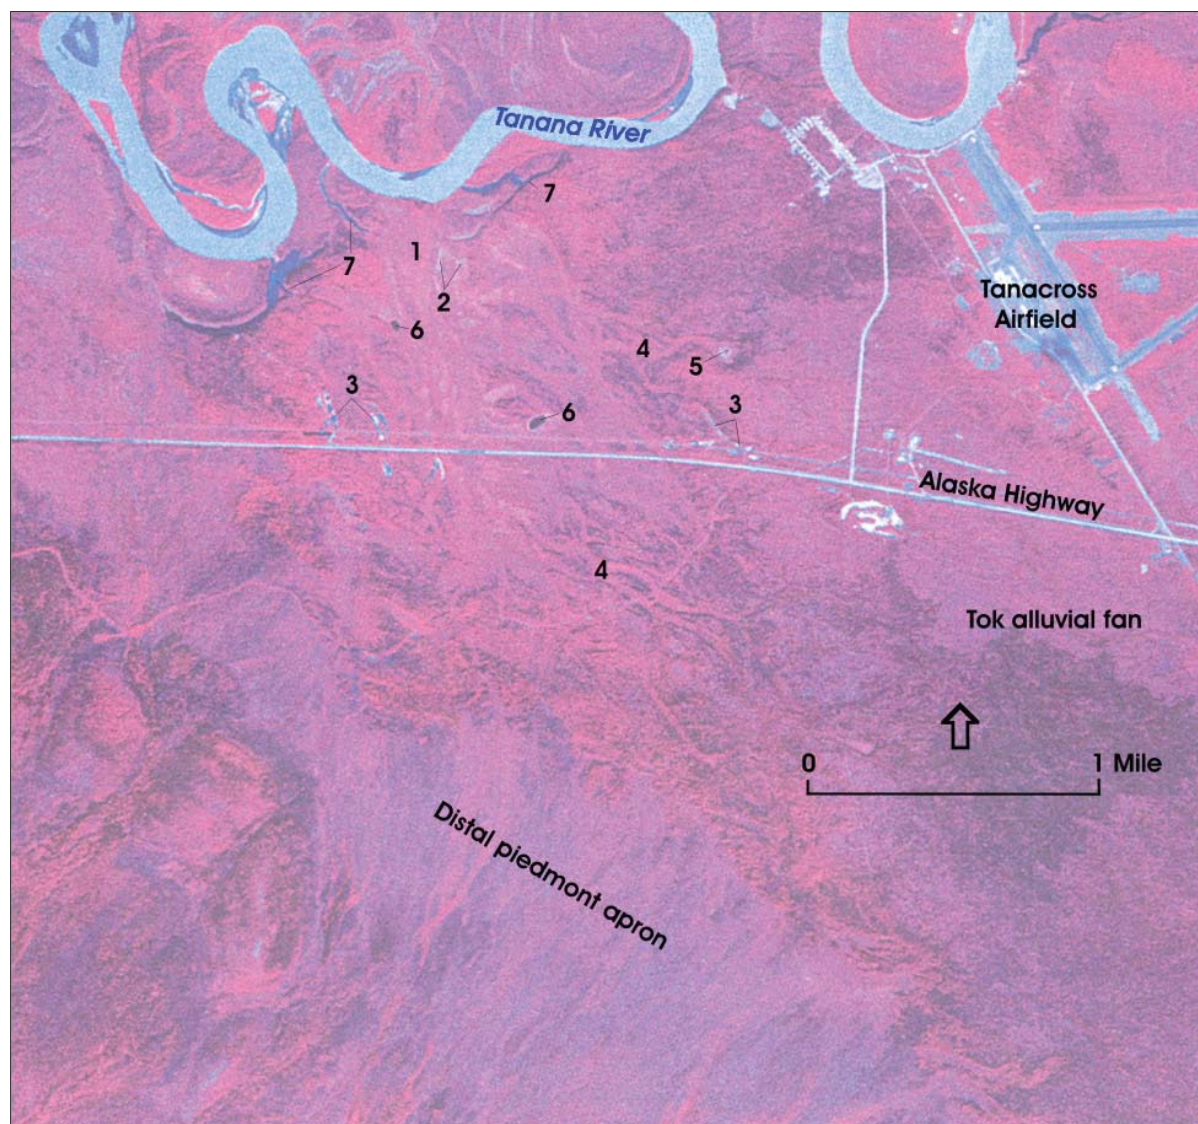
Figure 28. Airphoto showing features indicating groundwater emergence in vicinity of Tanacross Airfield, west-central Tanacross B-5 Quadrangle. Symbols: 1 = swampy vegetation, 2 = peat bogs, 3 = shallow artificial trenches, 4 = networks of shallow natural drainage channels, 5 = large clearwater spring, 6 = small clearwater lakes, and 7 = clearwater spring discharges (Alaska High Altitude Photograph ALK 60 CIR 21-269 taken July 1978).

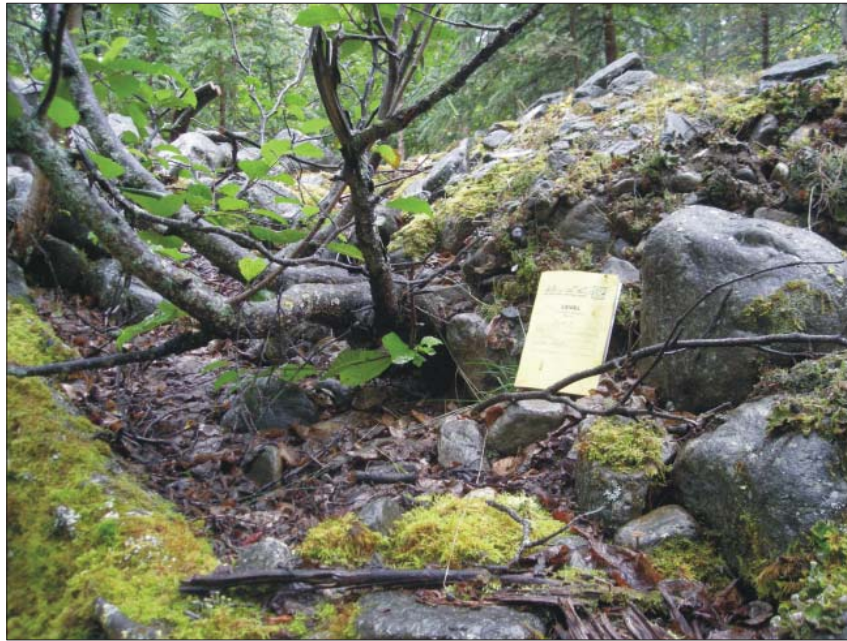
Figure 29. Photo showing curved stems of alder shrub tipped and broken during deposition of natural levee along unnamed small stream above Alaska Highway in east-central Tanacross B-6 Quadrangle. Field notebook measures 11.4 by 17.8 cm. Photograph taken 09/15/2008 by R.D. Reger.

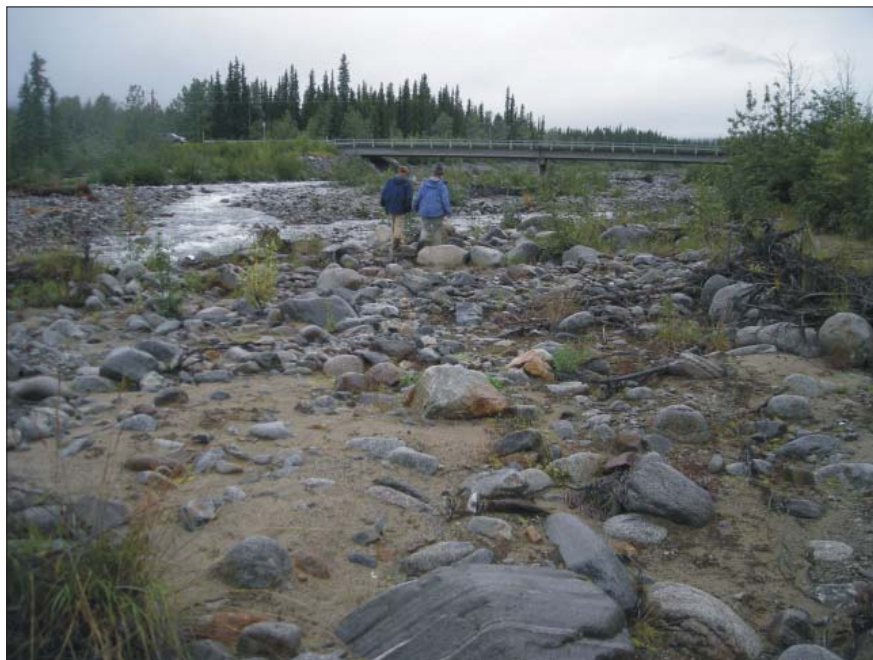
Figure 30. Photo showing view up floodplain of Yerrick Creek toward Alaska Highway bridge, east-central Tanacross B-6 Quadrangle, showing numerous large boulders deposited by torrential flooding. Note reduced summer flow of Yerrick Creek. Persons provide scale. Photograph taken 07/31/2008 by R.D. Reger.

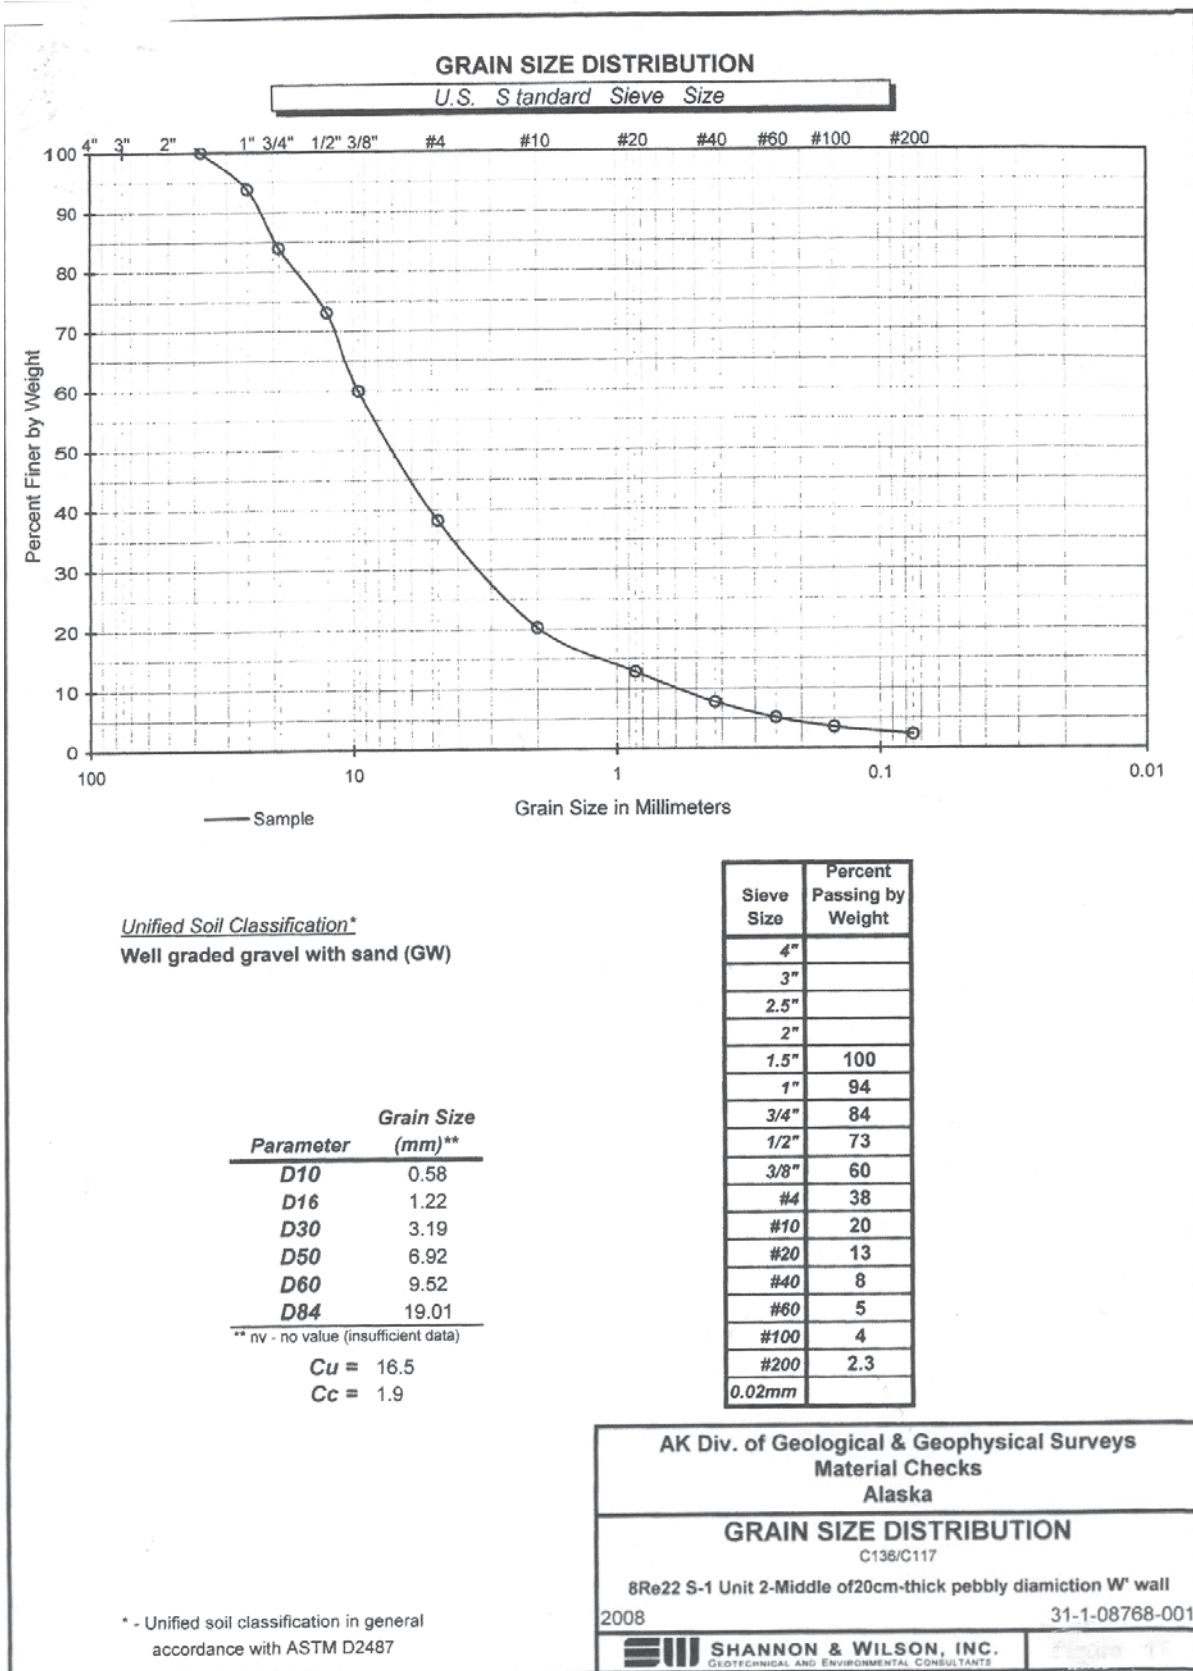
Figure A1. Diagram showing grain-size distribution of sample S-1 from M.S. 62-2-005-2 (fig. 20; sheet 4, locality A).

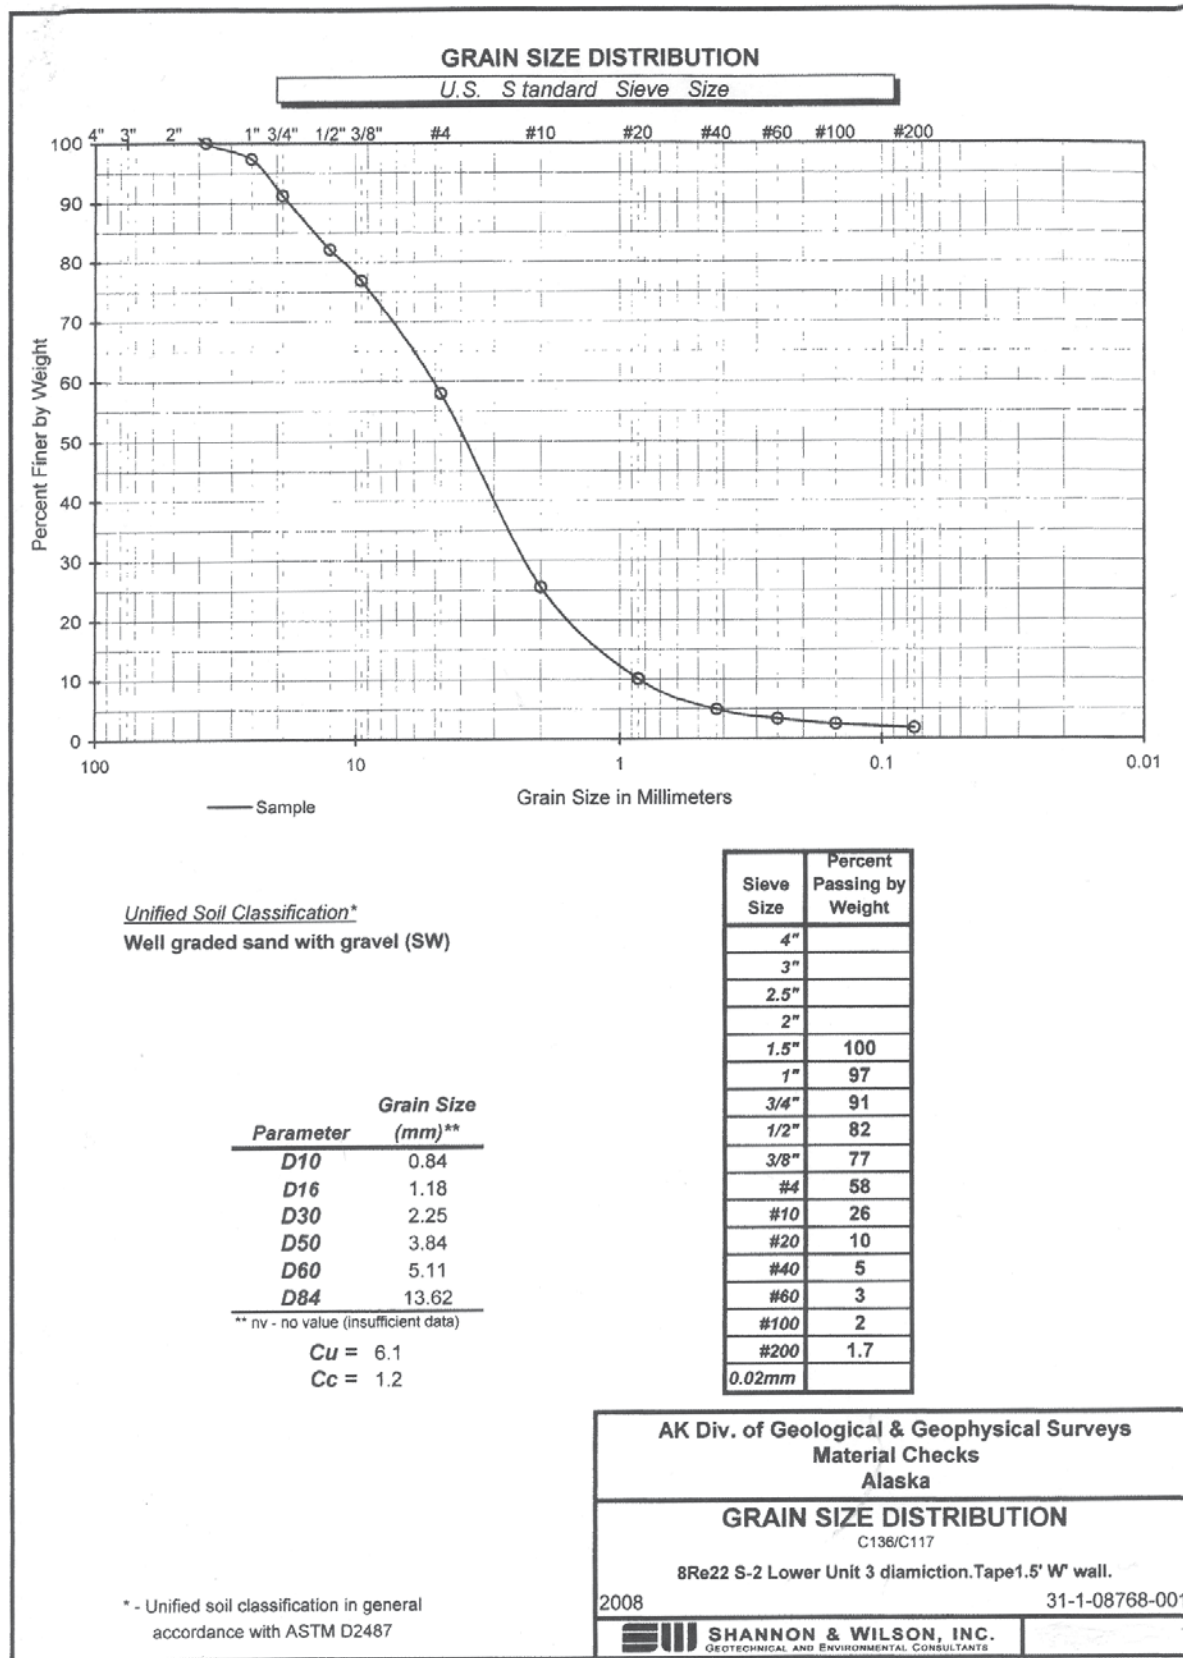
Figure A2. Diagram showing grain-size distribution of sample S-2 from M.S. 62-2-005-2 (fig. 20; sheet 4, locality A).

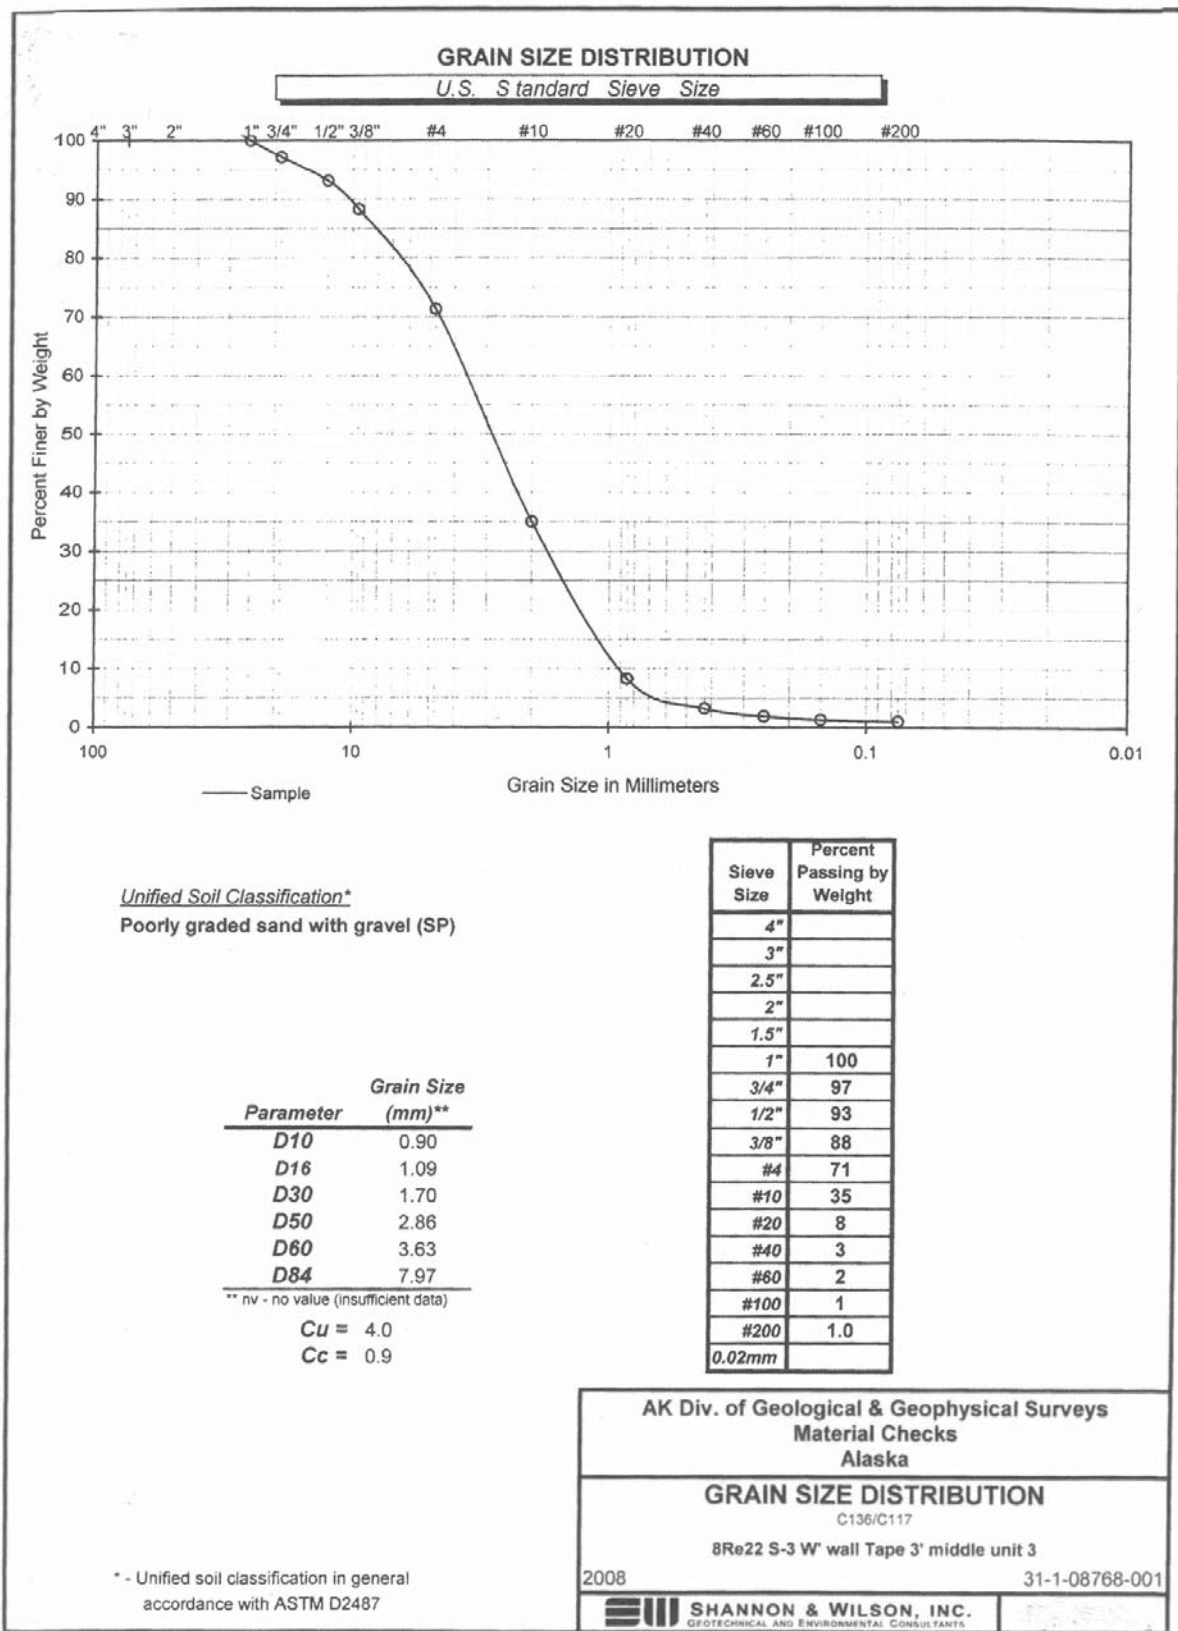
Figure A3. Diagram showing grain-size distribution of sample S-3 from M.S. 62-2-005-2 (fig. 20; sheet 4, locality A).

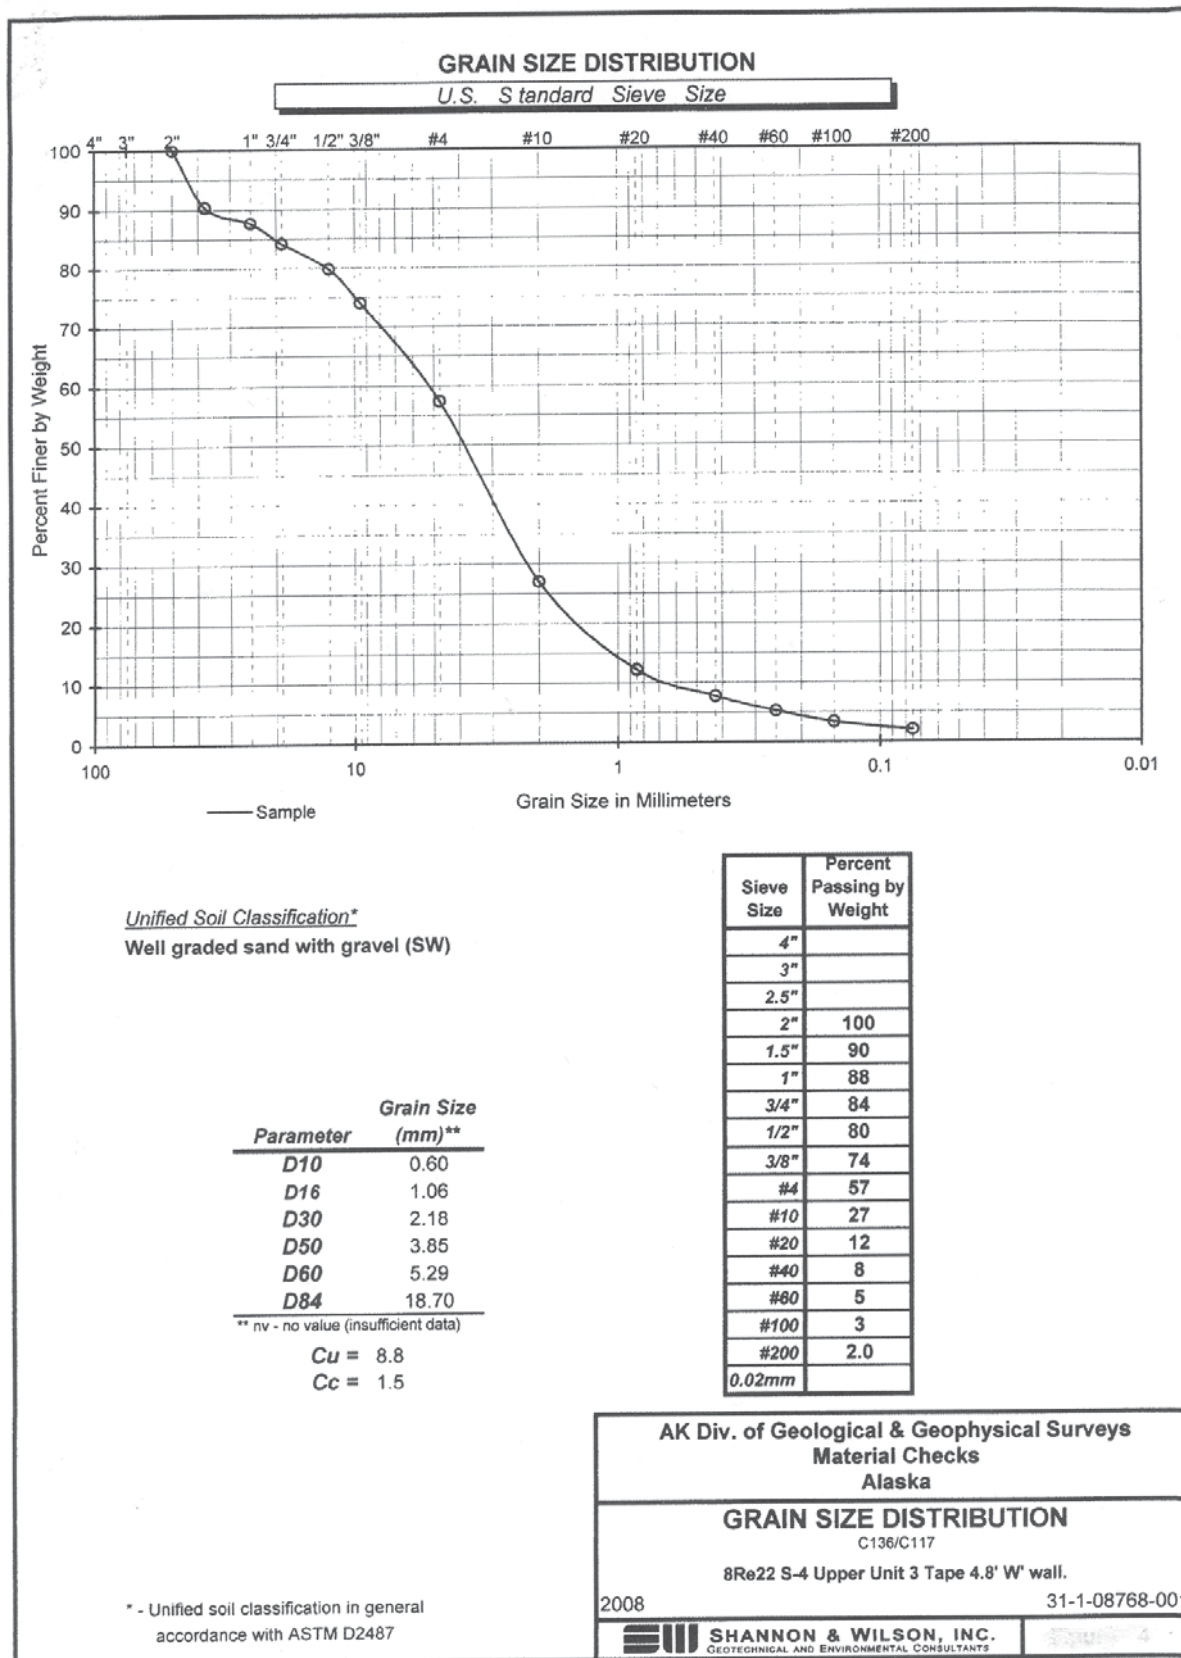
Figure A4. Diagram showing grain-size distribution of sample S-4 from M.S. 62-2-005-2 (fig. 20; sheet 4, locality A).

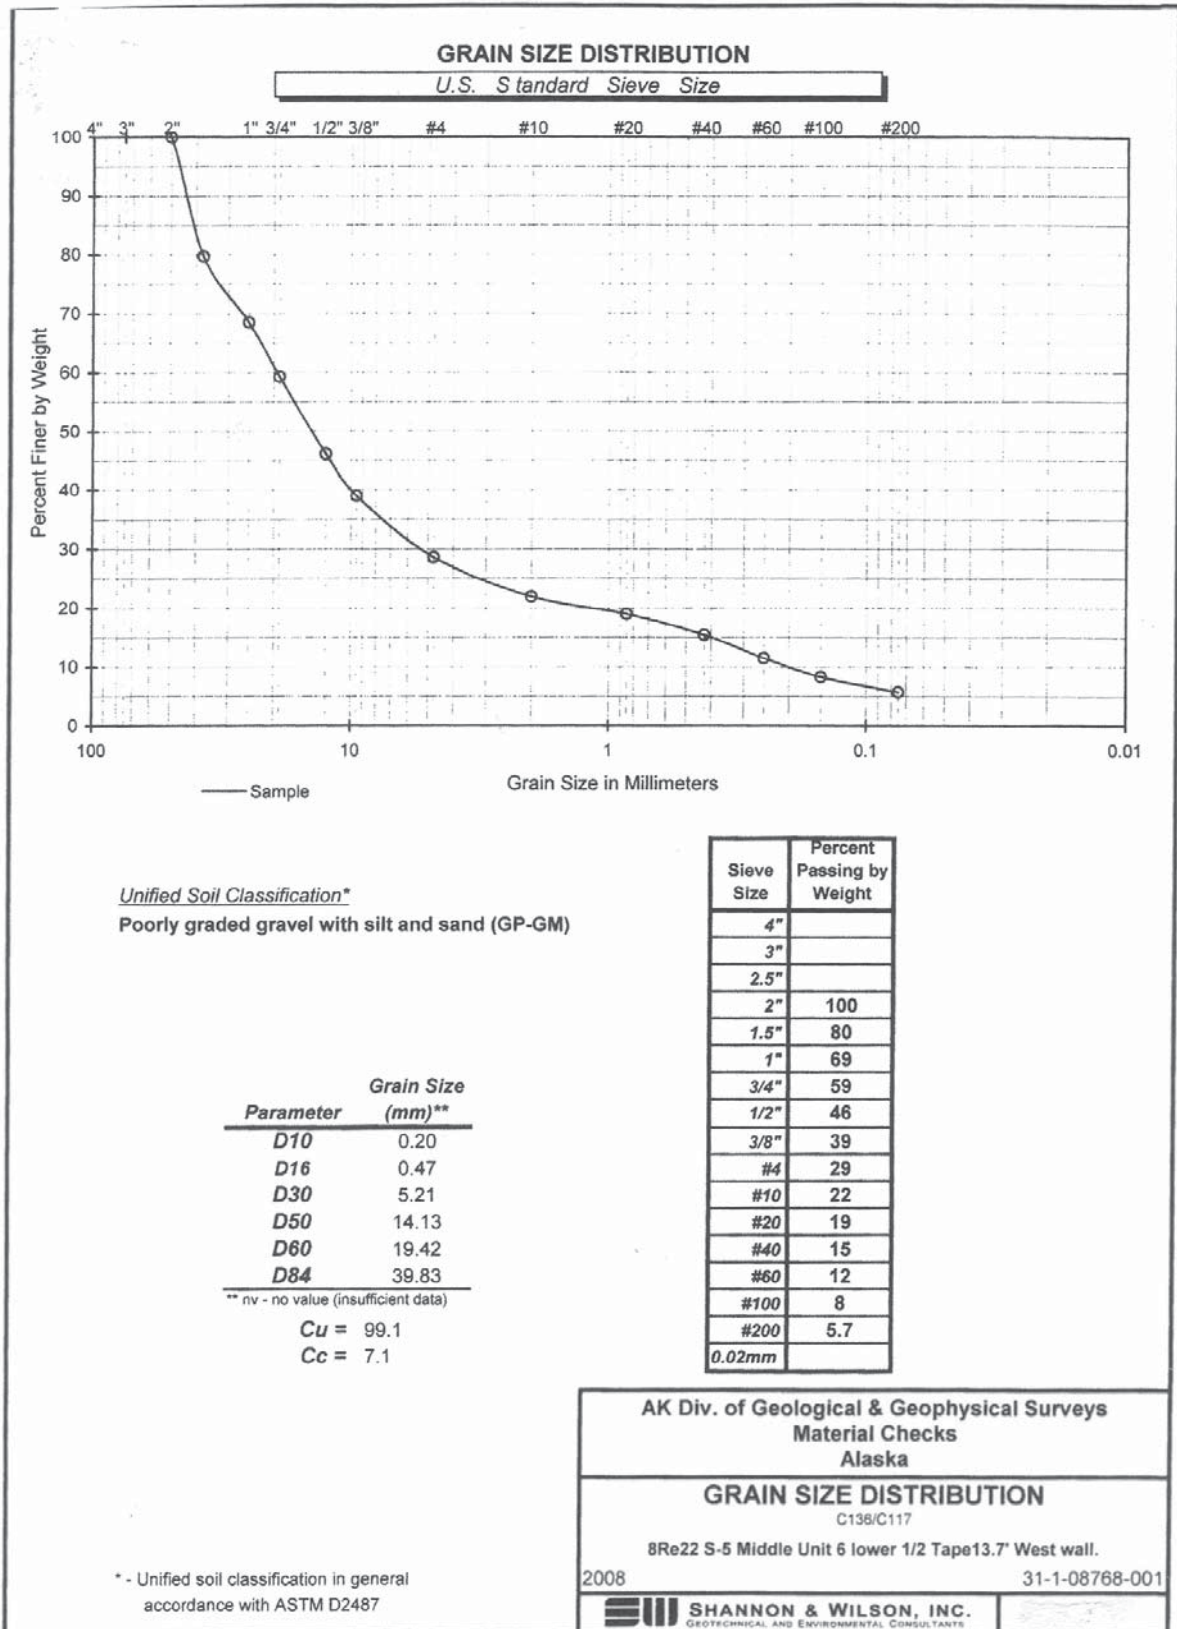
Figure A5. Diagram showing grain-size distribution of sample S-5 from M.S. 62-2-005-2 (fig. 20; sheet 4, locality A).

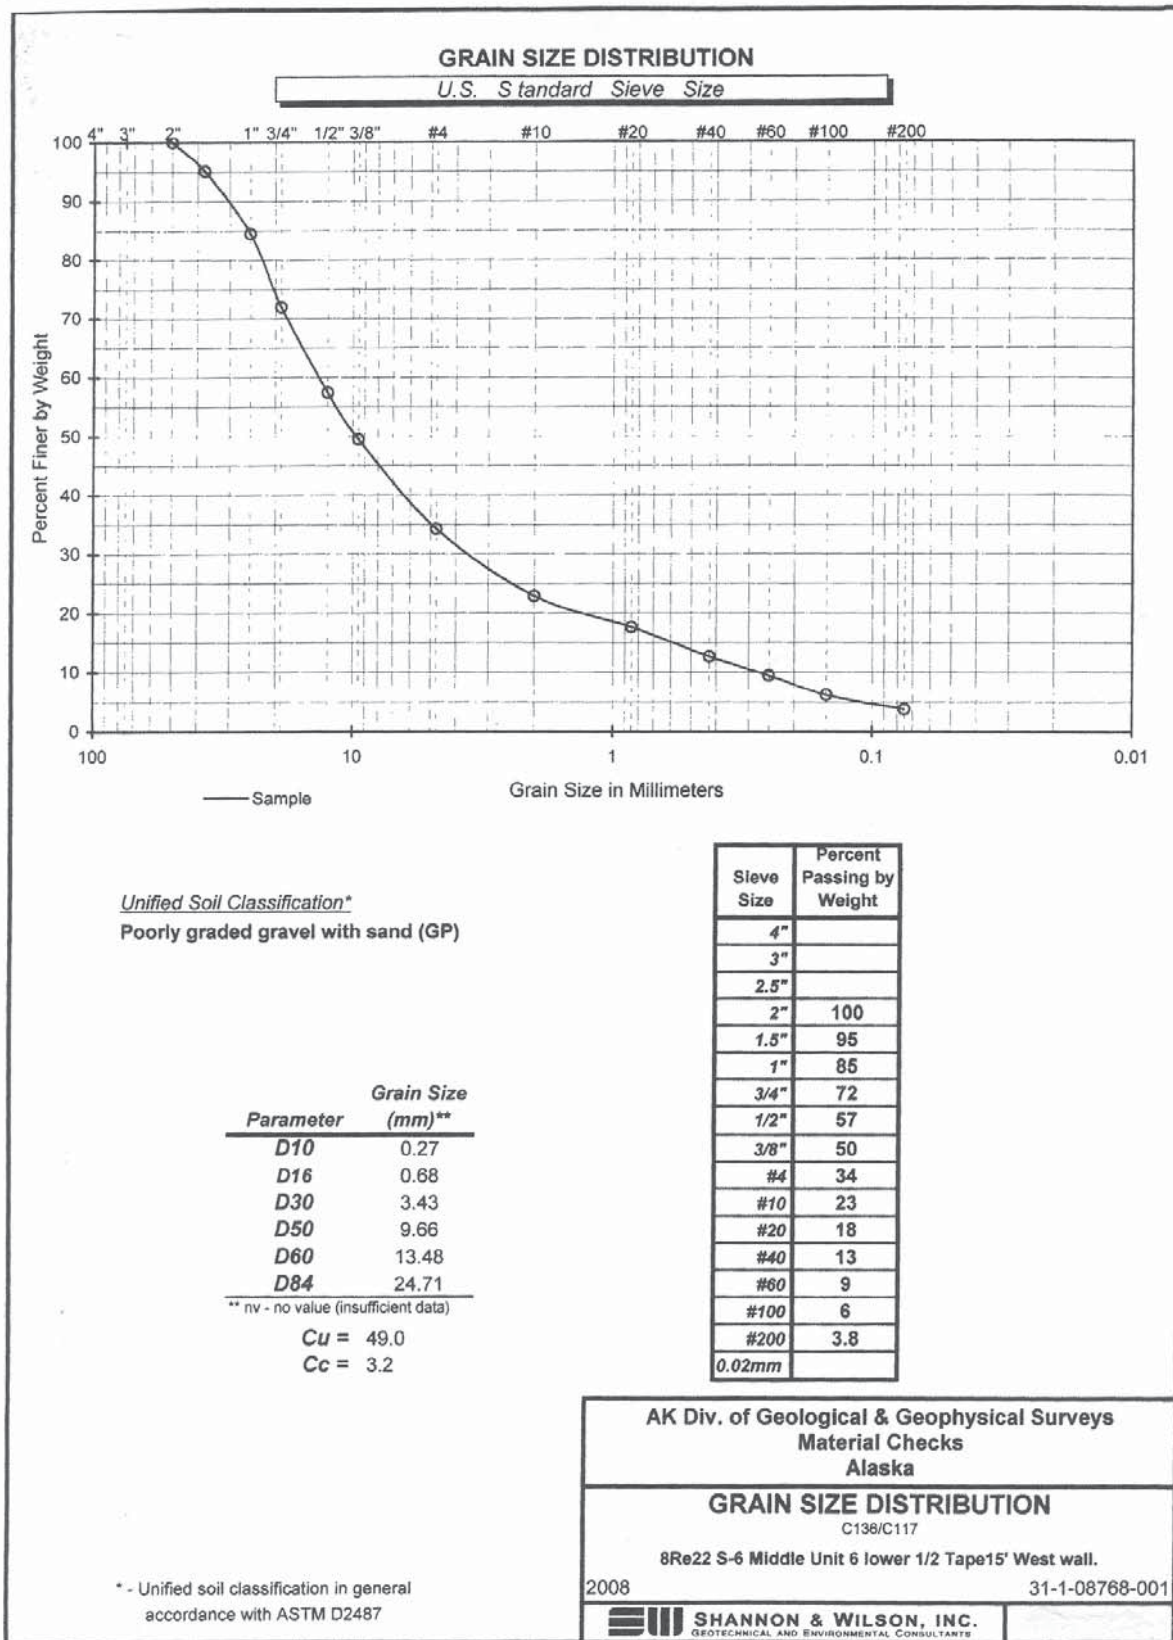
Figure A6. Diagram showing grain-size distribution of sample S-6 from M.S. 62-2-005-2 (fig. 20; sheet 4, locality A).
