PRELIMINARY INTERPRETIVE REPORT 2009-6a

**SURFICIAL GEOLOGY OF ALASKA HIGHWAY CORRIDOR,
ROBERTSON RIVER TO TETLIN JUNCTION, ALASKA**

Richard D. Reger, Trent D. Hubbard, and Gary A. Carver

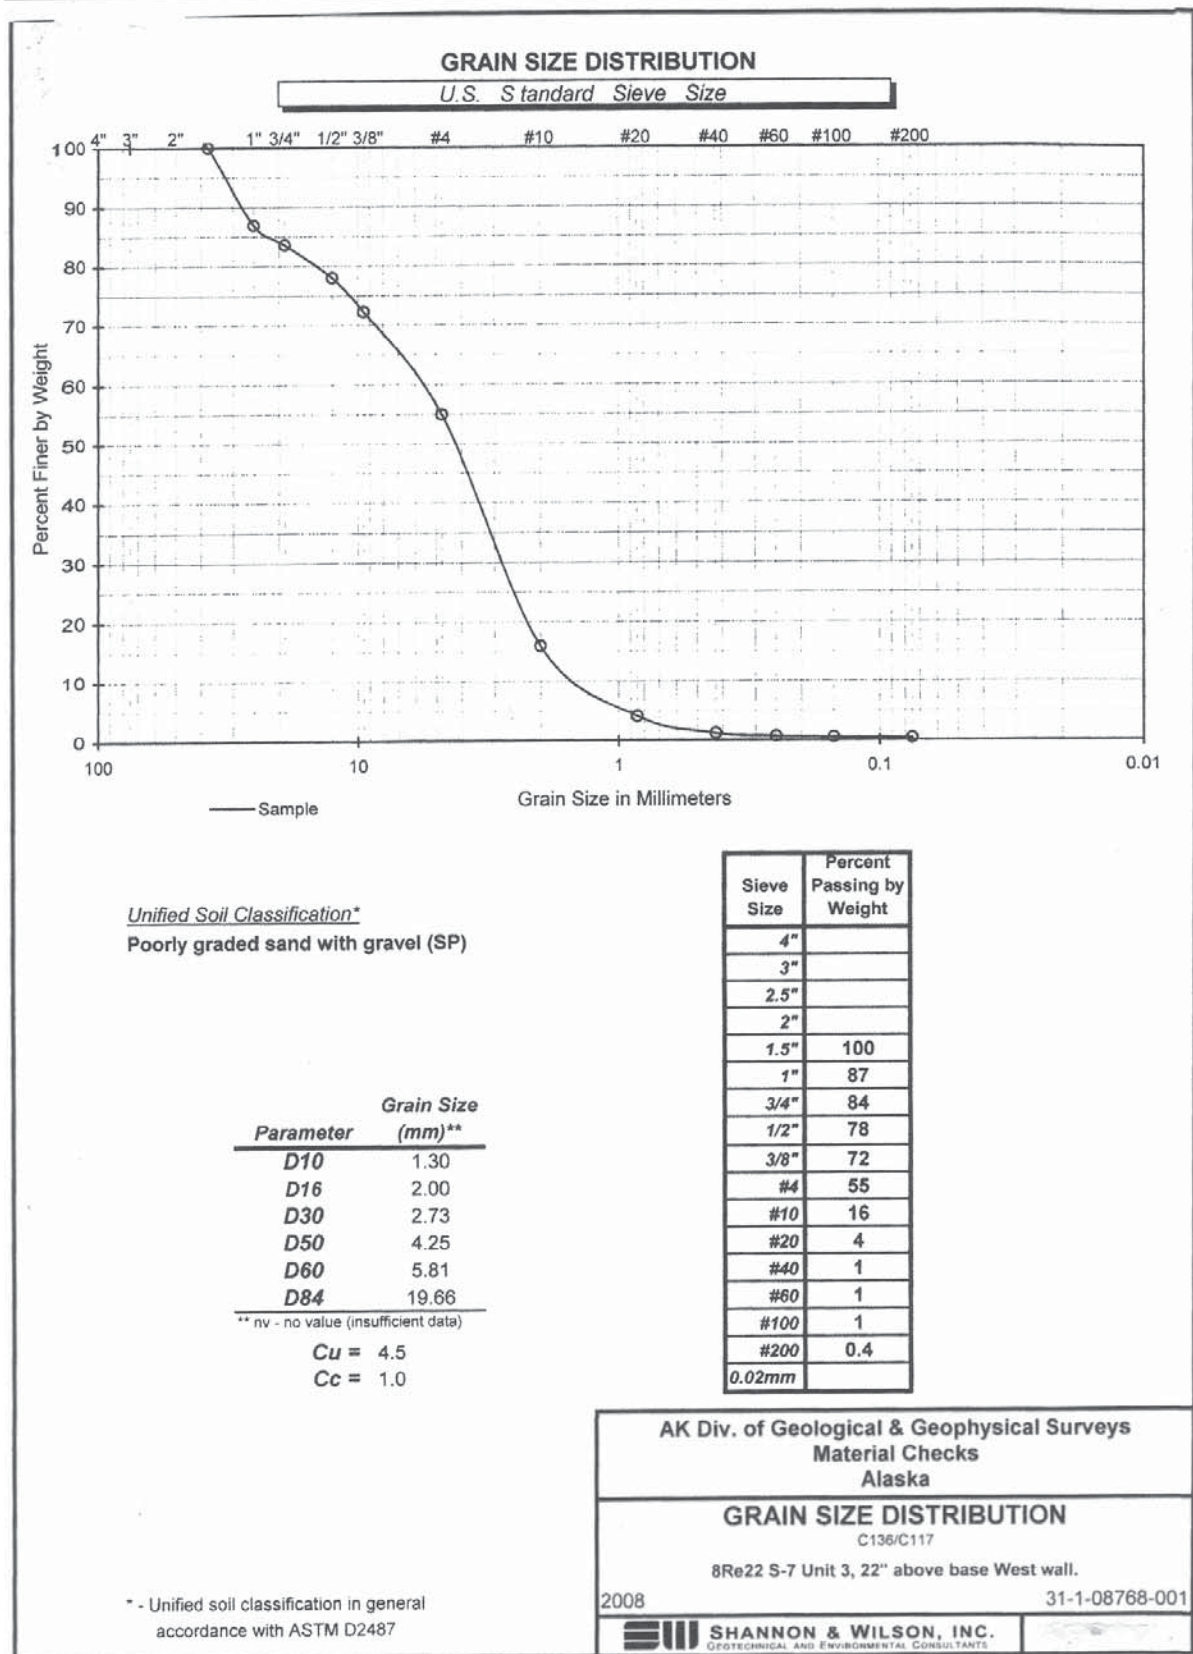
Figure A7. Diagram showing grain-size distribution of sample S-7 from M.S. 62-2-005-2 (fig. 20; sheet 4, locality A).

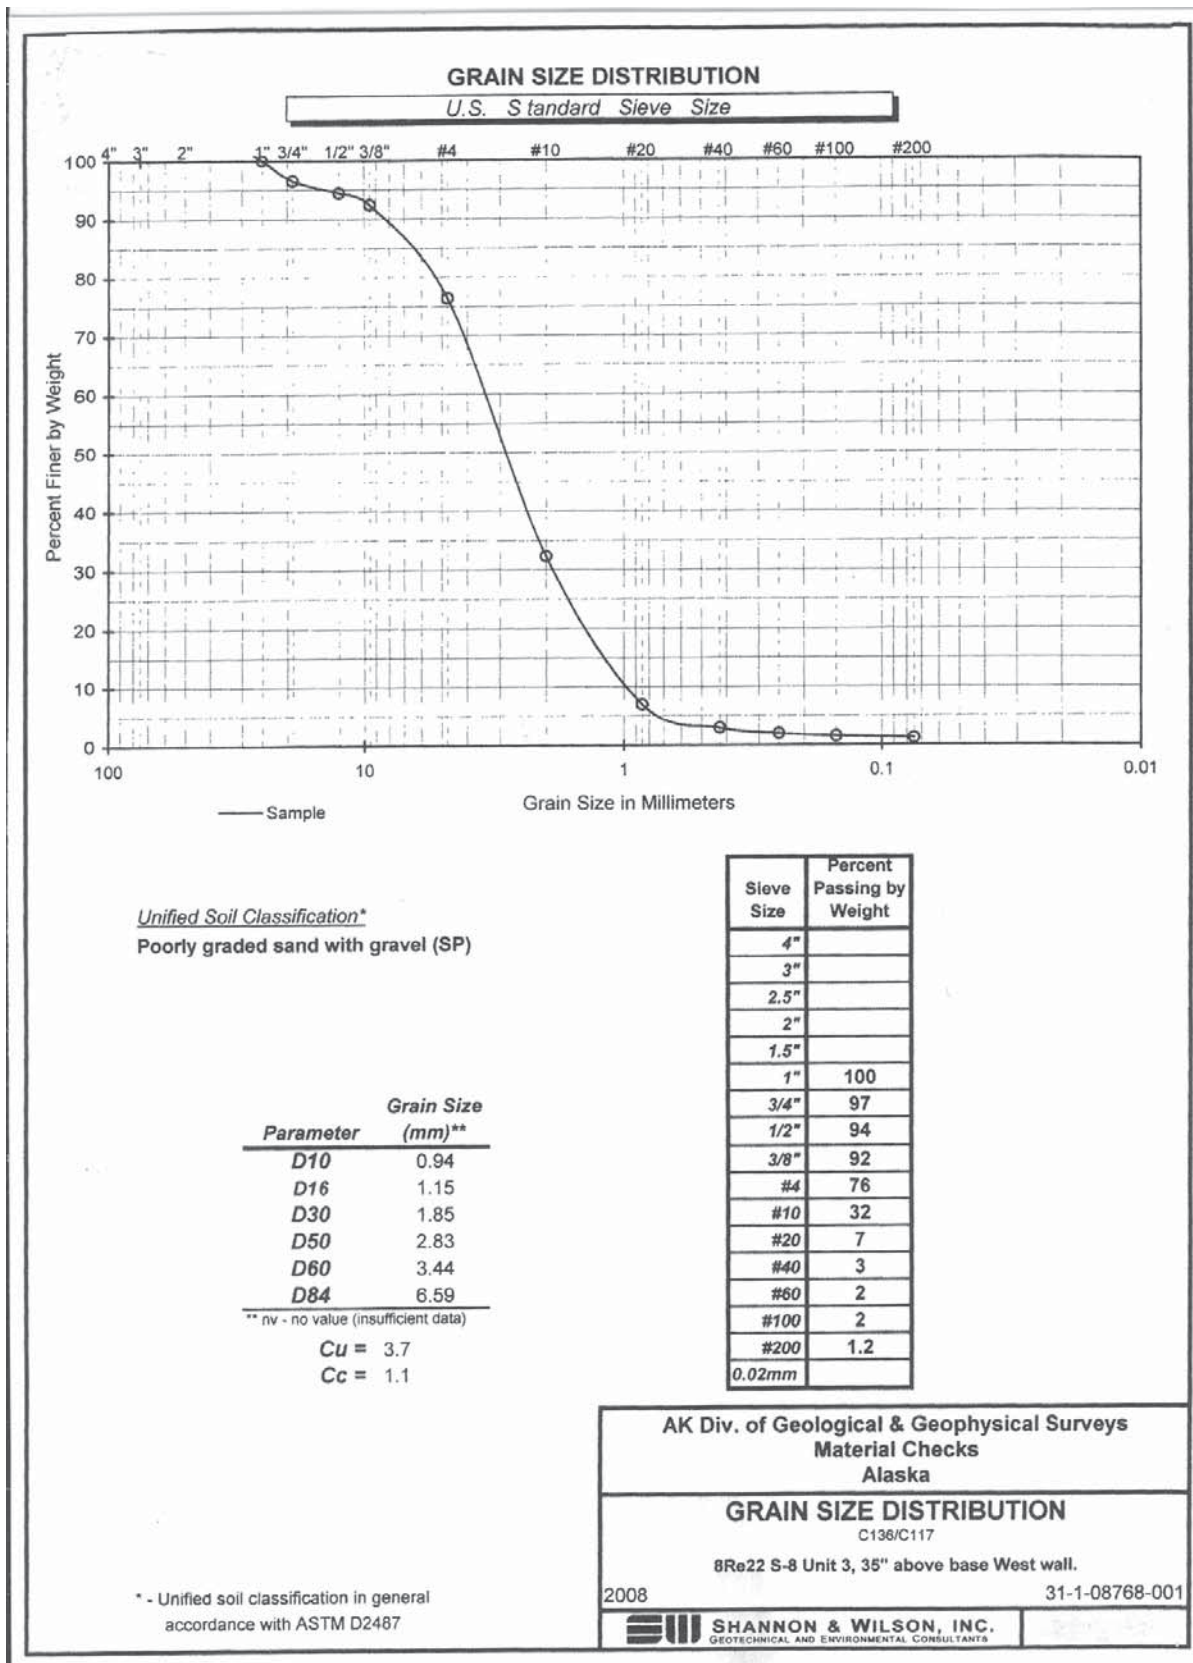
Figure A8. Diagram showing grain-size distribution of sample S-8 from M.S. 62-2-005-2 (fig. 20; sheet 4, locality A).

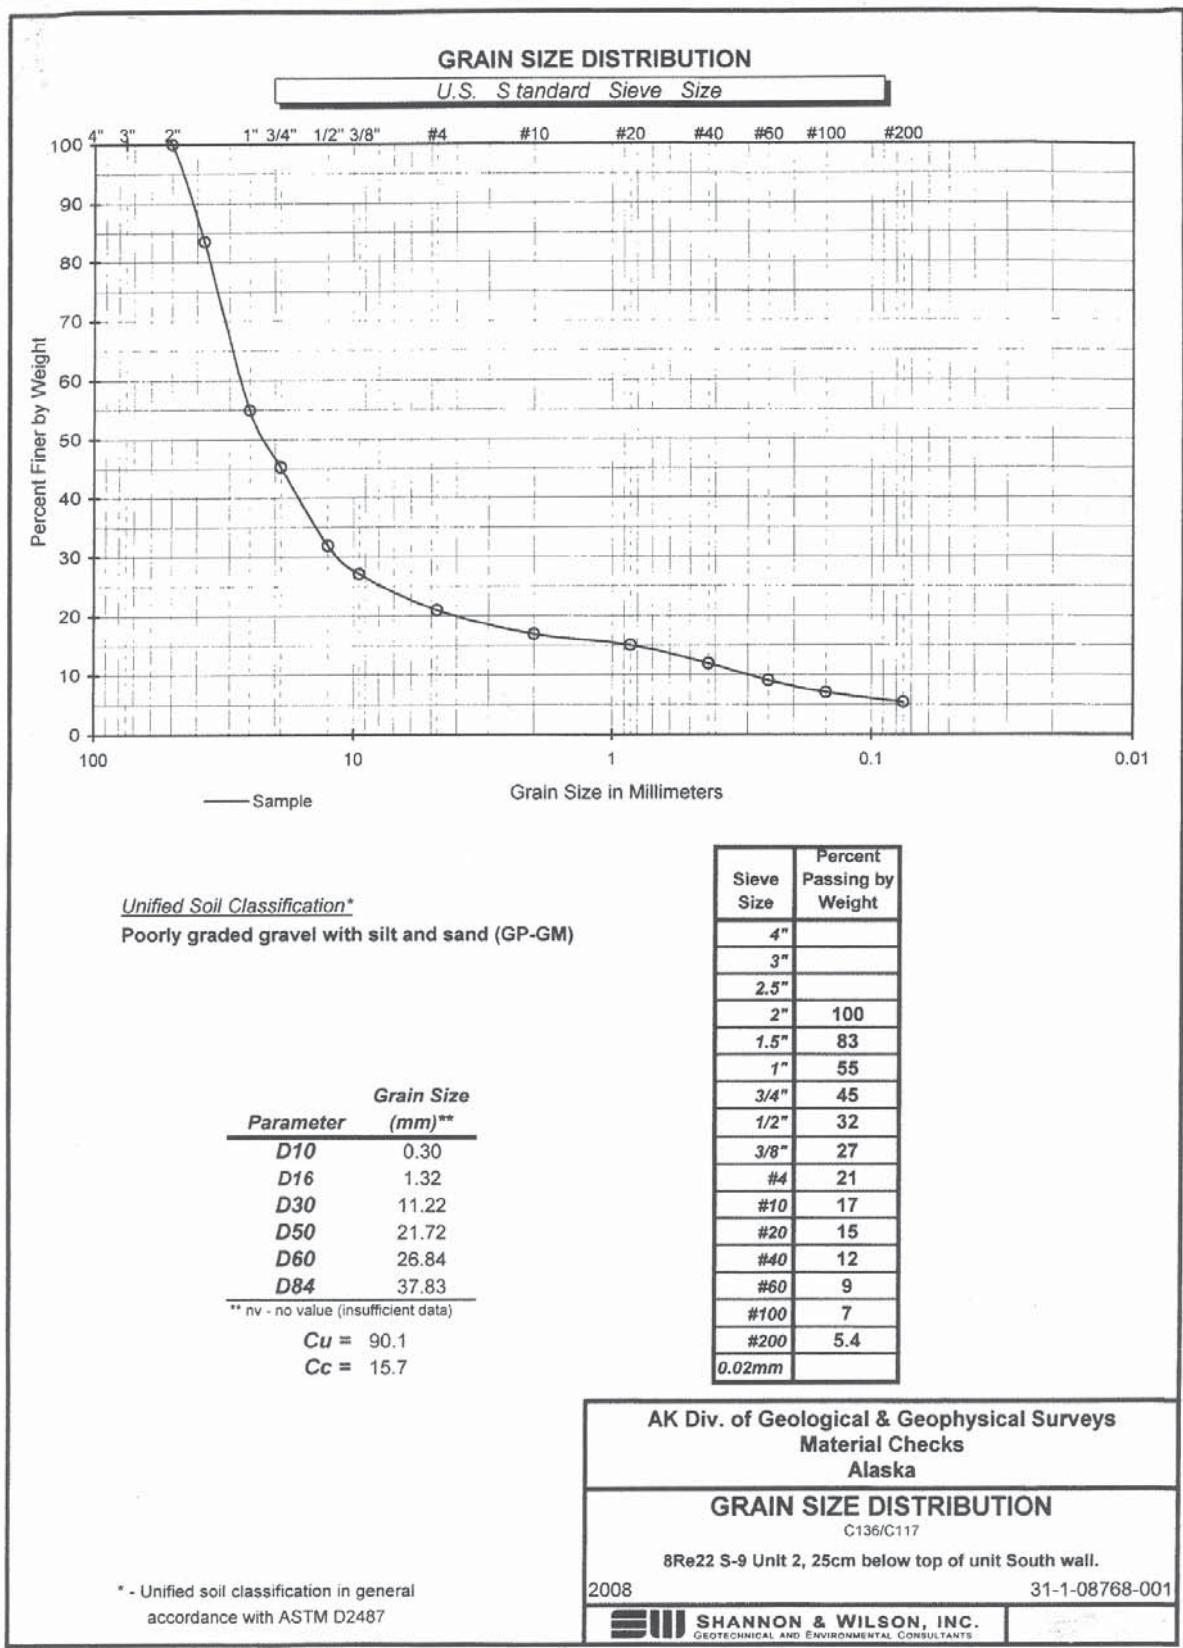
Figure A9. Diagram showing grain-size distribution of sample S-9 from M.S. 62-2-005-2 (fig. 18; sheet 4, locality A).

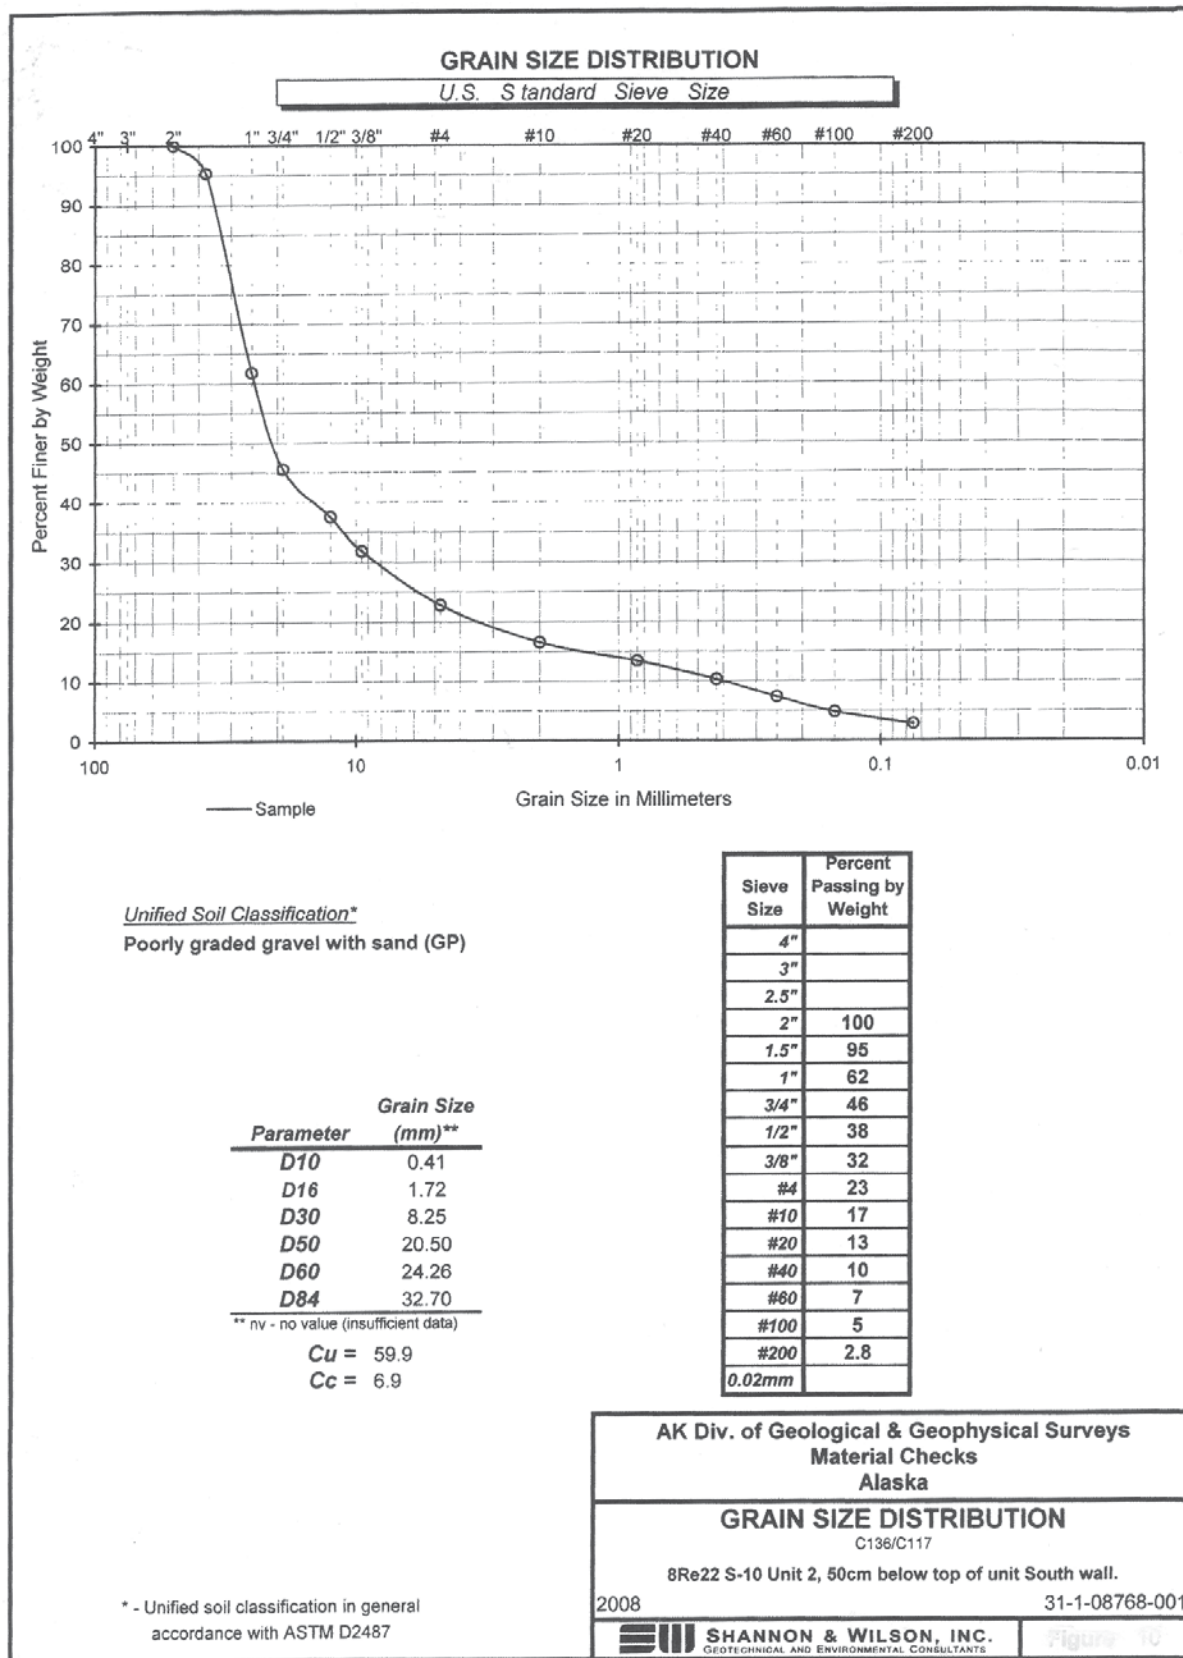
Figure A10. Diagram showing grain-size distribution of sample S-10 from M.S. 62-2-005-2 (fig. 18; sheet 4, locality A).

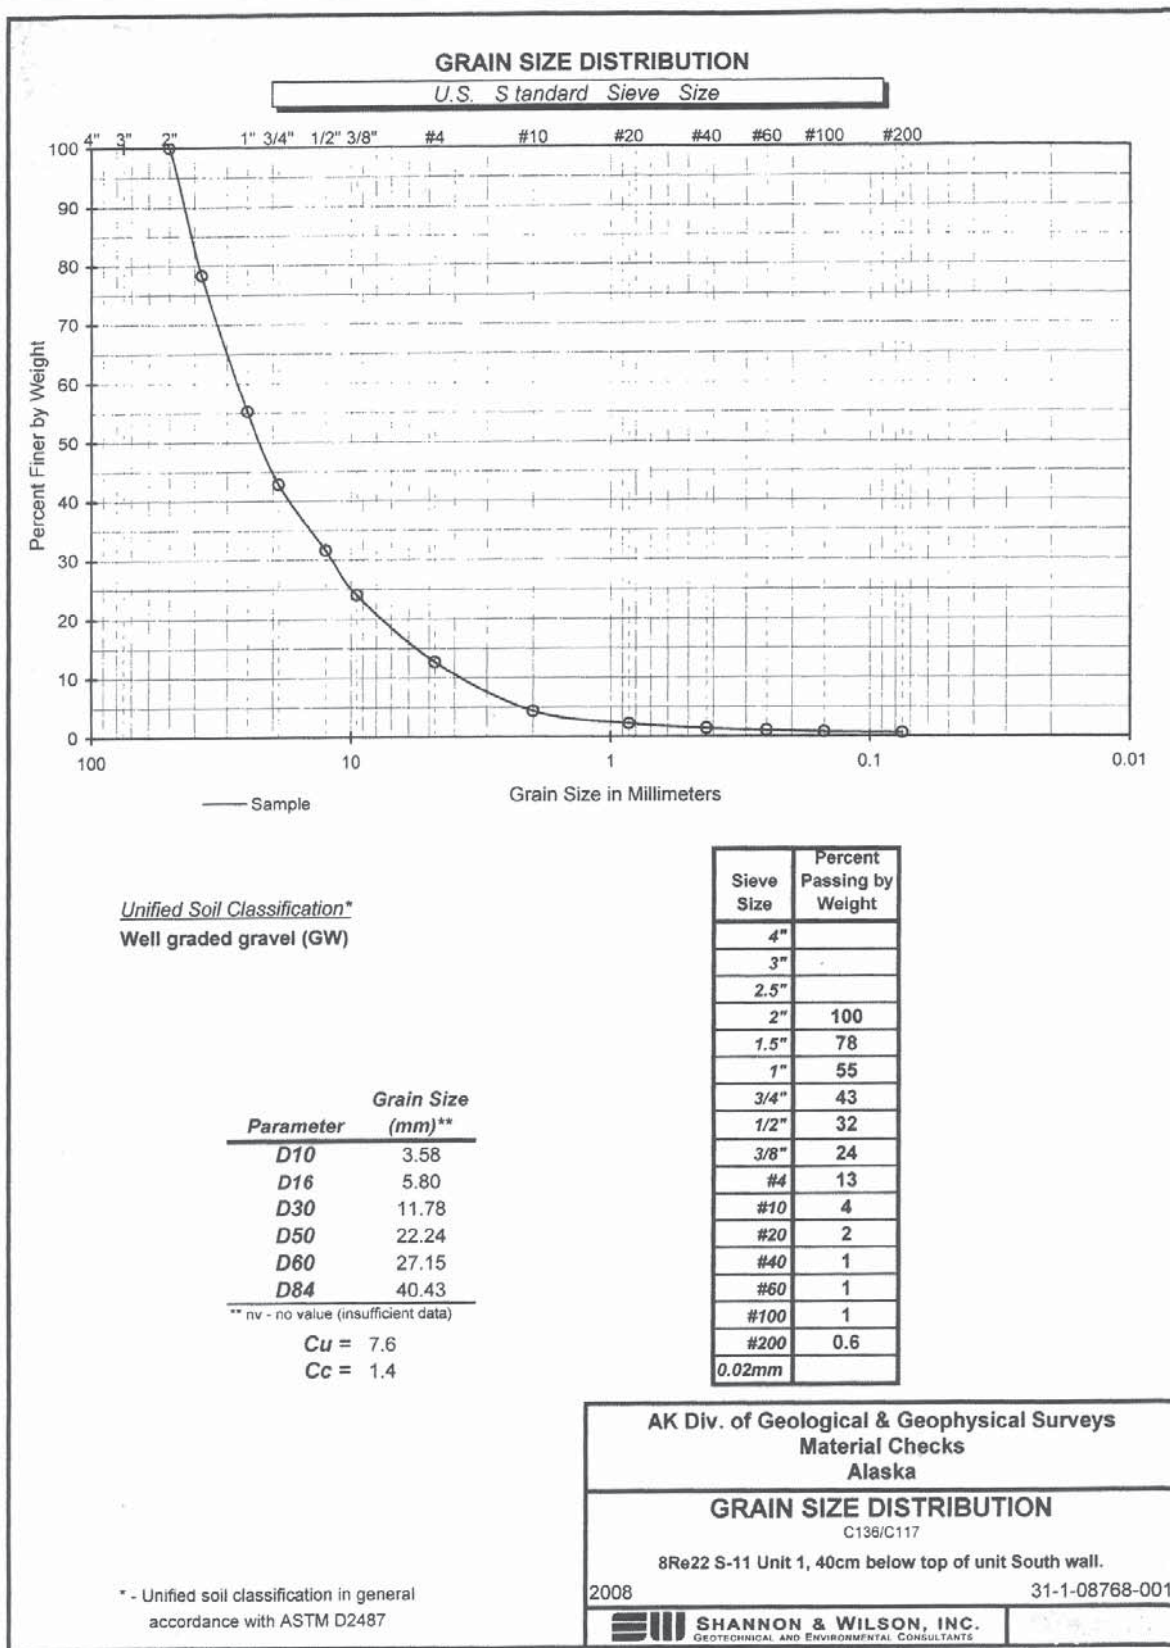
Figure A11 Diagram showing grain-size distribution of sample S-11 from M.S. 62-2-005-2 (fig. 18; sheet 4, locality A).

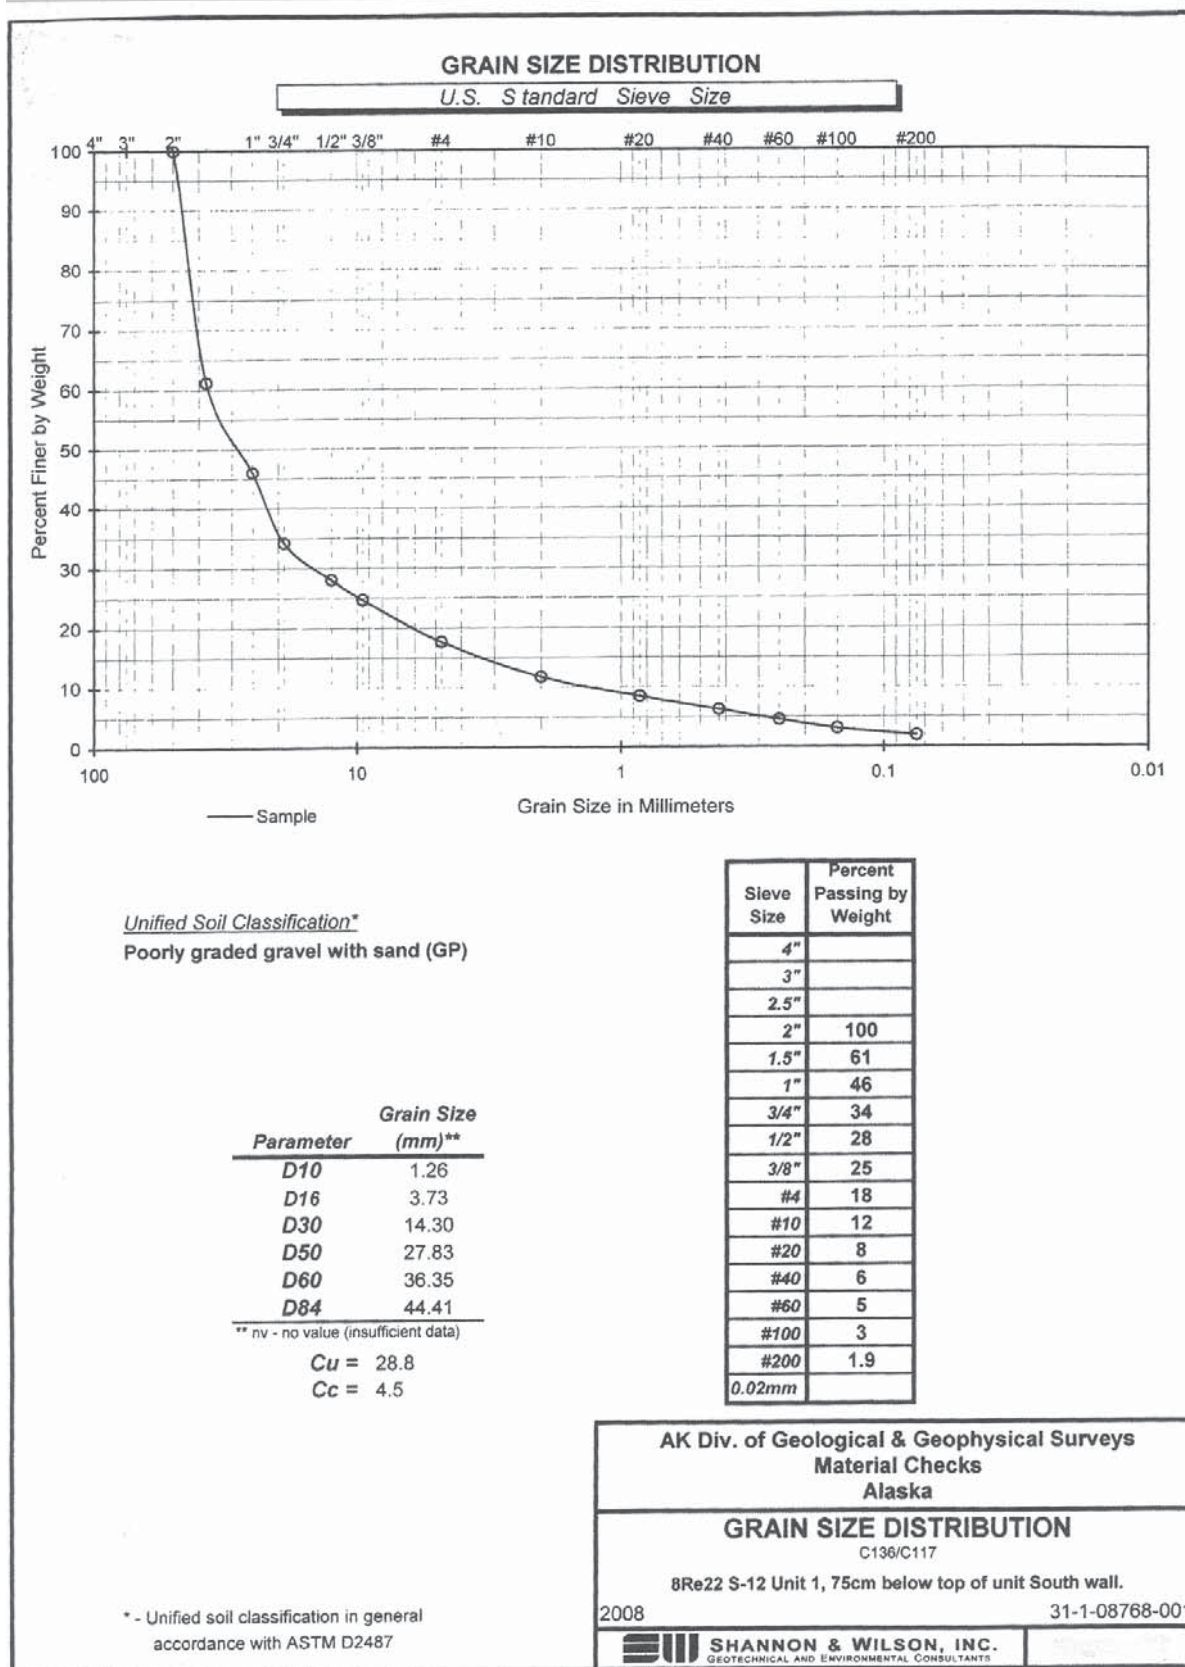
Figure A12. Diagram showing grain-size distribution of sample S-12 from M.S. 62-2-005-2 (fig. 18; sheet 4, locality A).

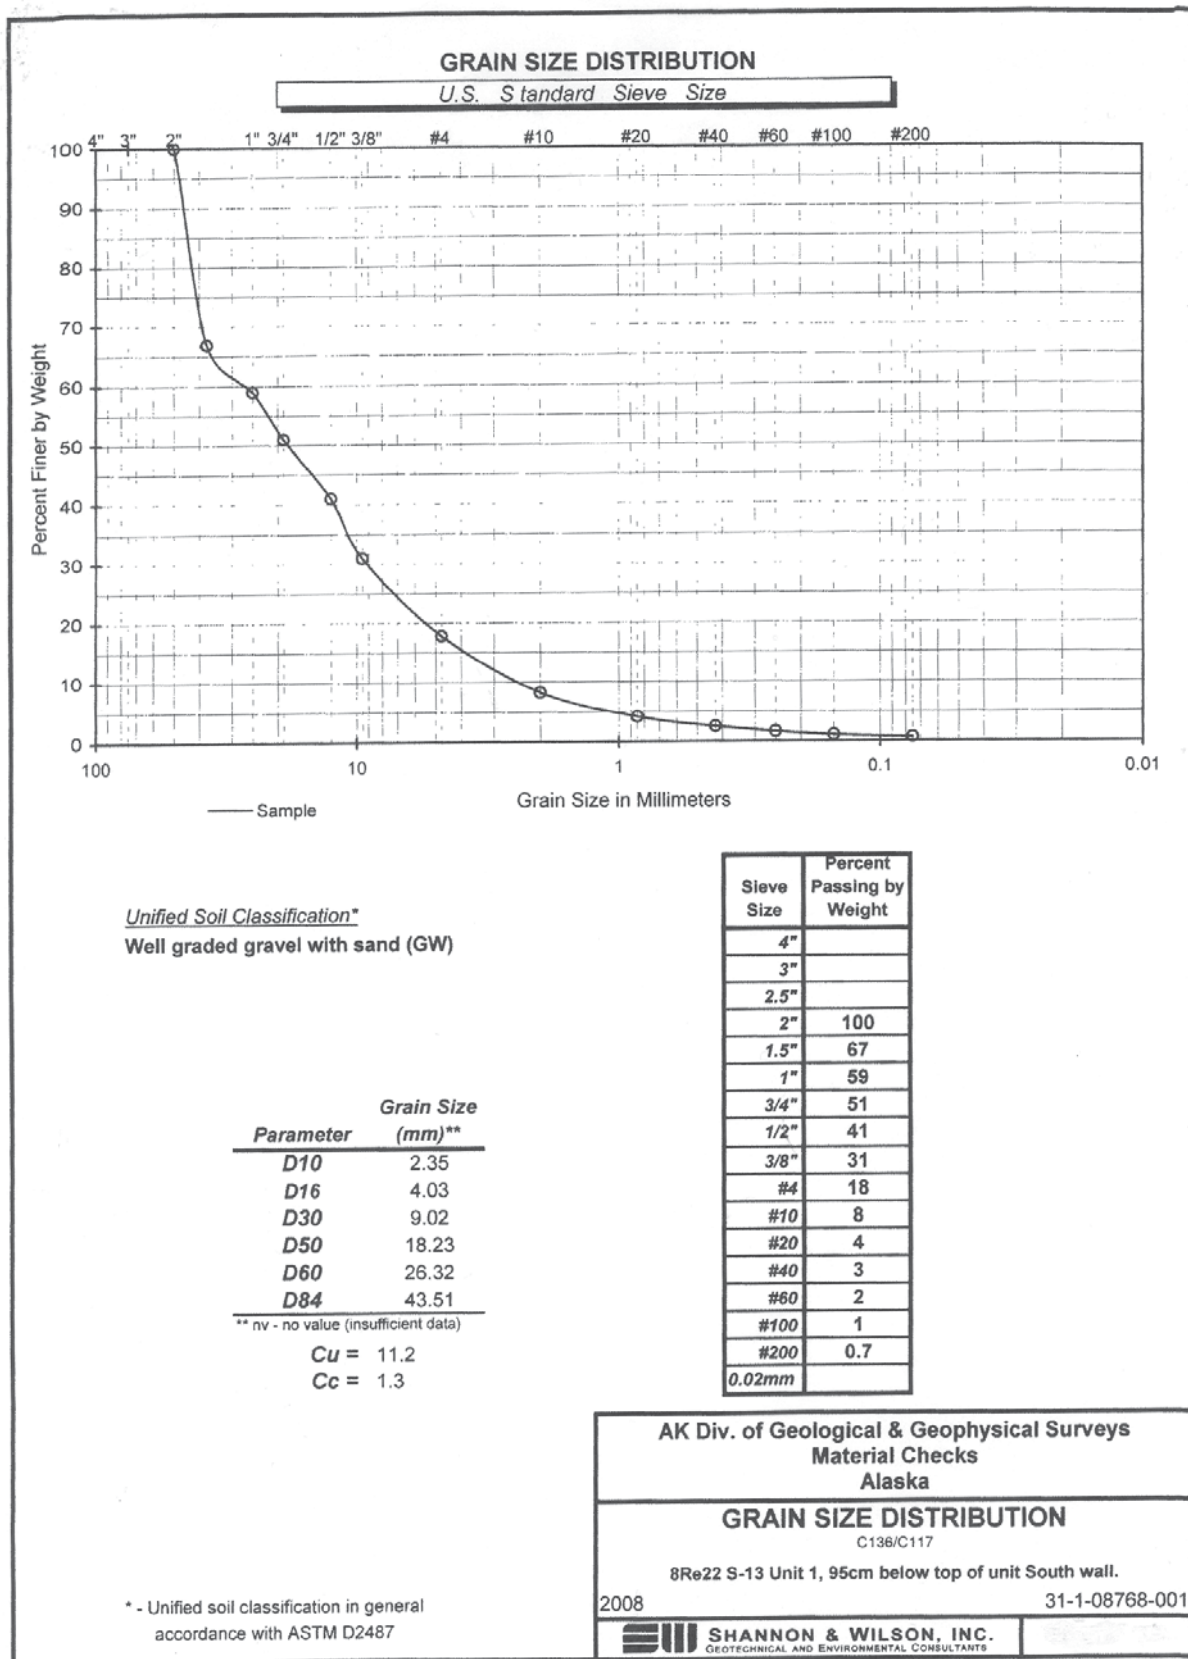
Figure A13. Diagram showing grain-size distribution of sample S-13 from M.S. 62-2-005-2 (fig. 18; sheet 4, locality A).
